Tweed River Entrance Sand Bypassing Project

Letitia Spit to Kirra

Monthly Environmental Monitoring Summary

September 2007

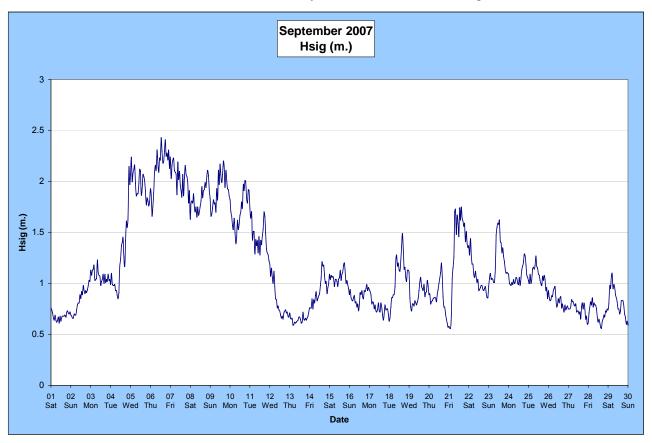
Waves of between 0.5-1.5 m from the SE dominated surf conditions on the Southern Gold Coast in September 2007 except for higher sea conditions from 5 to 11 September with wave heights of up to 2-2.4m. Winds varied over the month where the most predominant wind condition was SW at 10-20 Knots.

Readings from the Tweed Waverider Buoy showed a minimum significant wave height of 0.52m on 30th September and a maximum significant wave height of 2.43m on 6th September. There were 23 recorded days when waves dropped below 1.0m and 7 days when waves were above 2.0m.

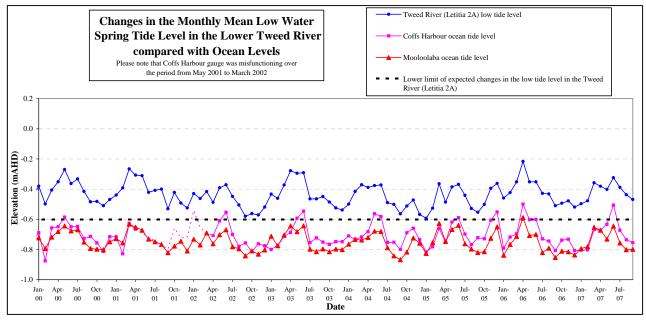
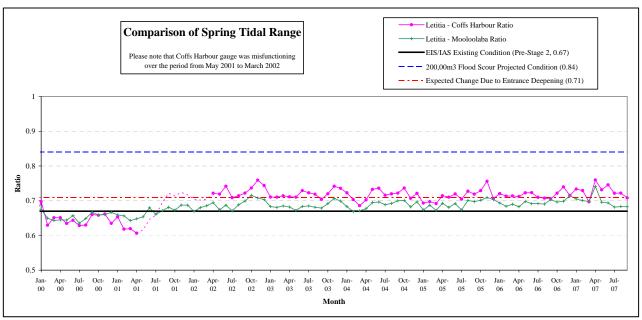
The Mean Low Water Spring (MLWS) tide level in the lower Tweed River decreased to -0.437 m AHD in August 2007 and -0.468 m AHD in September 2007.

The Letitia 2A tidal data for August and September mirrored the Mooloolaba tidal trends indicating that the TRESBP has not had a significant impact on Lower Tweed River tidal range.

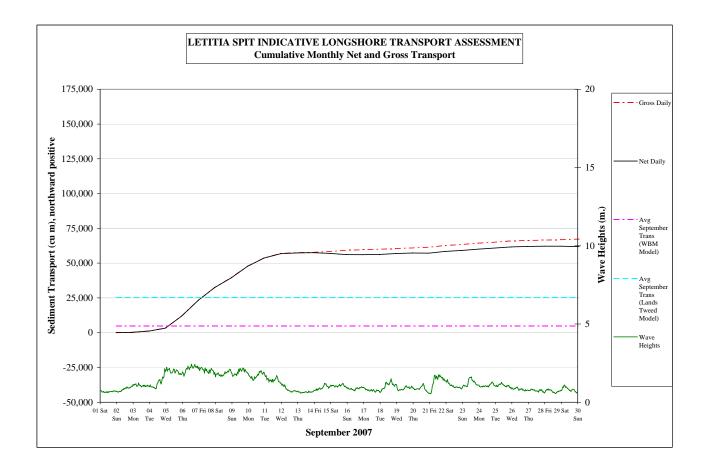
The longshore sand transport information presented in the graph below is based on a simplified sediment transport model and should only be used as an indicator of the actual sand transport quantities for the month.

It is estimated that during September 2007, 62,000m³ of sand was moved north towards the Tweed River entrance by natural processes. This is approximately two and a half times the average modelled sand transport quantity for the month of September.

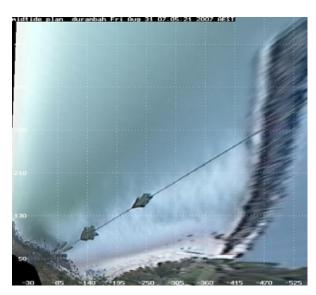
DURANBAH BEACH

31 August 2007

28 September 2007

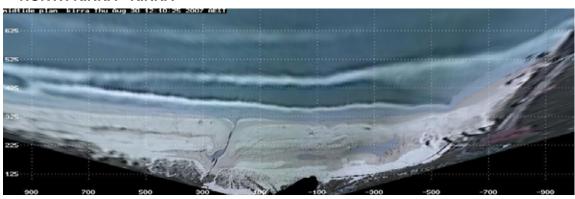
NORTH KIRRA - KIRRA

30 August 2007

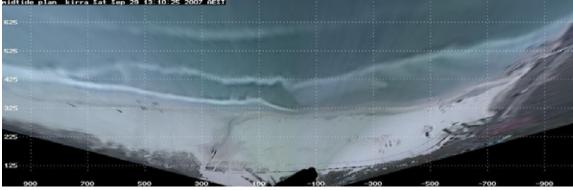
29 September 2007
