TWEED SAND BYPASSING

KIRRA BEACH

KIRRA REEF

KIRRA BEACH COASTAL MANAGEMENT STRATEGIES

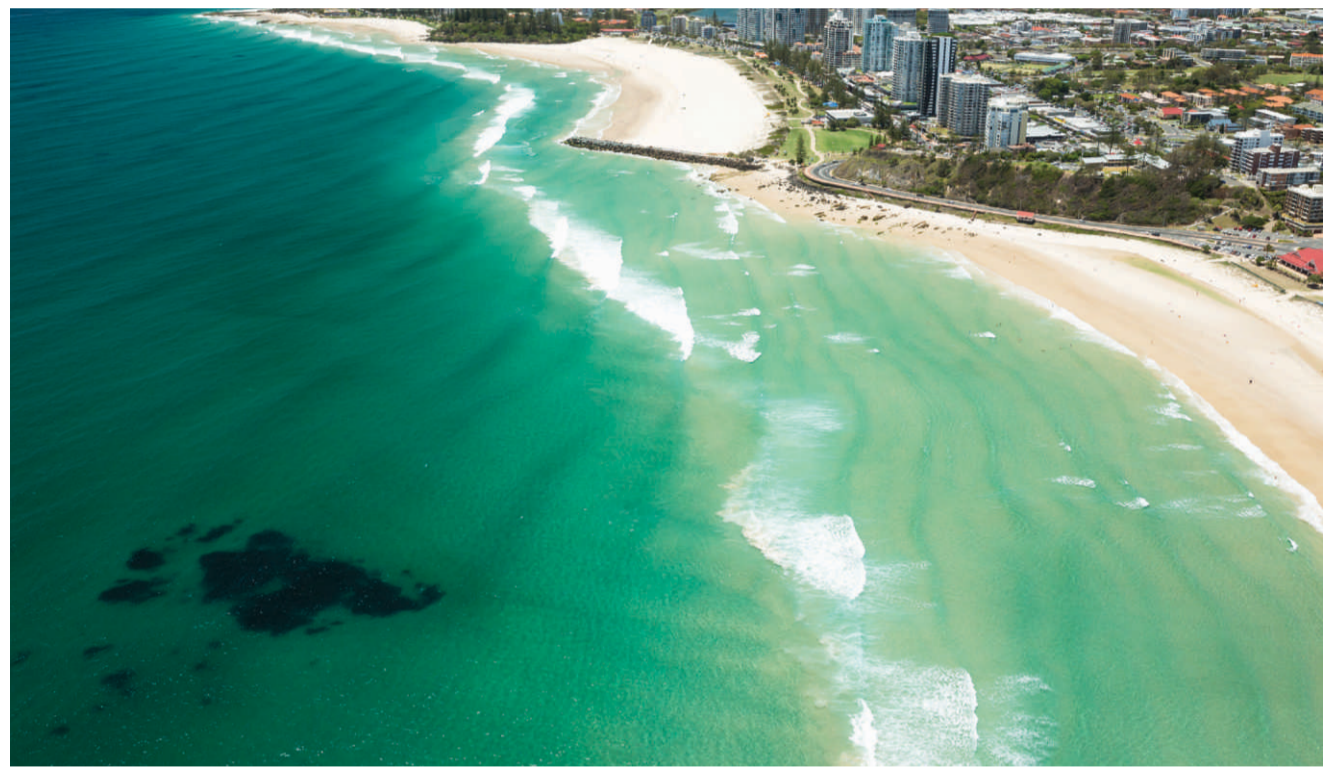
Kirra Reef located offshore of Kirra Beach - December 2014

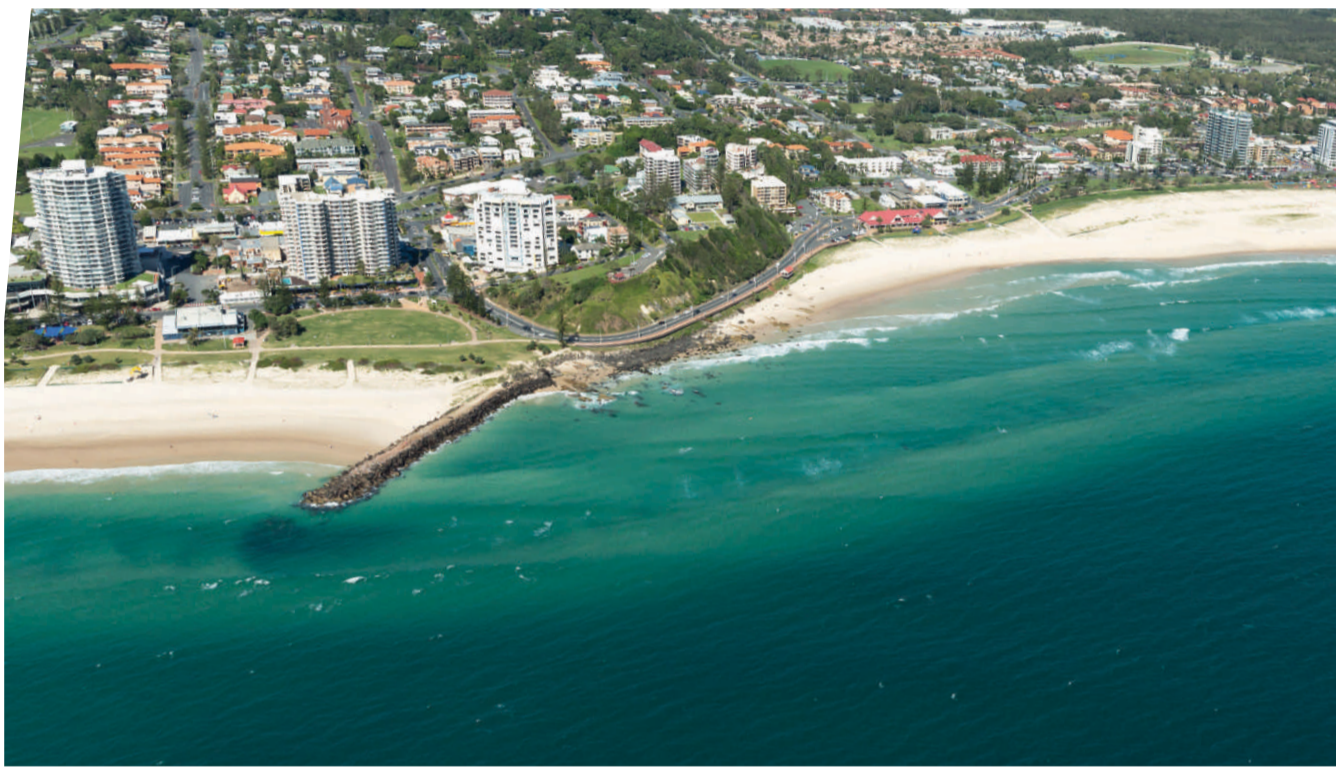
Kirra Point and Kirra beach before groyne extension - October 2012

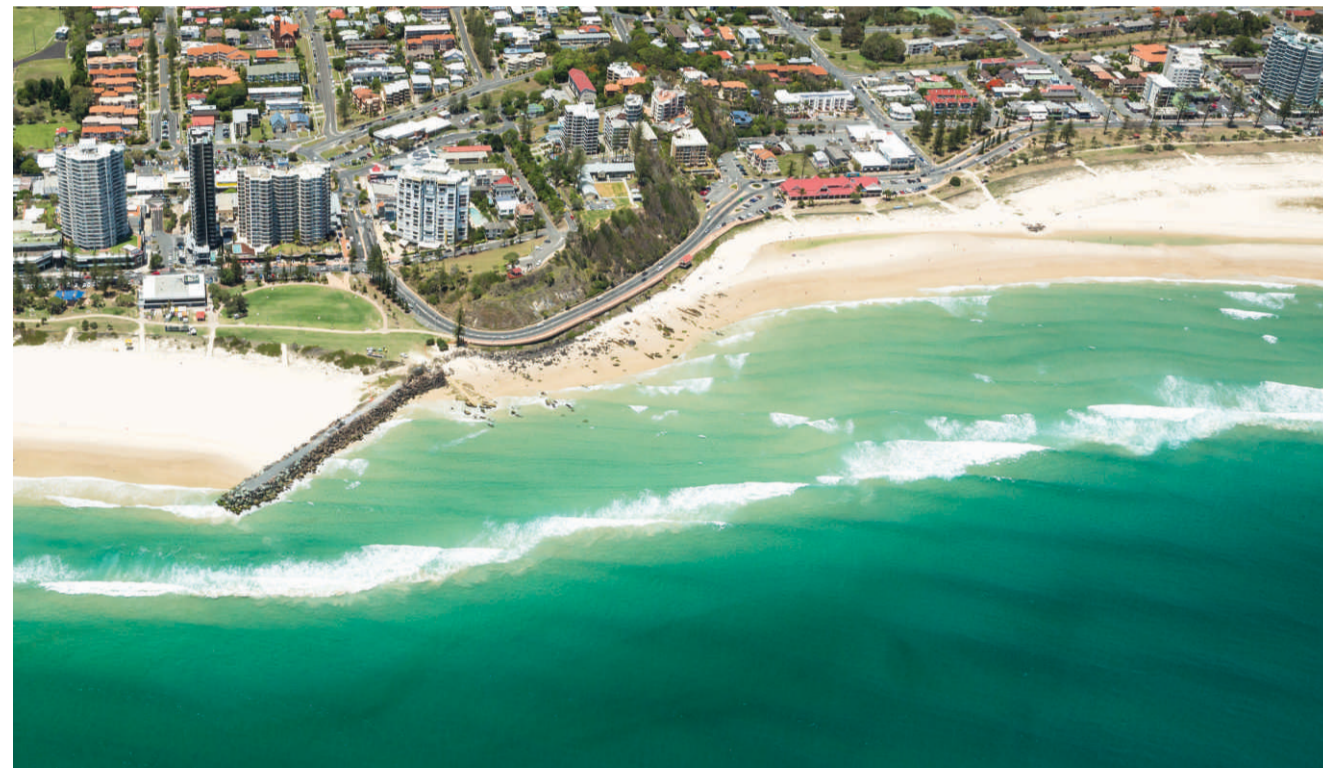
Kirra Point and Kirra Beach after groyne extension - December 2014

Since 2009 Kirra sand volumes have continued to reduce. As a result the beach width has reduced and exposure of Kirra Reef has further increased. However, conditions will continue to naturally fluctuate reflecting the seasonal variation of sand flow into Coolangatta Bay, around Kirra Point groyne and through Kirra and central Kirra Beach areas. Severe storm activity can alter these patterns at any time. Gold Coast City Council extended the length of Kirra Point groyne in December 2013 by about 30 metres. Miles Street groyne was covered by sand in 2003 and remained buried for about 10 years until wave action exposed the head of the groyne in October 2013. The head of the groyne was covered again for a while but has remained exposed since September 2014.

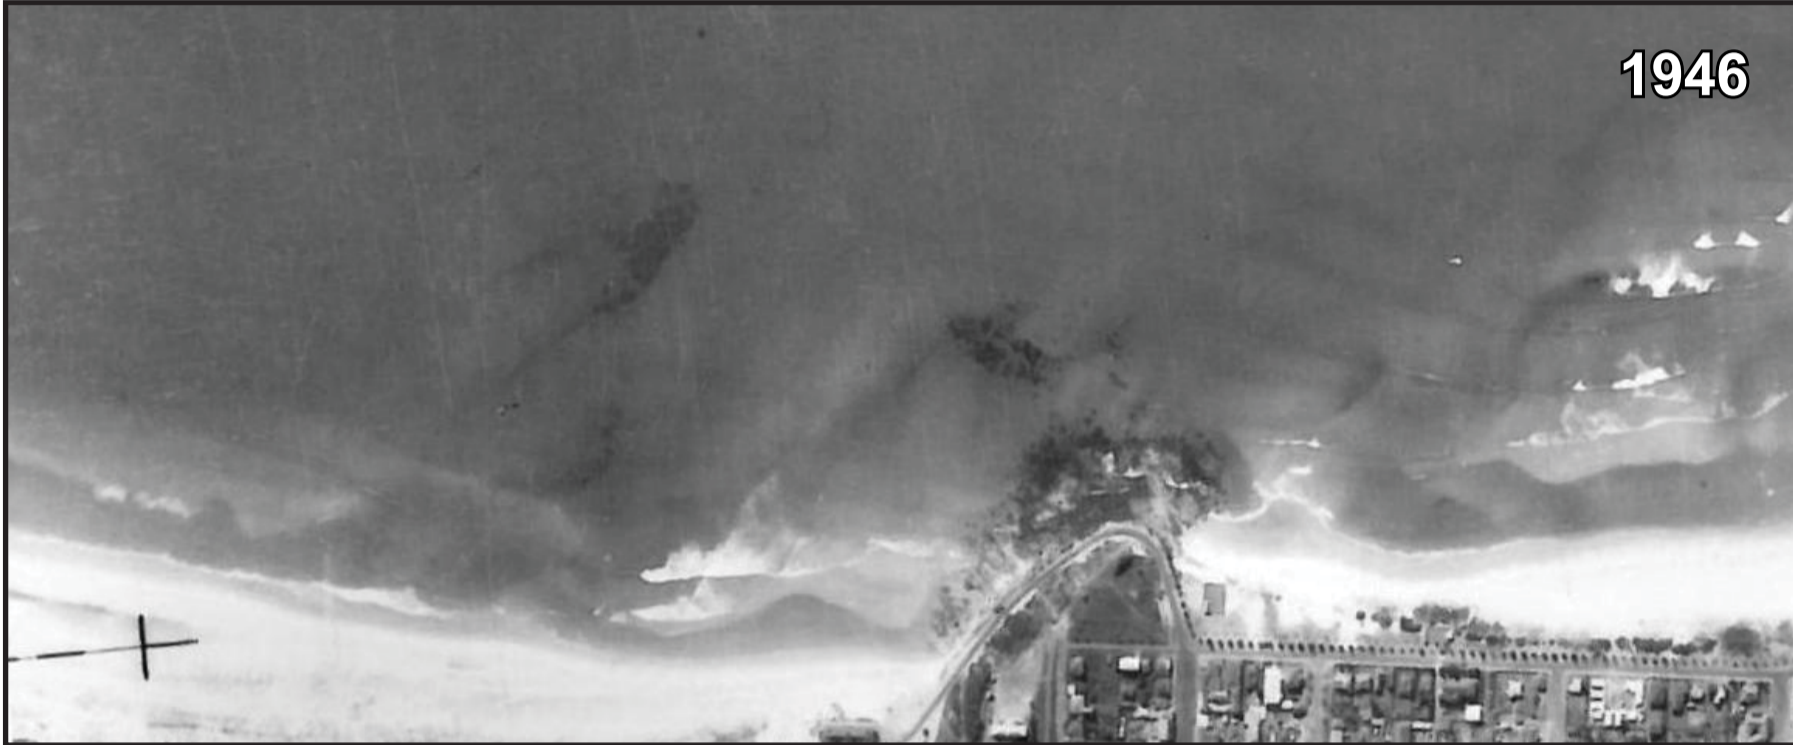
Pre 1960's Prior to the extension of the Tweed River entrance training walls and the construction of Kirra Point Groyne.
- Substantial sand coverage on both Coolangatta and Kirra beaches
- Kirra Reef partially covered by sand

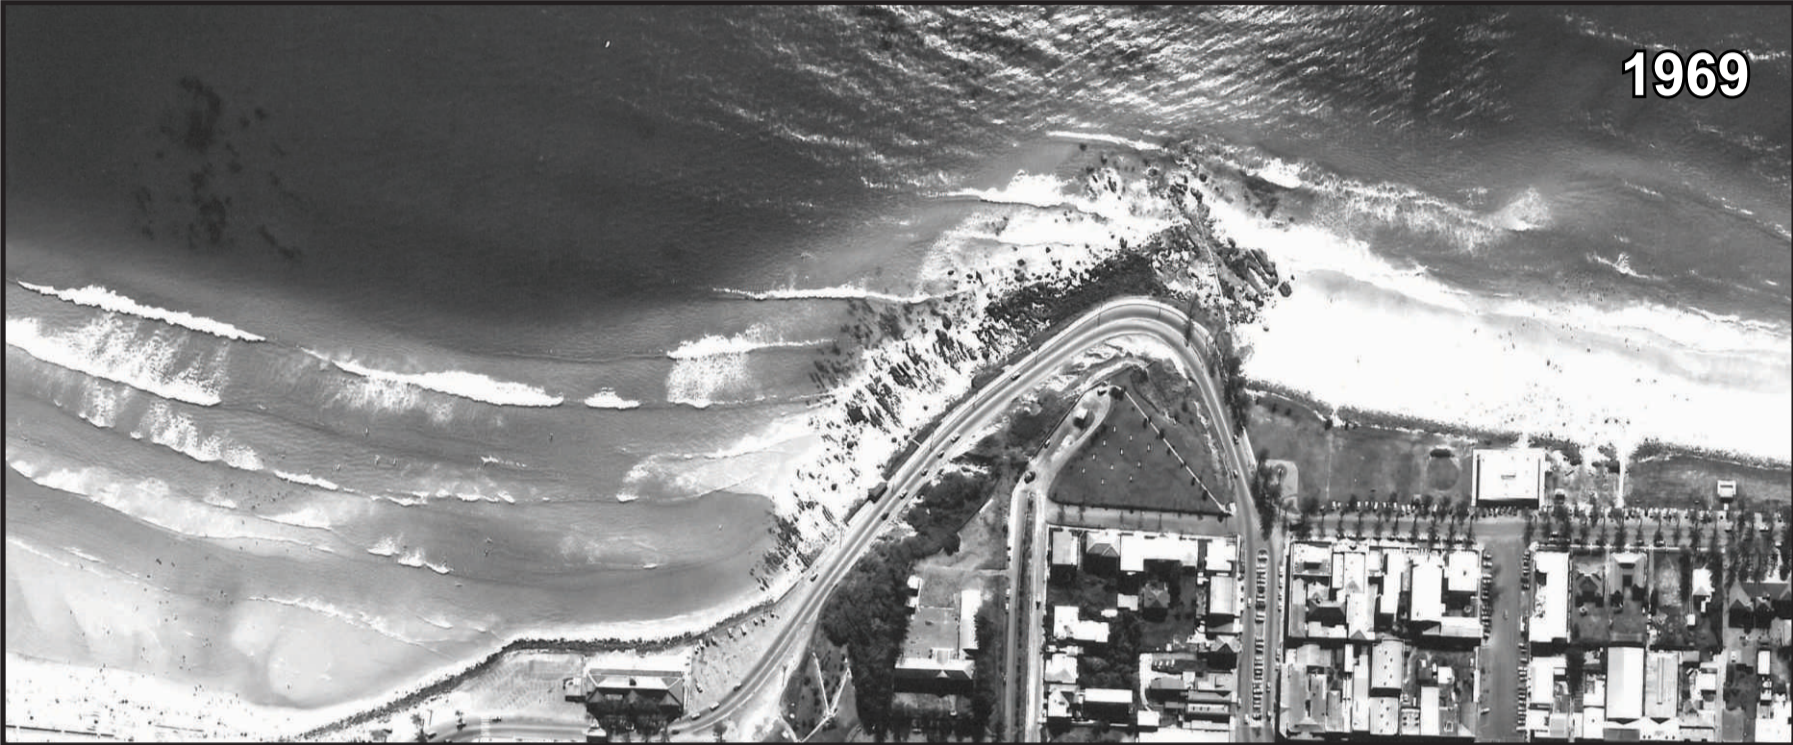
1962 – 1971 After the extension of the Tweed River training walls (1962-1965) but prior to Kirra Point Groyne being constructed.
- Depleted sand supply causing both Coolangatta and Kirra beaches retreat
- Kirra reef becoming increasingly exposed

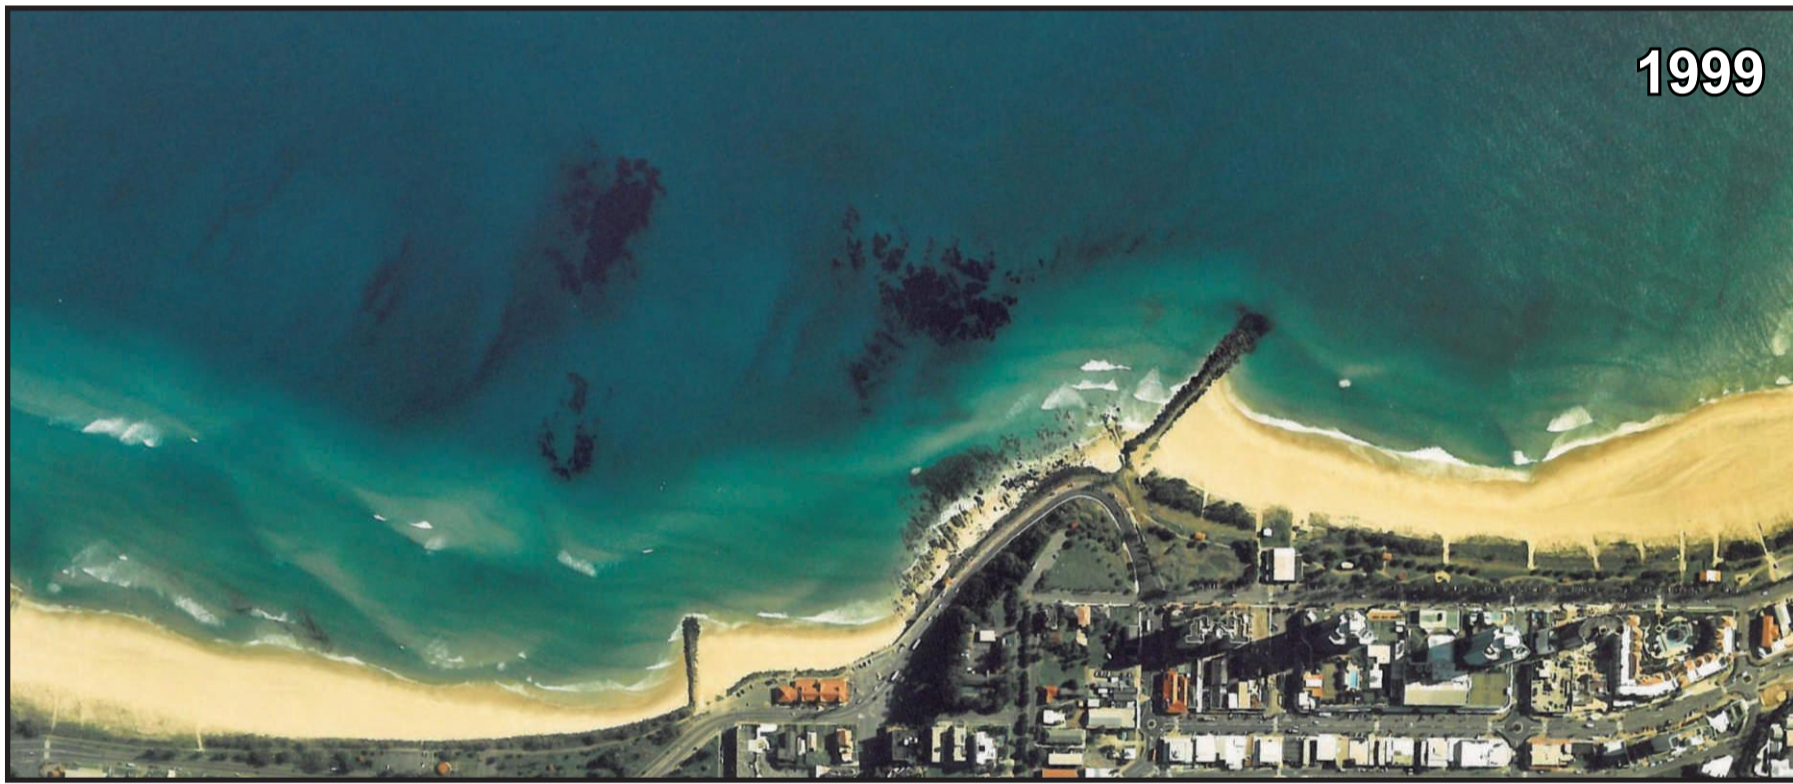
1972 – 2001 After the construction of Kirra Point Groyne (1972) but prior to the commencement of Tweed Sand Bypassing
- Coolangatta beach expands as sand accumulates updrift of Kirra Point Groyne.
- Kirra beach retreats and Miles Street groyne is constructed in 1974.
- Kirra reef is at its most exposed in recent years.

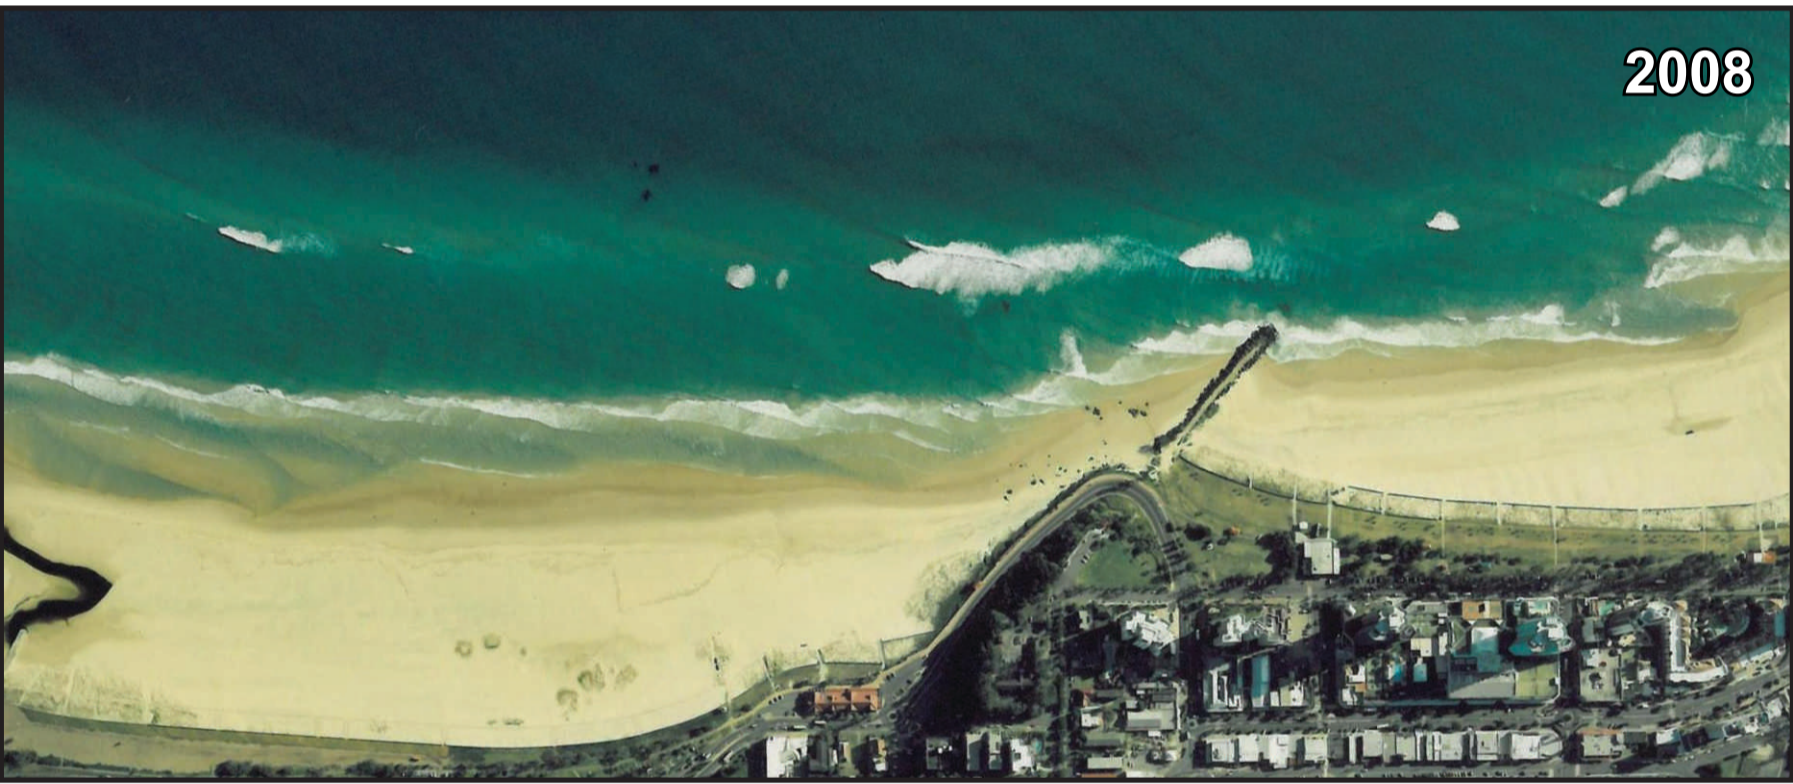
2002 – 2008 After initial commencement of Tweed Sand Bypassing
- Coolangatta and Kirra beaches widen as large supplies of sand are delivered as part of the initial stages of Tweed Sand Bypassing.
- Kirra Reef becomes inundated by sand, especially the inner and eastern reefs

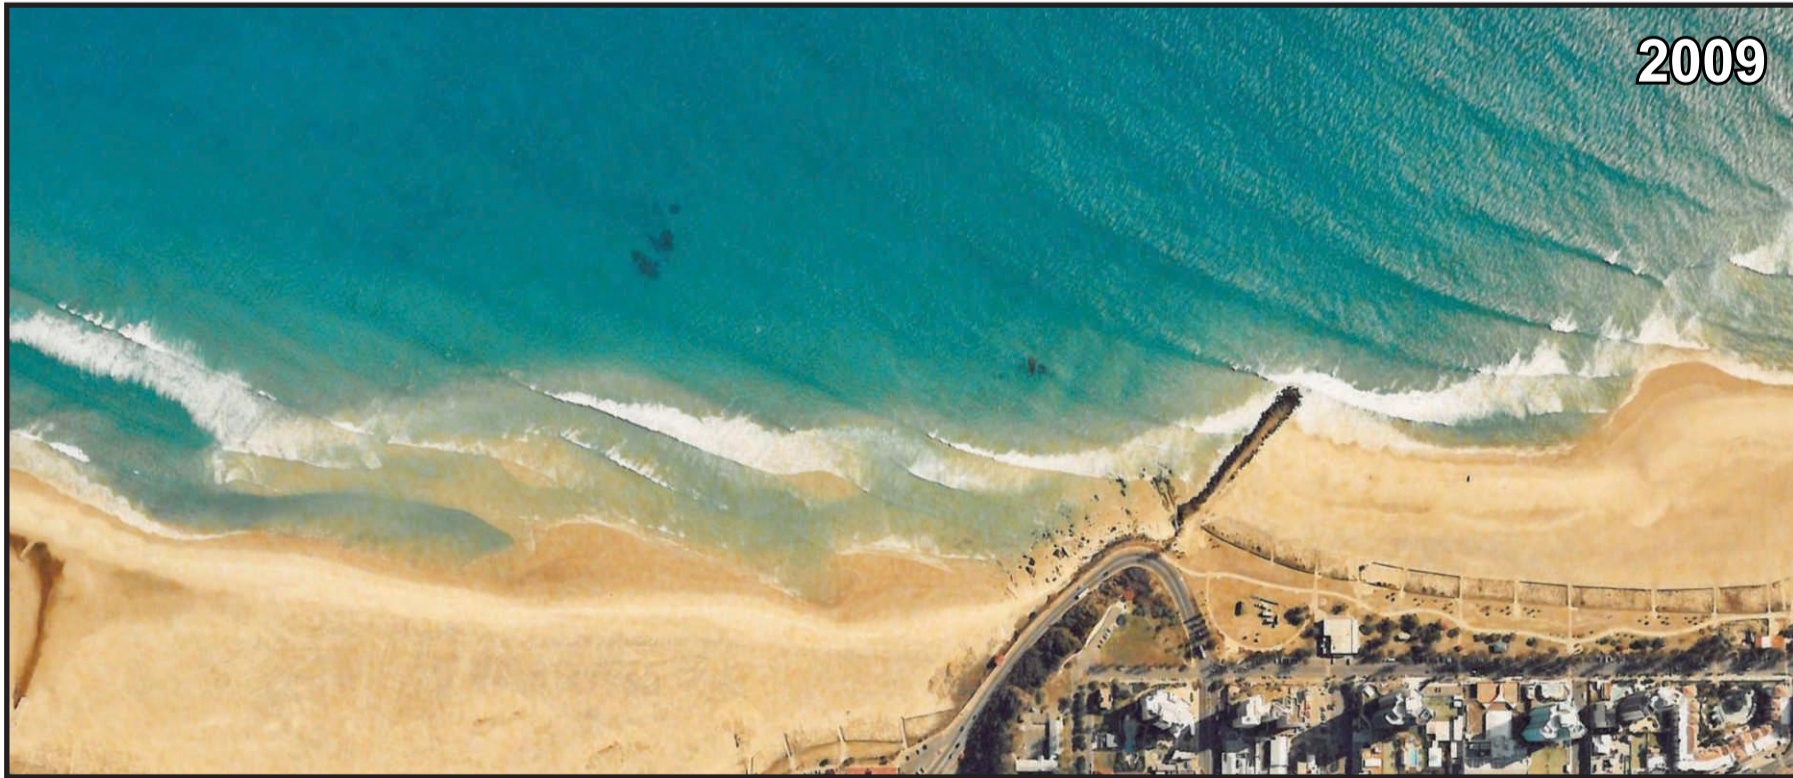
2009 Eight years after Tweed Sand Bypassing commenced
- A series of severe storms in May 2009 shift approximately 200,000 cubic metres of sand towards Bilinga and Tugun beaches to the north, uncovering Kirra Reef.

The supplementary sand did not disperse north as quickly as predicted. This was due to the region experiencing a decade of calmer than usual storm seasons, particularly a lack of cyclonic events from the North East. In May 2009 there were a series of large storm events which saw a loss of over 200,000 cubic metres of sand from the upper beach and offshore area between the Kirra Point and Miles Street groynes. By mid 2009, the seabed had lowered in depth by about 2 metres and Kirra Reef became more exposed. In addition to natural processes, the Queensland Government completed the Kirra Beach restoration project which saw Gold Coast City Council relocating 136,000 cubic metres of sand from the intertidal zone to form a low profile back beach dune. These works were successful in further reducing beach widths at Kirra.

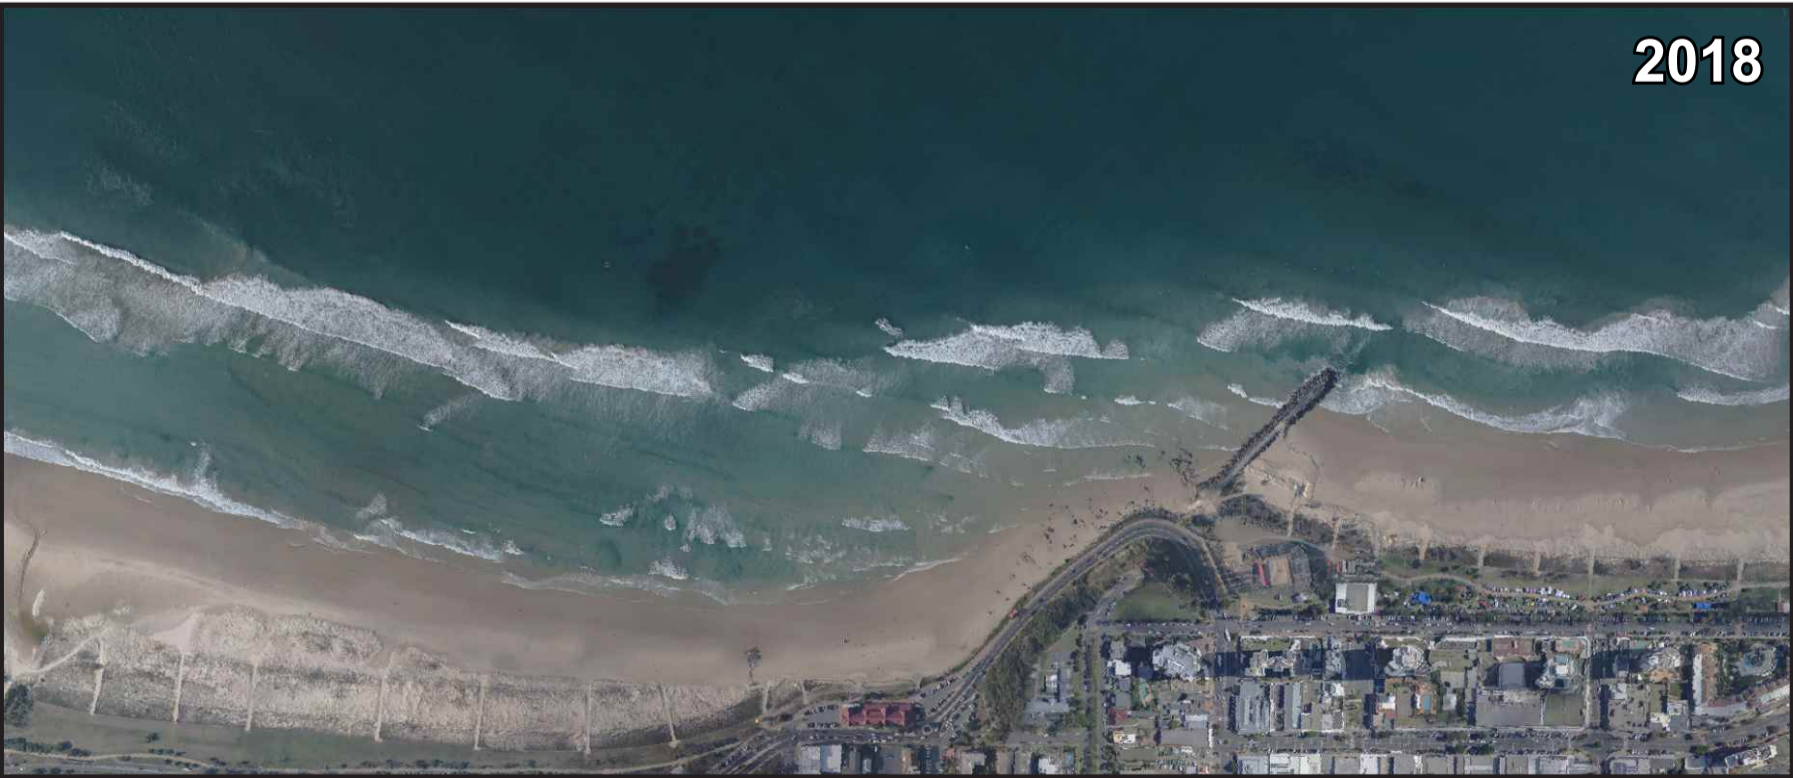
2009 – 2018 Nine years after the May 2009 storms
- The overall sand volumes at Kirra continue to reduce and Kirra reef is exposed.

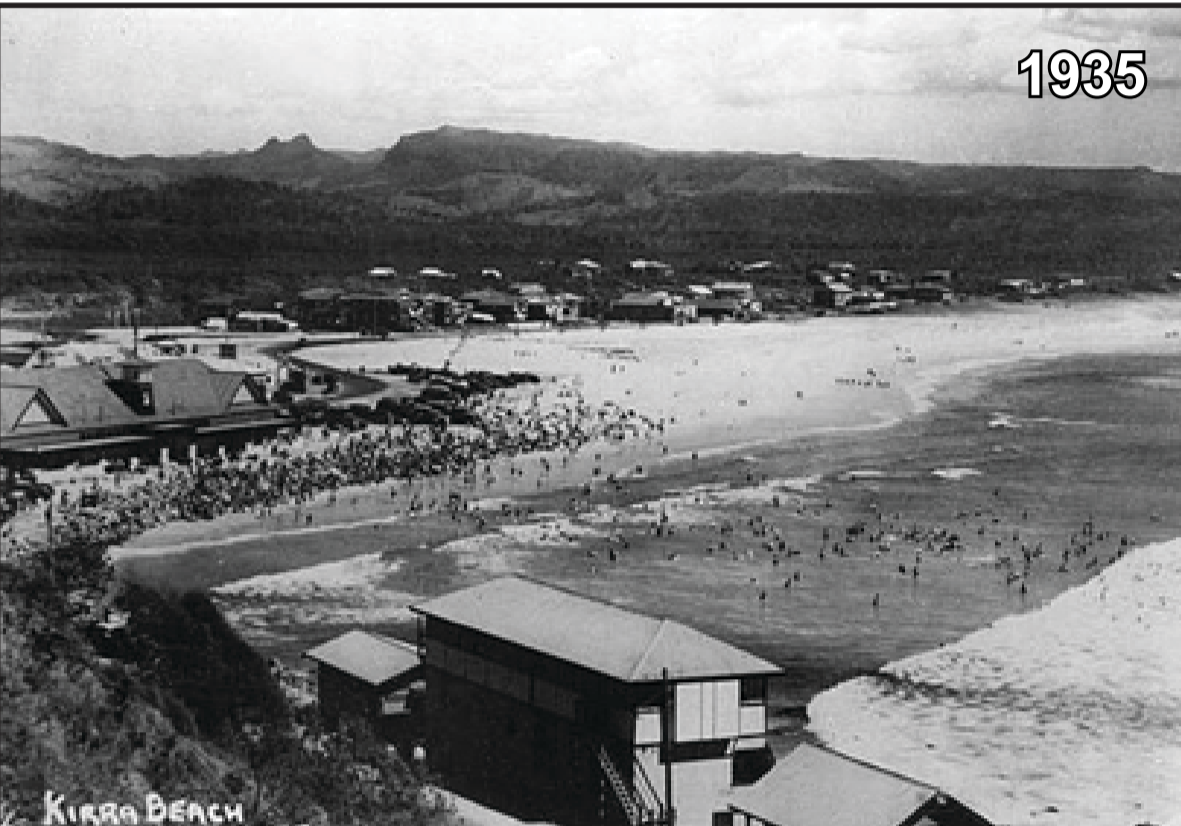
1930's Kirra Beach and foredune comprised a total width of approximately 200 metres

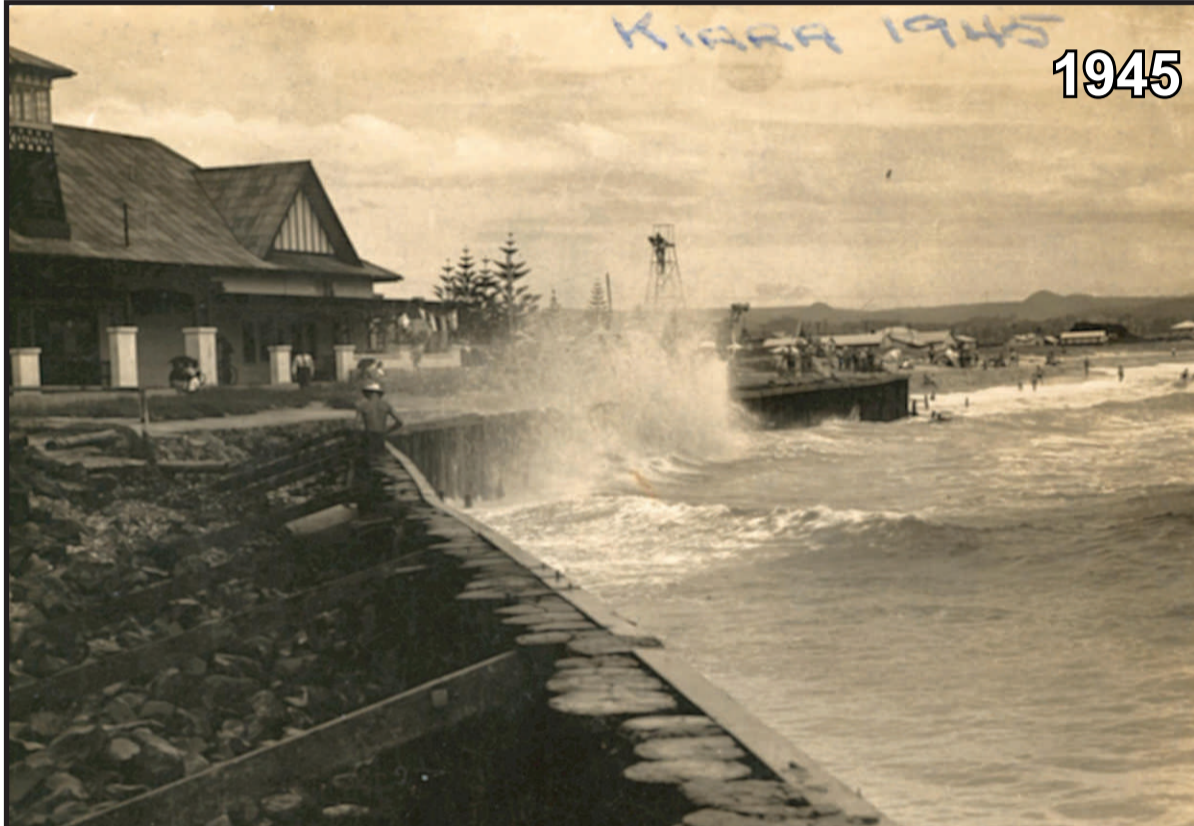
1940's There were a series of catastrophic storms, and during this time Kirra and other beaches of the southern Gold Coast were in a severely eroded condition. Seawalls were built to protect the infrastructure.

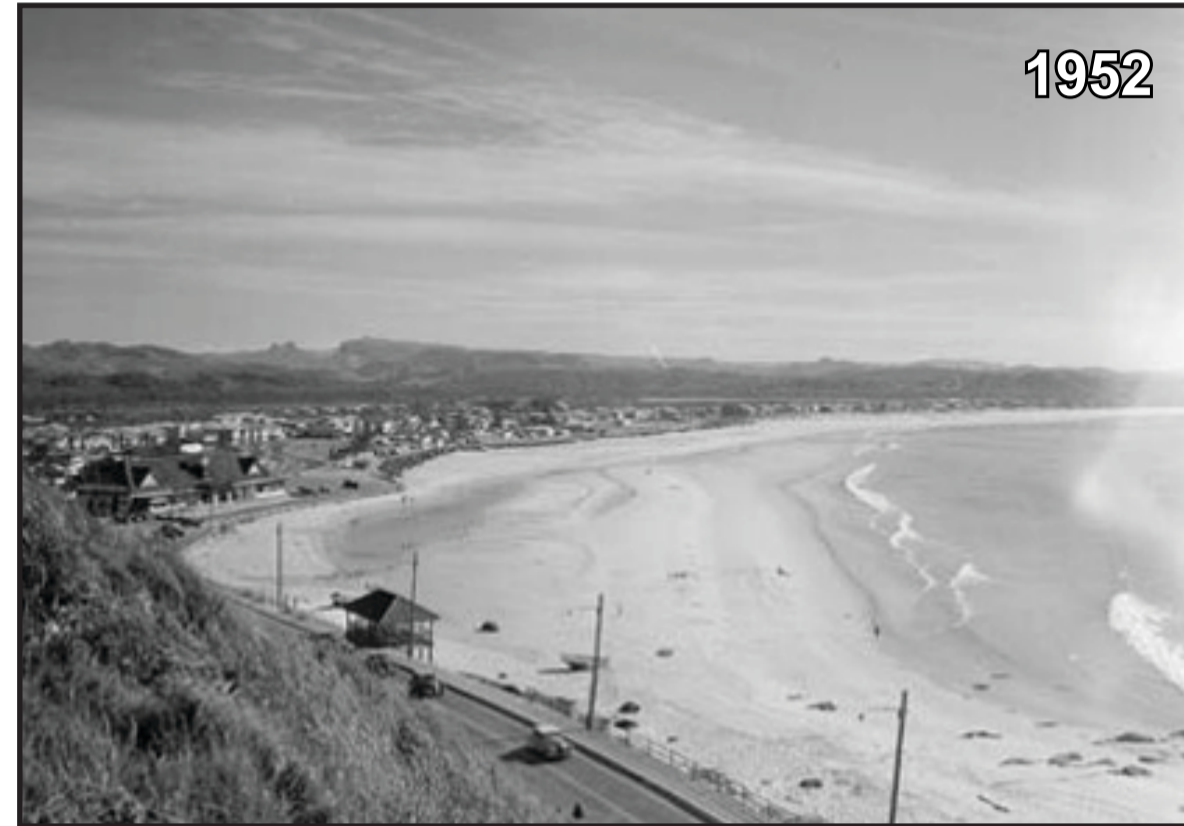
1950's Kirra had recovered from storm events in the previous decade and was in an accreted condition.

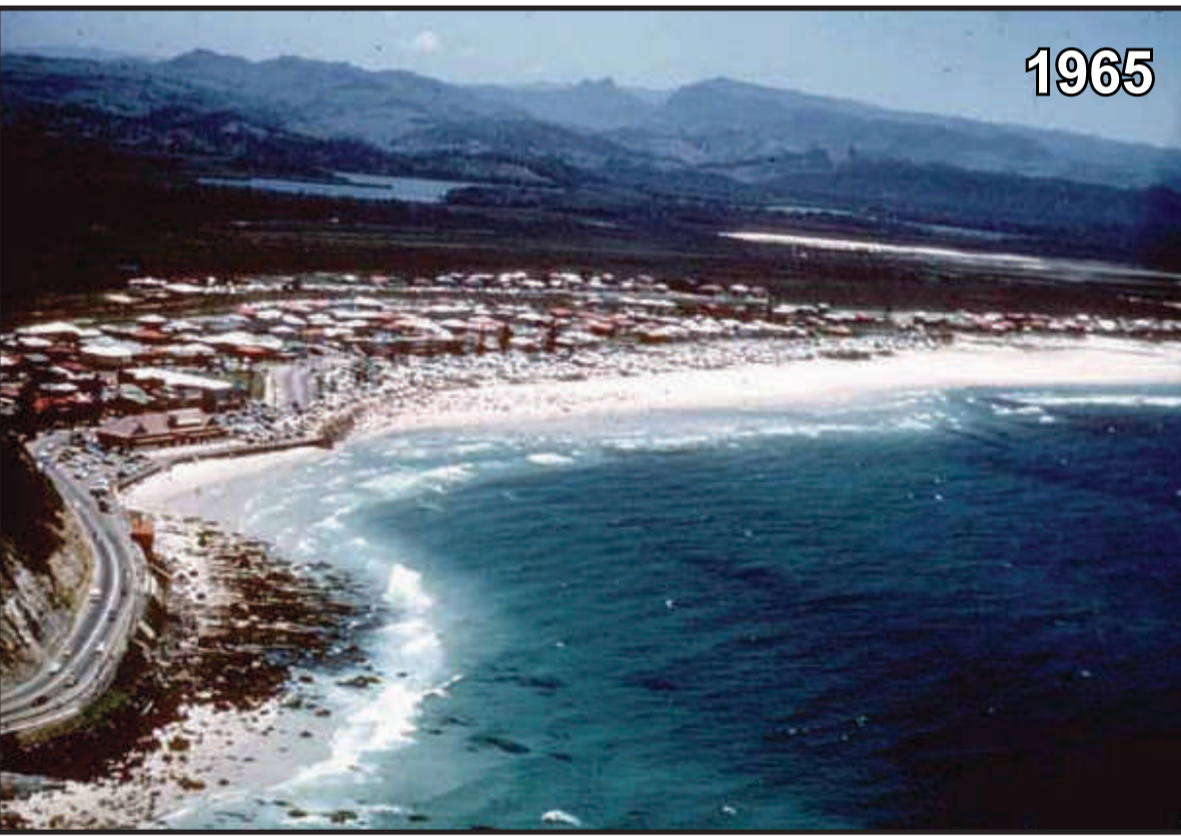
1960's The Tweed River training walls were extended between 1962 and 1965 to maintain a navigable entrance. During 1967 the Gold Coast experienced several cyclones and the erosion effects due to the disruption in longshore sand supply became apparent.

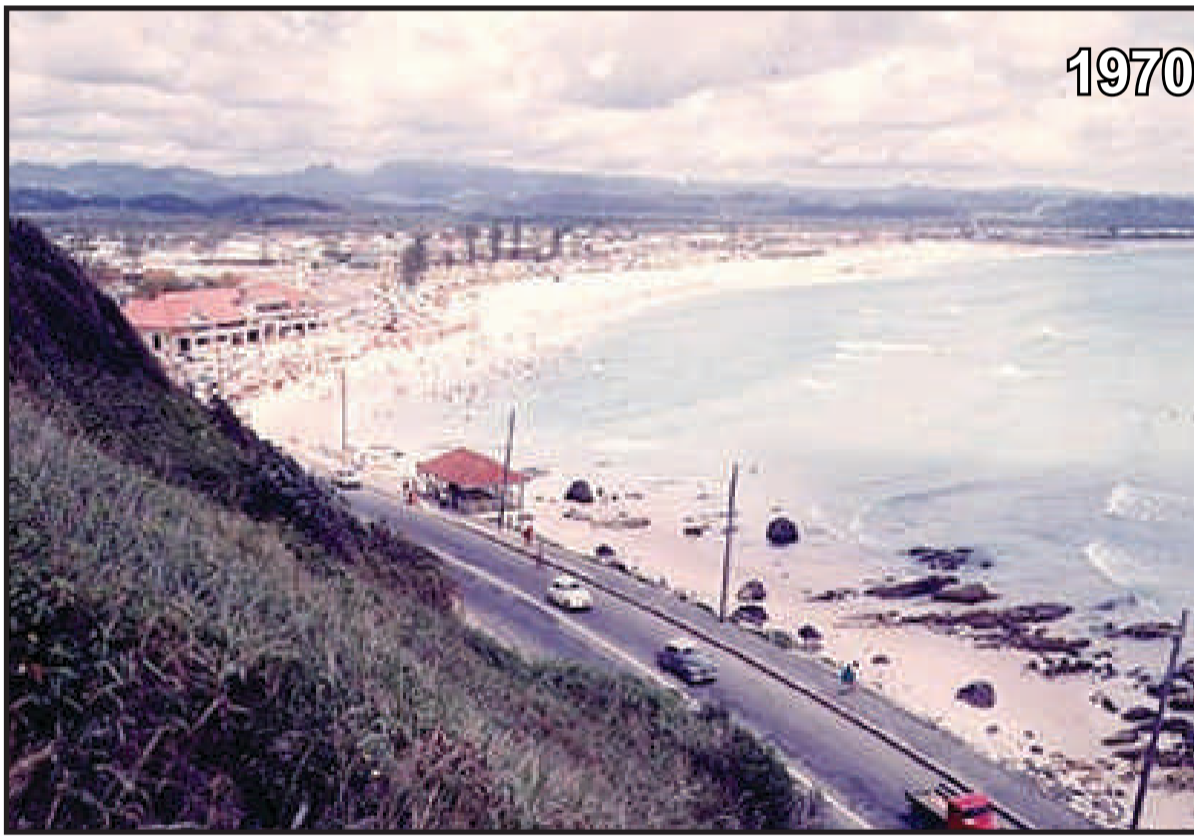
1970's In 1972 the Kirra Point Groyne was built, followed by a seawall in 1973 and Miles Street groyne in 1974. In 1975 a total of 765,000 cubic metres of sand was pumped from the lower reaches of the Tweed River to nourish Kirra.

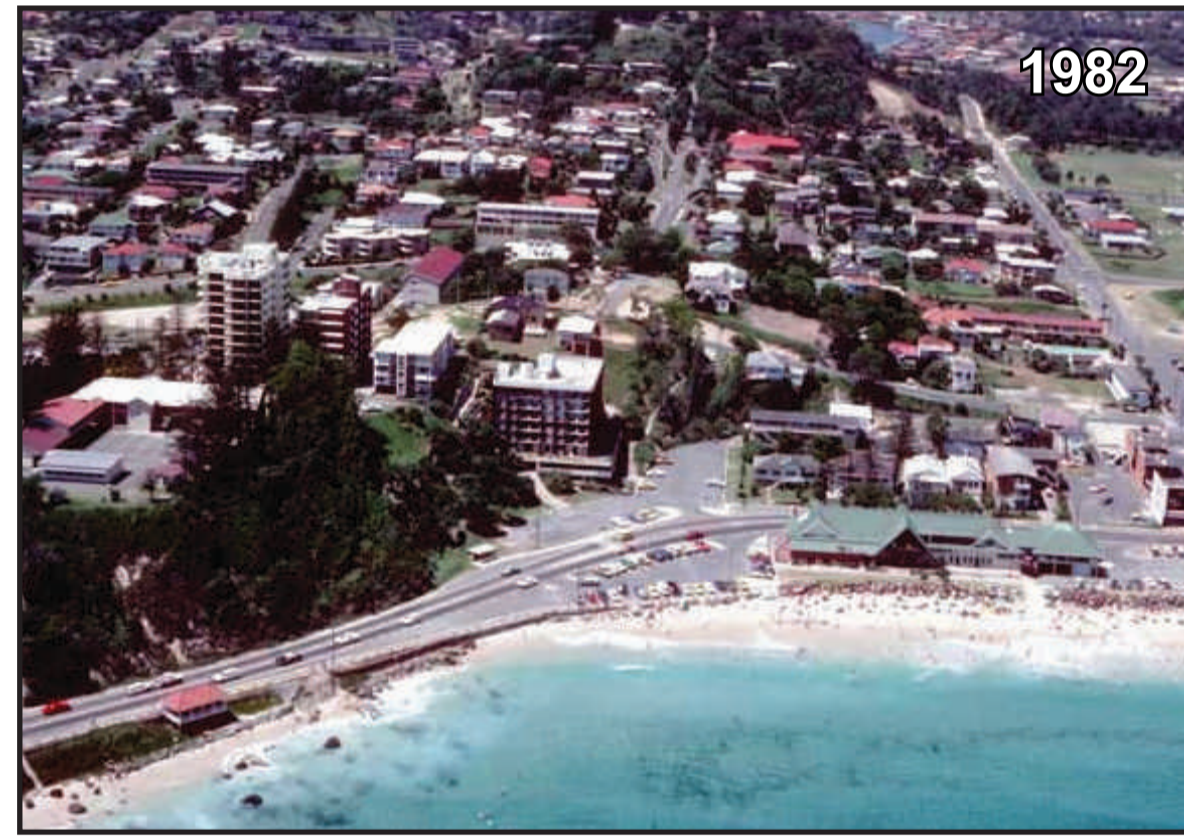
1980's Erosion at Kirra reached a peak in 1982 and rock exposure at Kirra headland and Kirra reef was greatest during this period. In 1985 a further 315,000 cubic metres was placed at North Kirra beach.

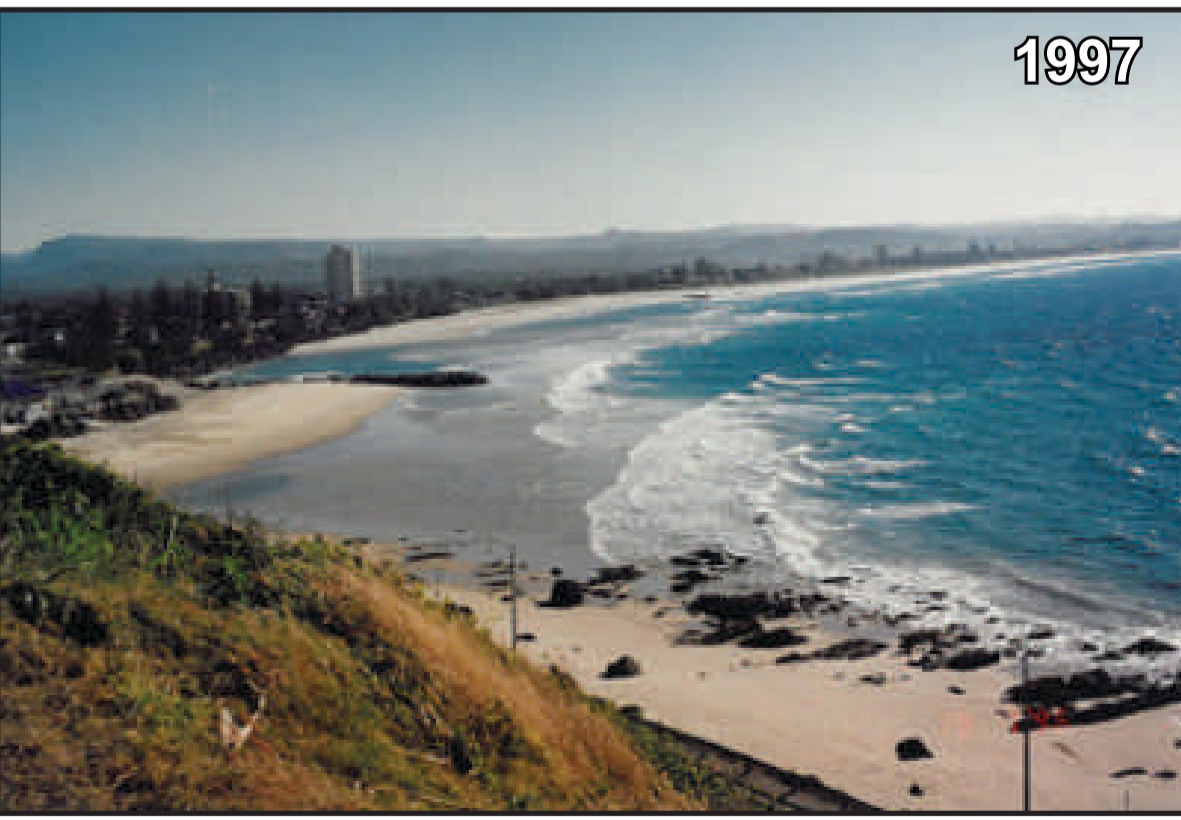
1990's The initial stages of the TRESBP provided 3.6 million cubic metres between Kirra and Tugun to offset severe erosion and allow for new beaches to be established.

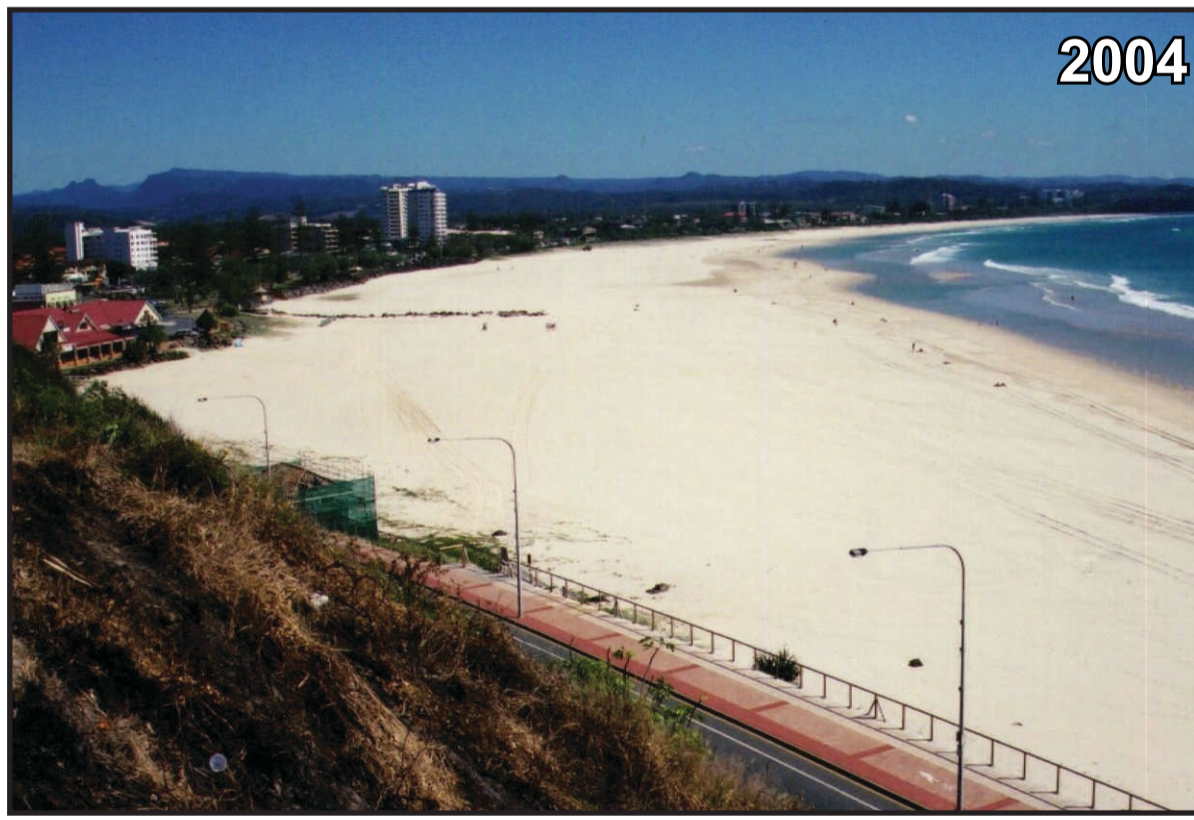
2000's The Tweed River Entrance Sand Bypassing Act was passed in 1995 in NSW and 1998 in Qld with the permanent bypassing system officially commissioned in 2001.

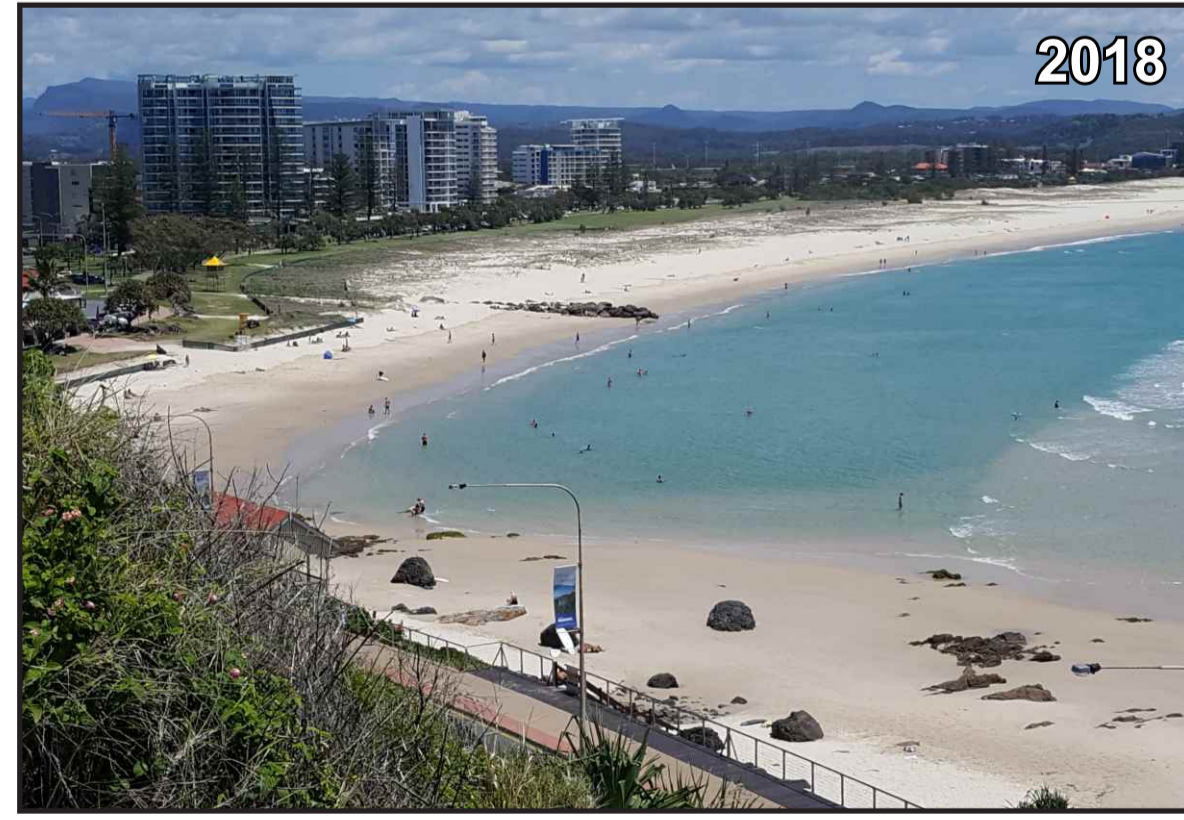
2018 Since 2009 Kirra Beach has significantly reduced in width.
