Tweed River Entrance Sand Bypassing Project

Letitia Spit to Kirra

Monthly Environmental Monitoring Summary

MARCH 2007

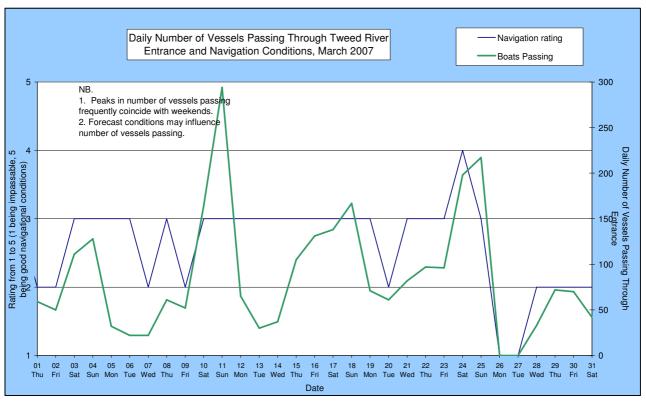
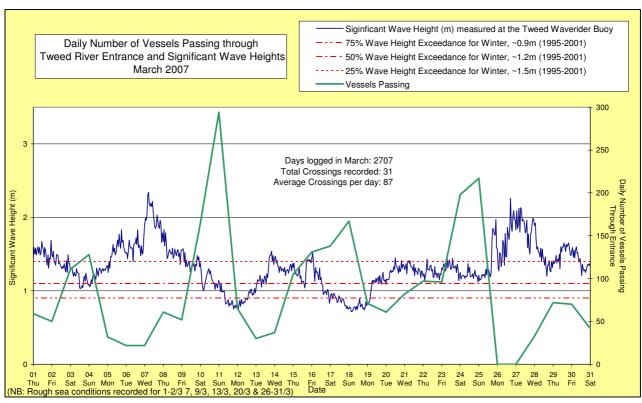
Volunteer Marine Rescue Pt Danger (VMR) has been monitoring daily entrance conditions on behalf of the TRESBP since 20 January 2002, monitoring results for March 2007 are presented below.

2 – Difficulty encountered 5 – Good conditions 1 – Impassable 3 – Some difficulty encountered

4 – Relatively good crossing

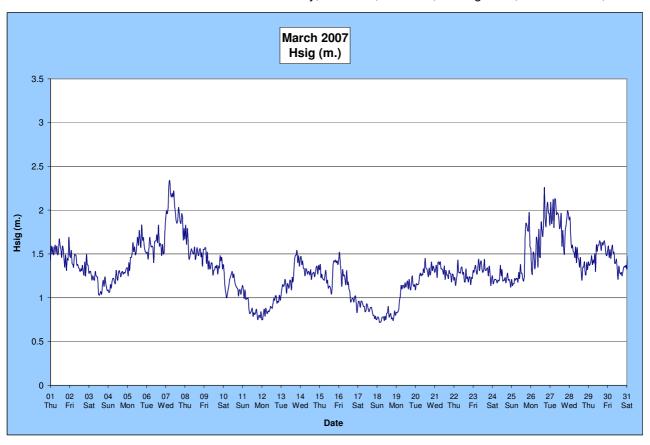
Waves of between 1-2 m from the E dominated surf conditions on the Southern Gold Coast in March 2007. Winds varied over the month where the most predominant wind conditions were SE and SW at 10-25 Knots.

Readings from the Tweed Waverider Buoy showed a minimum significant wave height of 0.72m on 18 March and a maximum significant wave height of 2.34m on 7 March. There were 6 recorded days when waves dropped below 1.0m and 3 days when waves were above 2.0m.

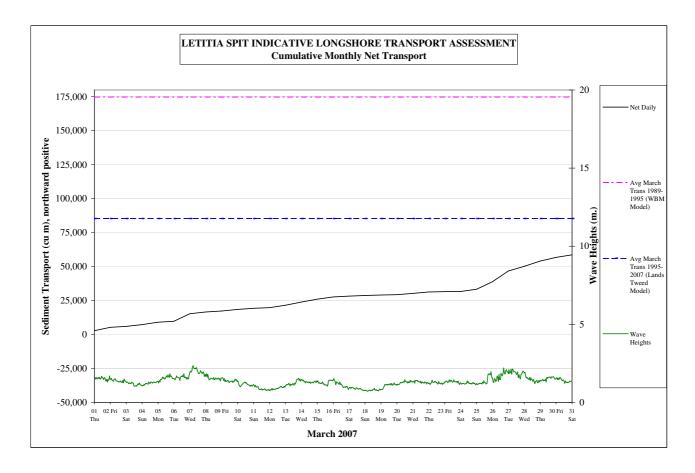
The longshore sand transport information presented in the graph below is based on a simplified sediment transport model and should only be used as an indicator of the actual sand transport quantities for the month.

It is estimated that during March 2007, 59,000m³ of sand was moved north towards the Tweed River entrance by natural processes. This is less than the modelled average sand transport quantity for the month of March.
