Land and Property
Management Authority

Kirra Groyne Effects Study

301001-00826 – 001

9-Nov-09

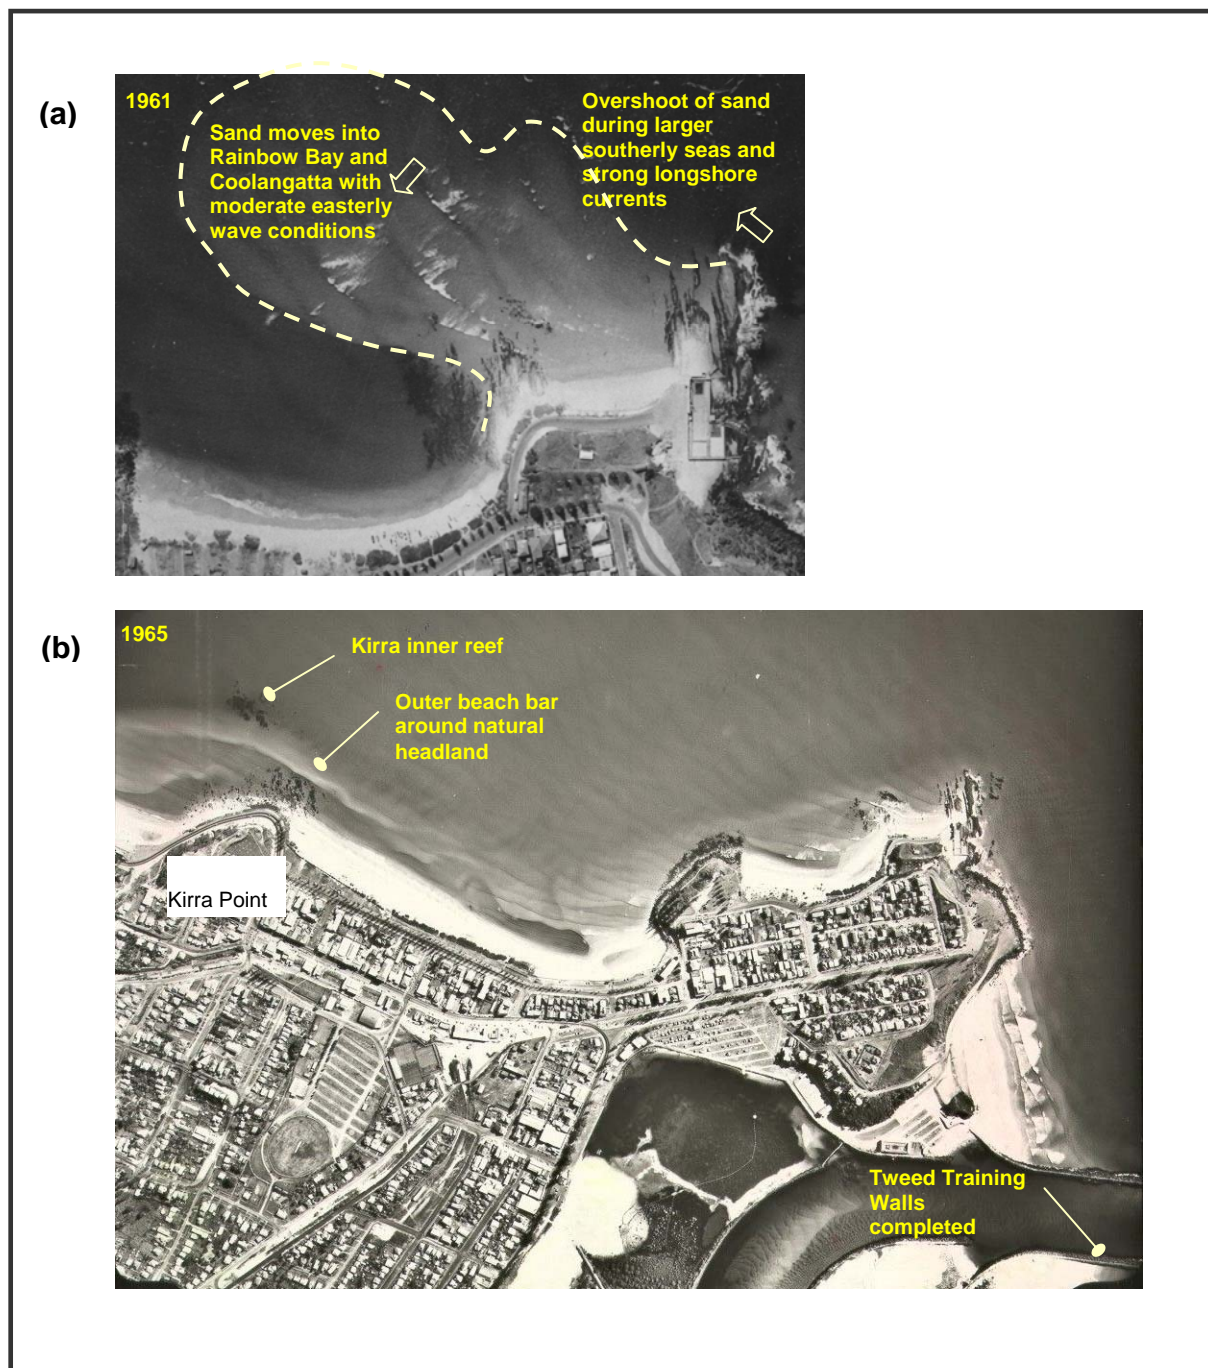
Figure A.3 Sand movements (a) 1961 (b) 1965

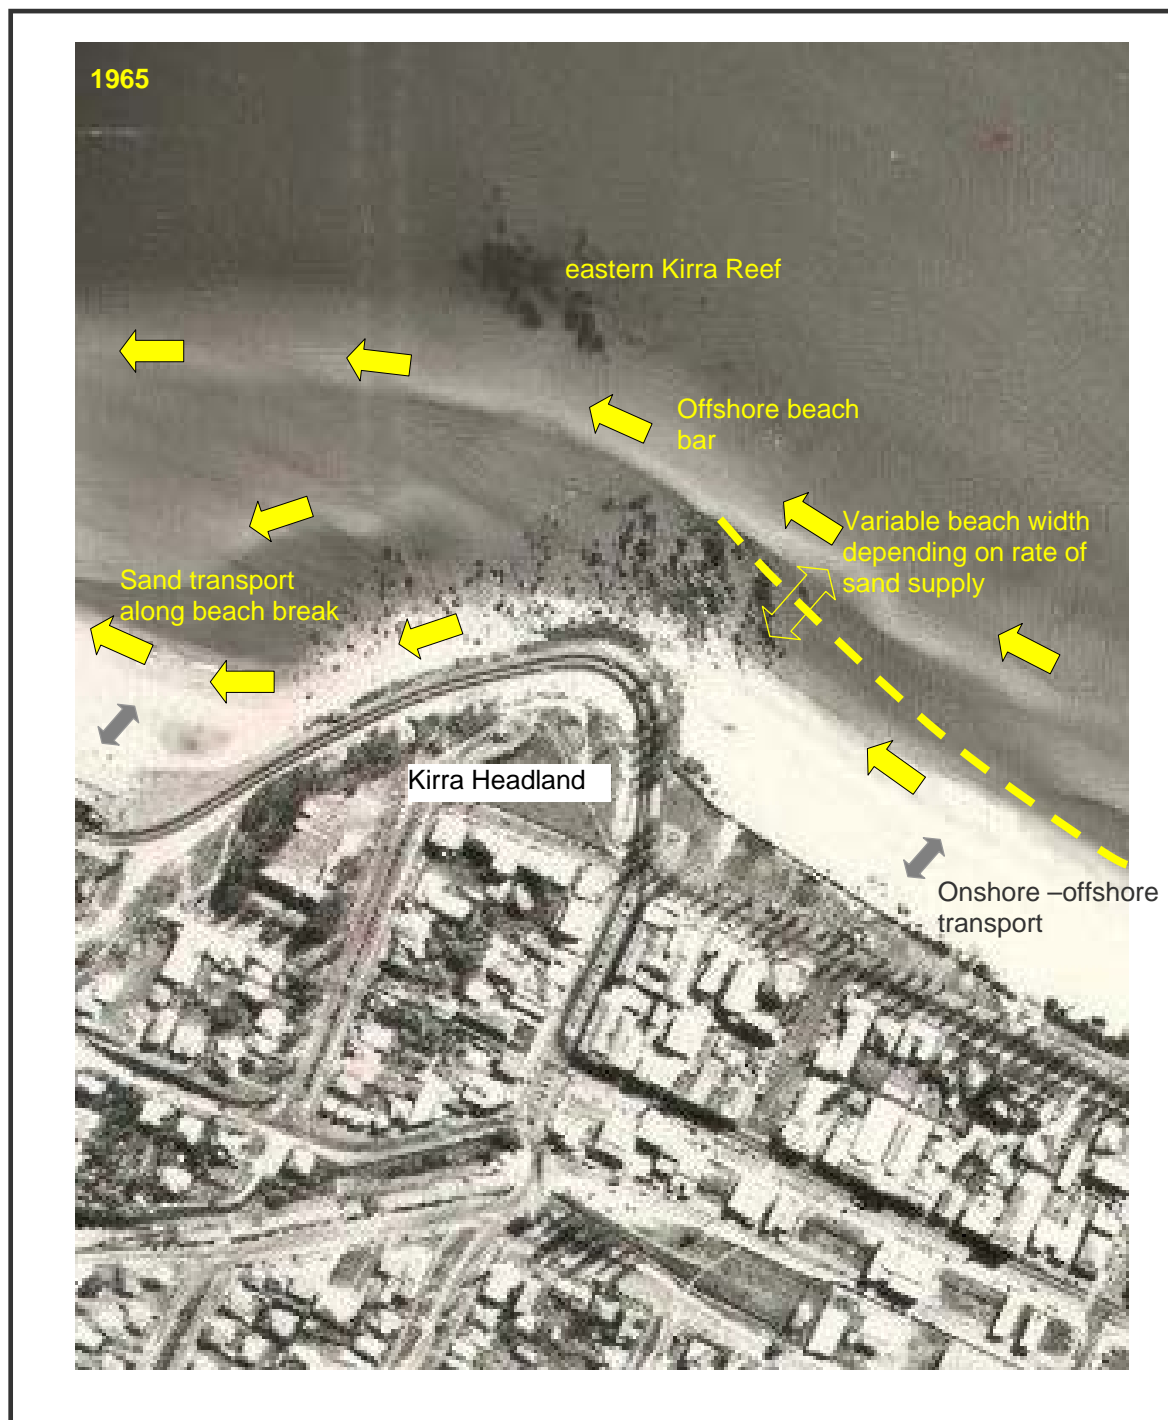
Figure A.4 Kirra headland sand movement mid-1960s

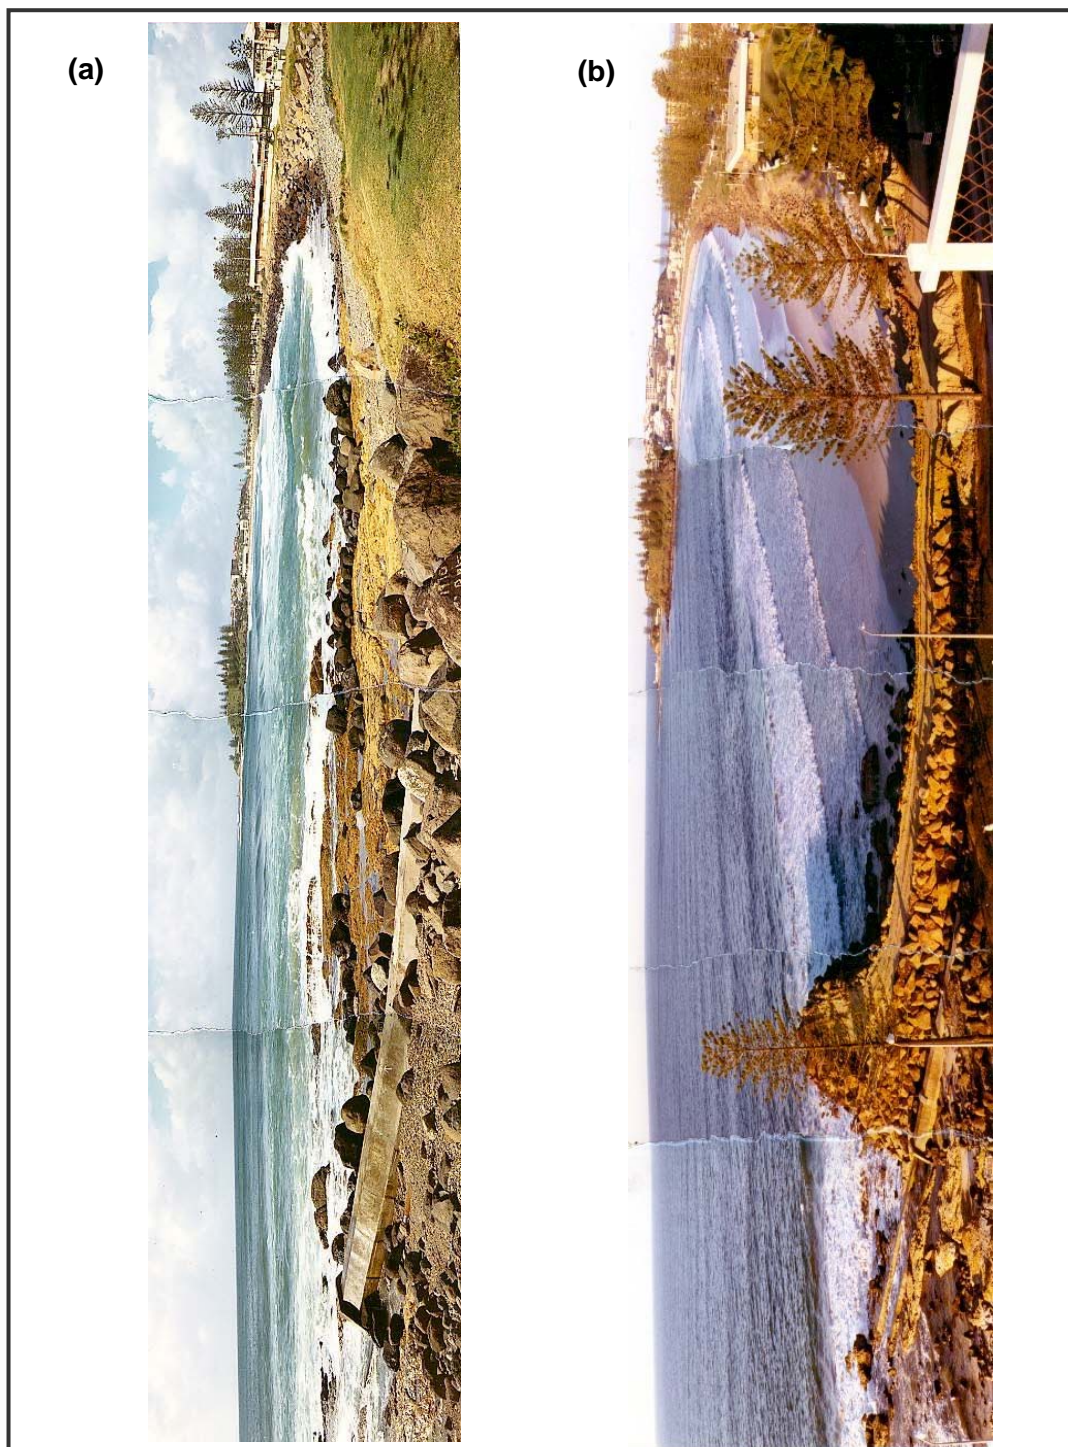
Figure A.5 Kirra Groyne (a) May 1972 (b) End of June 1972

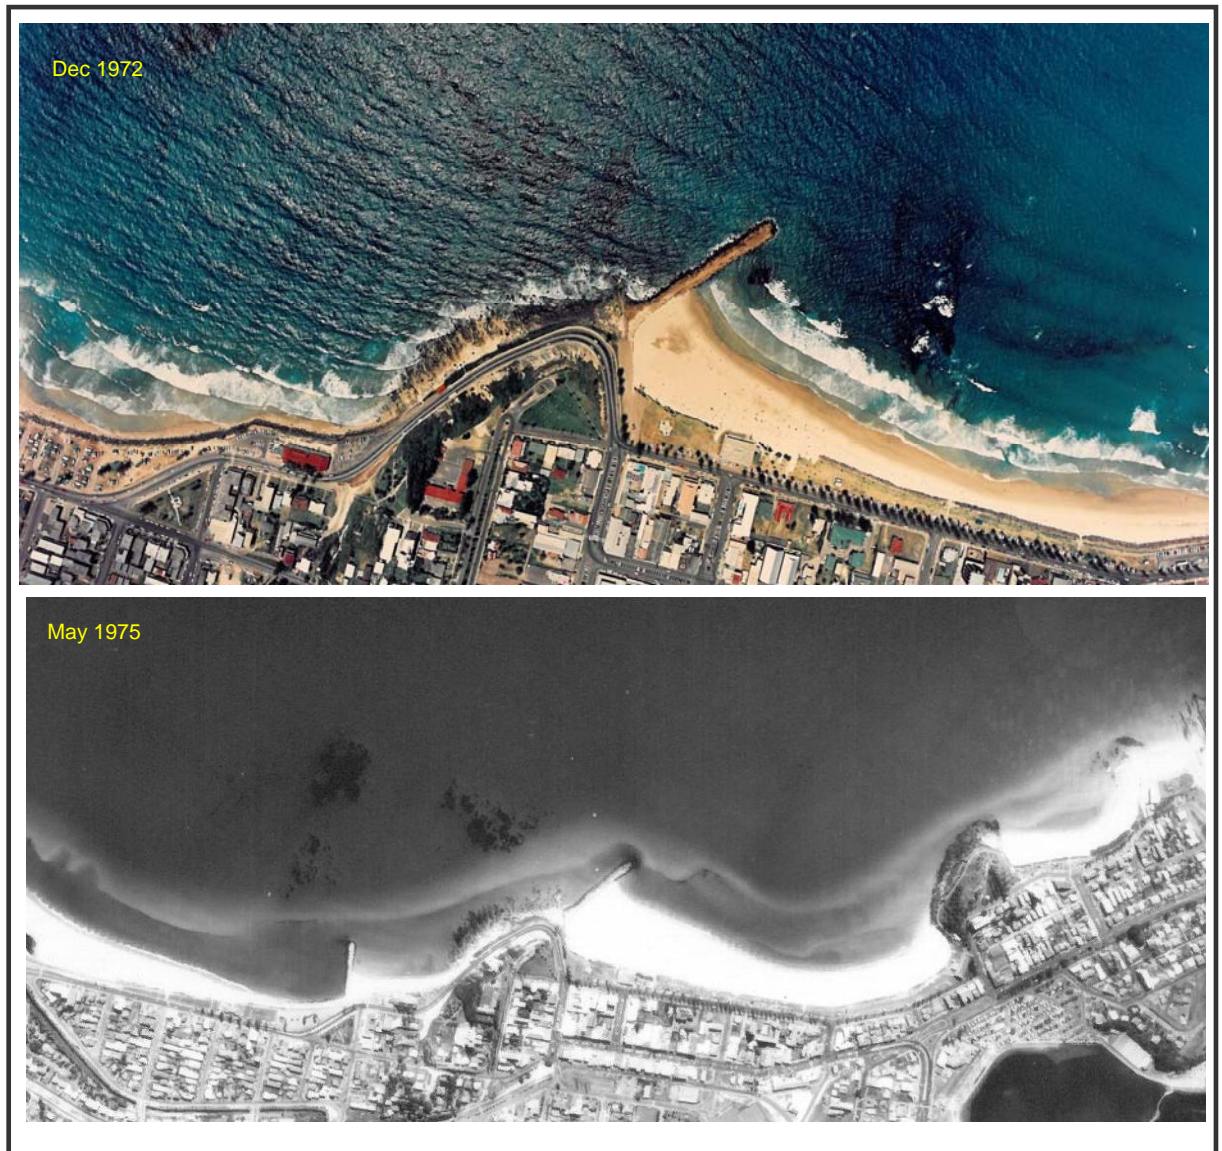
Figure A.6 Sand movements post Kirra Groyne (a) 1972 (b) 1975

- ▶ A groyne at Miles St was constructed in 1974 in order to retain sand in front of the Kirra Surf Club and can be seen in Figure A.6(b). Kirra beach conditions, in general, did not improve for

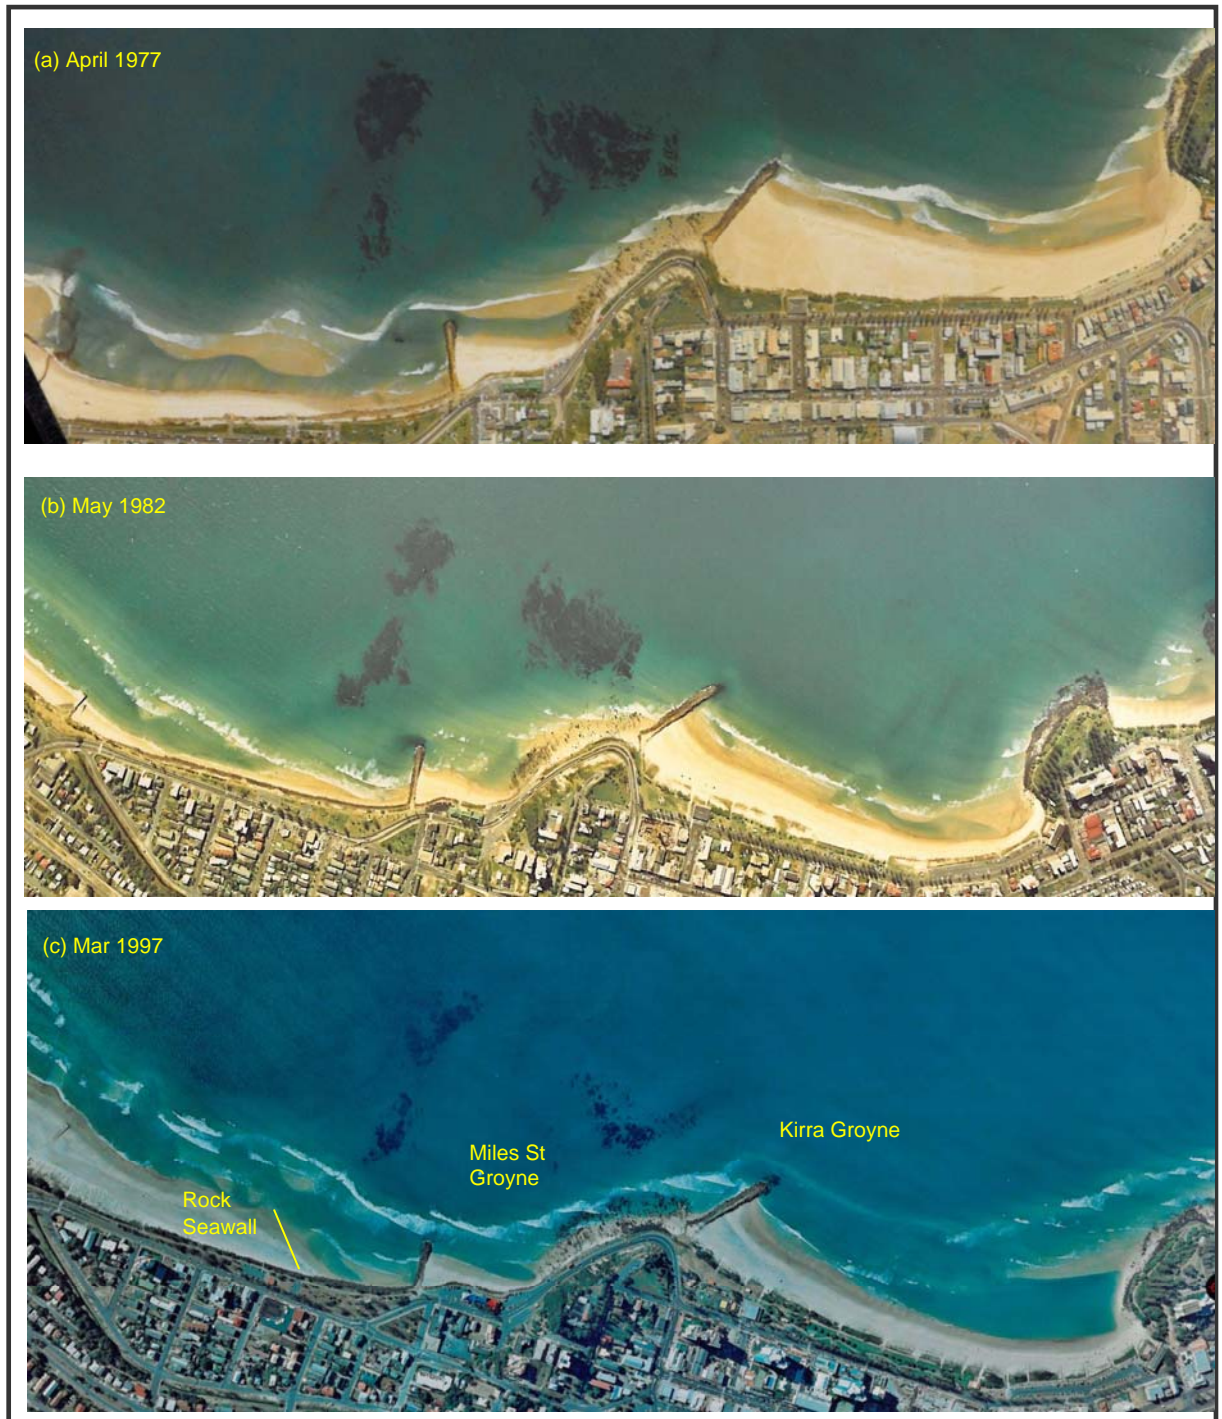
Figure A.7 Sand movements post Kirra Groyne (a) Apr 1977 (b) May 1992 (c) Mar 1997

Figure A.7 shows the state of Kirra and Coolangatta/Greenmount beach in the twenty year period from 1977 to 1997 and although sand was retained on Coolangatta due to Kirra groyne and sand nourishment programs, the beach conditions to the west of the groyne were poor. Because of its alignment and the lack of sand supply, the rock wall in front of Musgrave St was always exposed and rarely had a beach during the 1970s, 80s and 90s unless nourishment programs occurred.

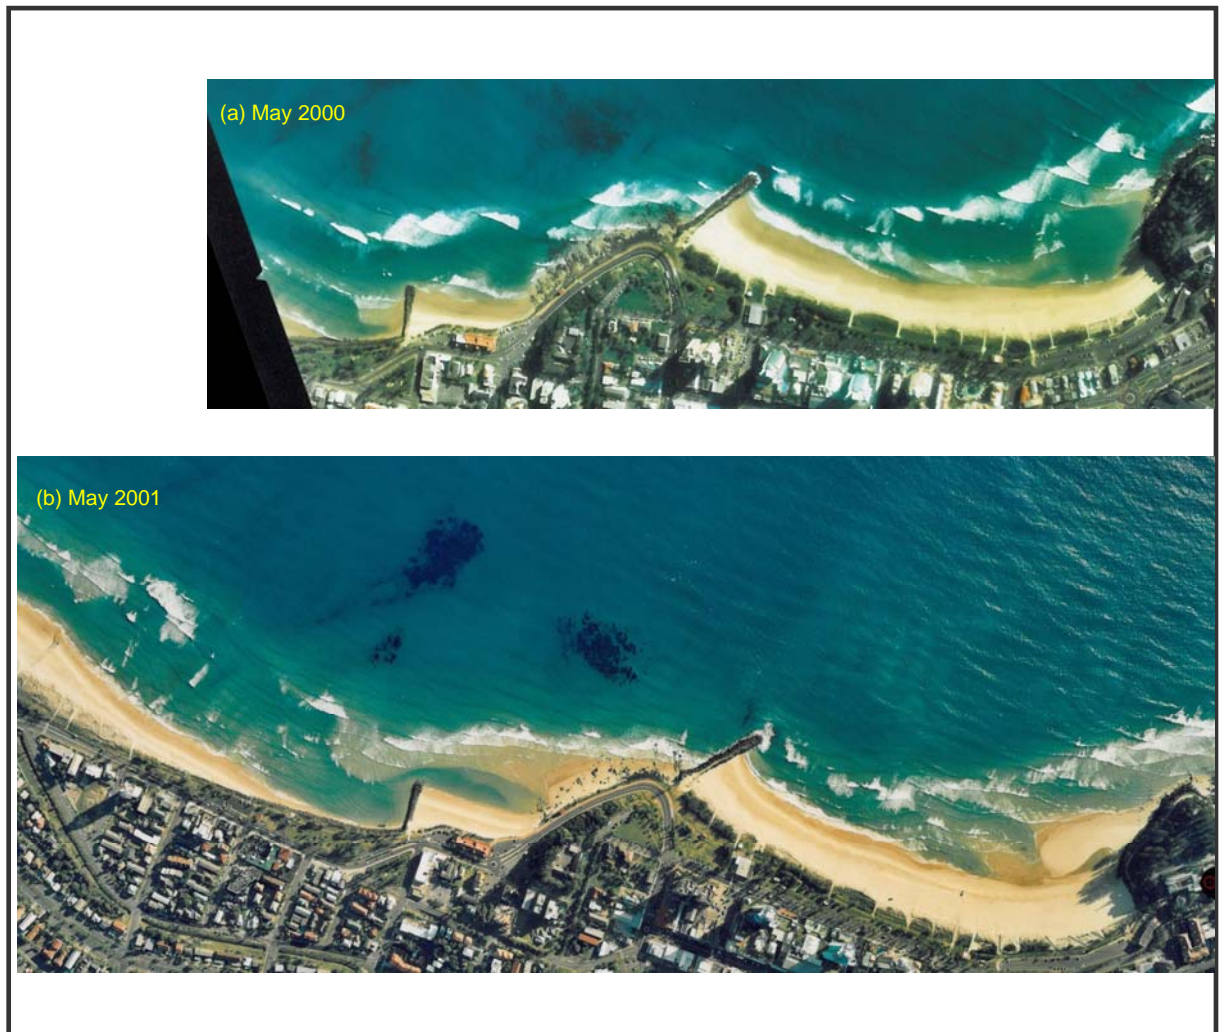
Figure A.8 Sand movements post TRESBP (a) May 2000 (b) May 2001

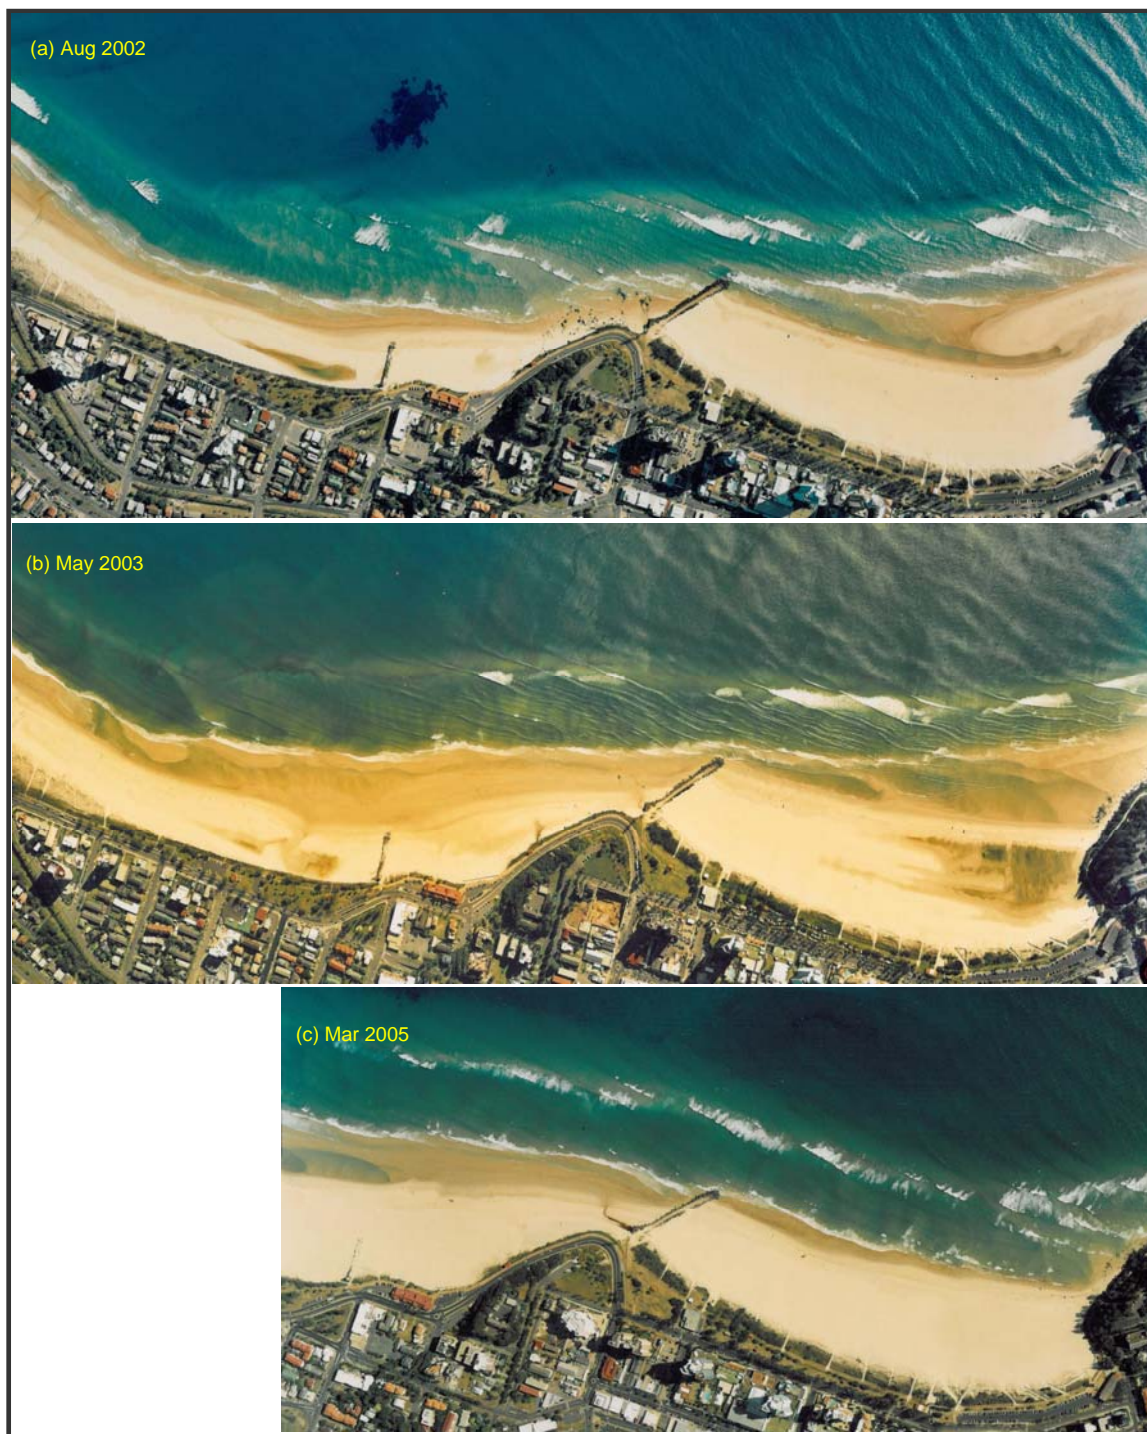
Figure A.9 Sand movements post TRESBP (a) Aug 2002 (b) May 2003 (c) Mar 2005

- ▶ In May 2003, as shown in the aerial photo of Figure A.9(b) taken at low tide, the beach alignment was virtually a straight line from Greenmount headland to North Kirra. The offshore bar was also continuous and straight, and referred to as the 'super bank'. Breaking waves were providing experienced surfers with a ride from Snapper Rocks all the way to Kirra. However, this condition exhibits an oversupply of sand to these beaches and, as shown in Figure A.9, Kirra Point Groyne is close to, or no longer functioning to retain sand. It is clearly being bypassed by the volume of sand in the system. During this period the beach at Kirra grew so wide that the beach from Greenmount to North Kirra was continuous;

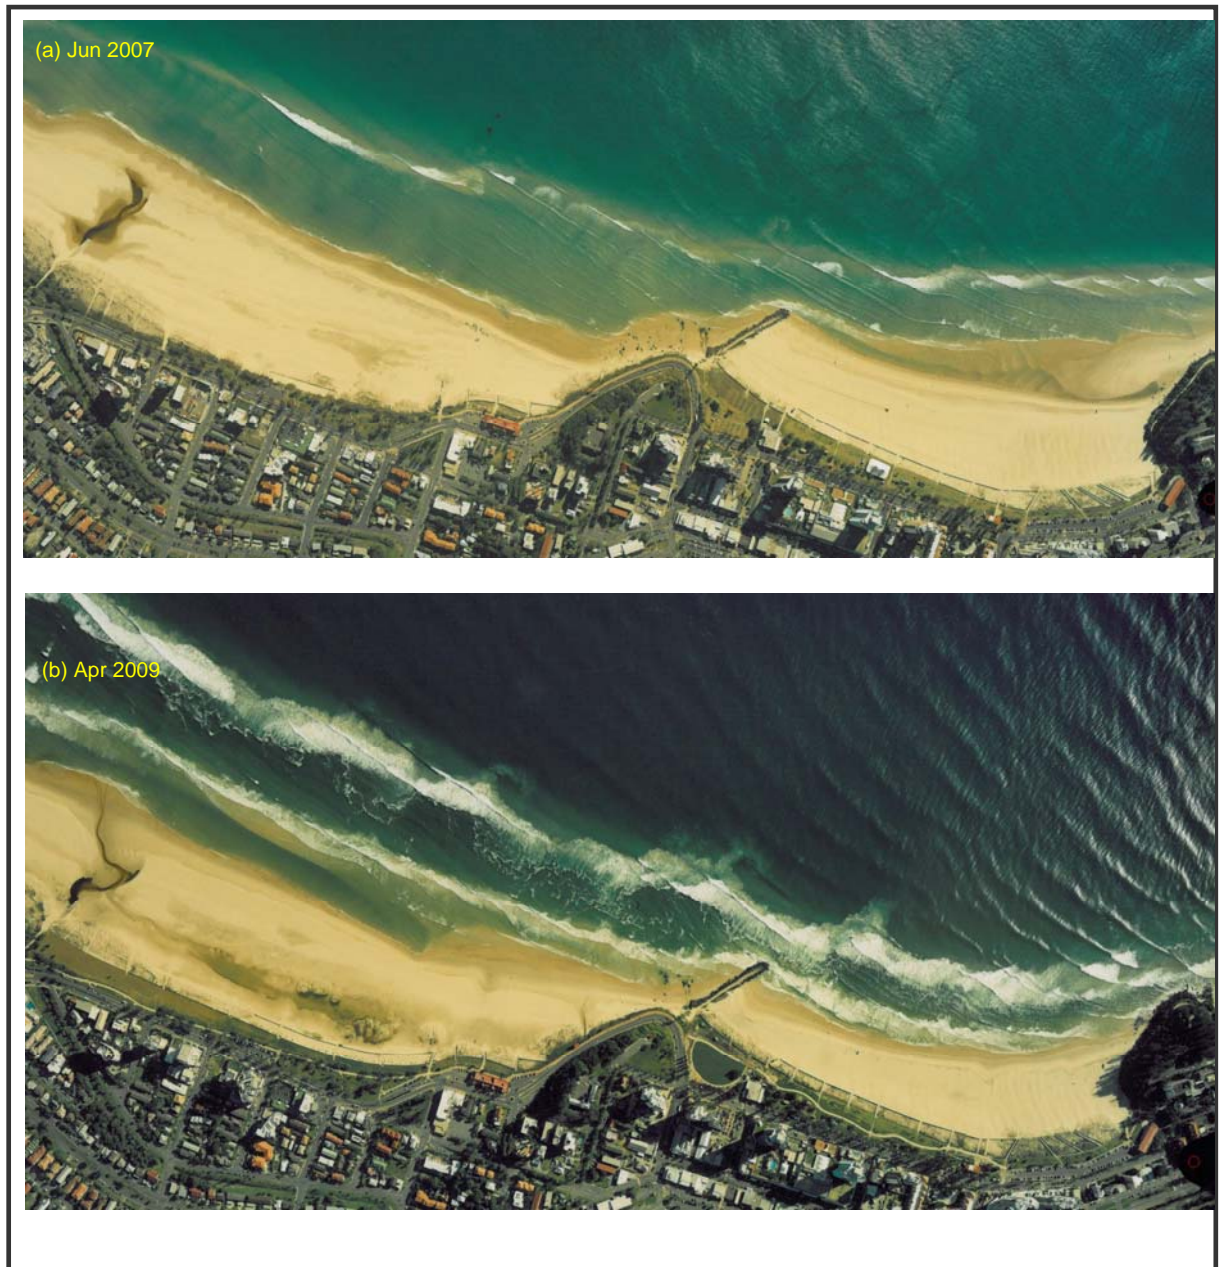
Figure A.10 Sand movements post TRESBP (a) Jun 2007 (b) Apr 2009

- ▶ Figure A.10(b) is an aerial photo (April 2009) taken before the severe storm in May 2009 that caused substantial and widespread erosion to much of the southern Queensland coastline including some of the Gold Coast beaches to the north of the Study Area. Wave events recorded at the Tweed River buoy were as follows:

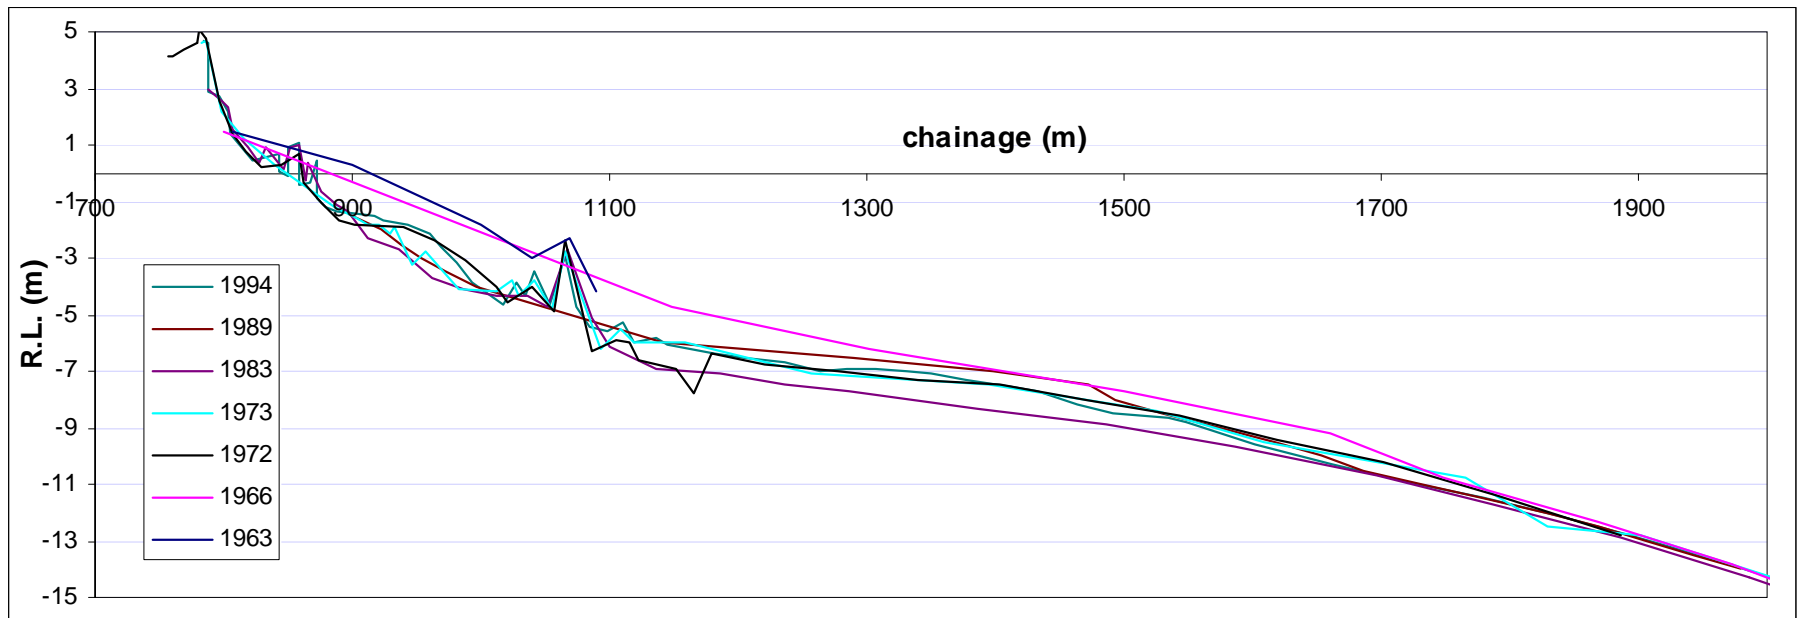
Figure A.12 Survey lines corresponding to Beta 3.3

The dates of the beach surveys do not coincide directly with aerial photography dates where the offshore beach bar is observed. Therefore it is not always possible to definitively locate the offshore beach bar on the survey profile figures, but in general it appears to be about the -2m contour within 100m of the shoreline according to the Beta 2.4 and 3.3 beach profiles corresponding to 1983 and 1994 surveys.

Also observed in the beach profiles in this era are the raised bed levels near the 1400 m chainage (Beta 3.3 profile) and 700 m chainage (K1 profile) that correspond to offshore sand placement during

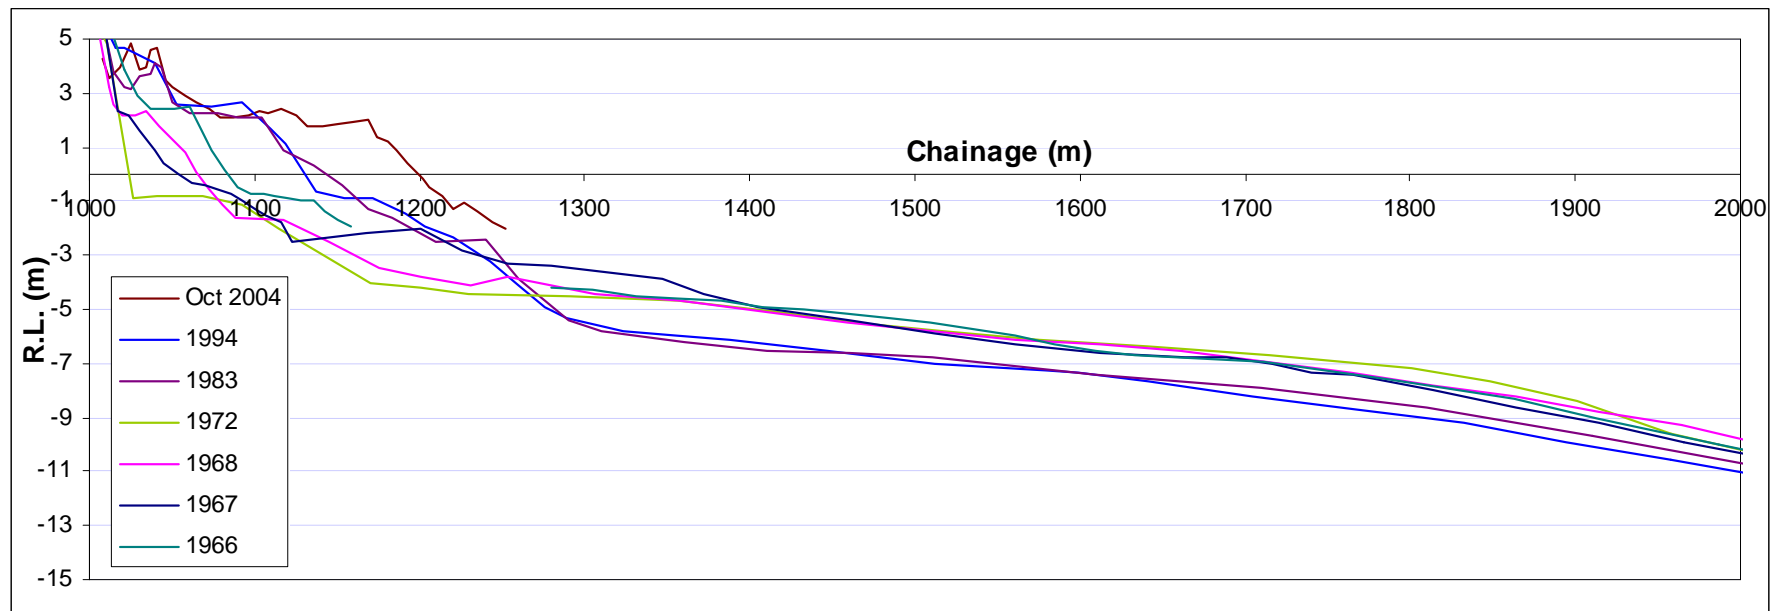
Figure A.14 Survey lines corresponding to Beta 2.4

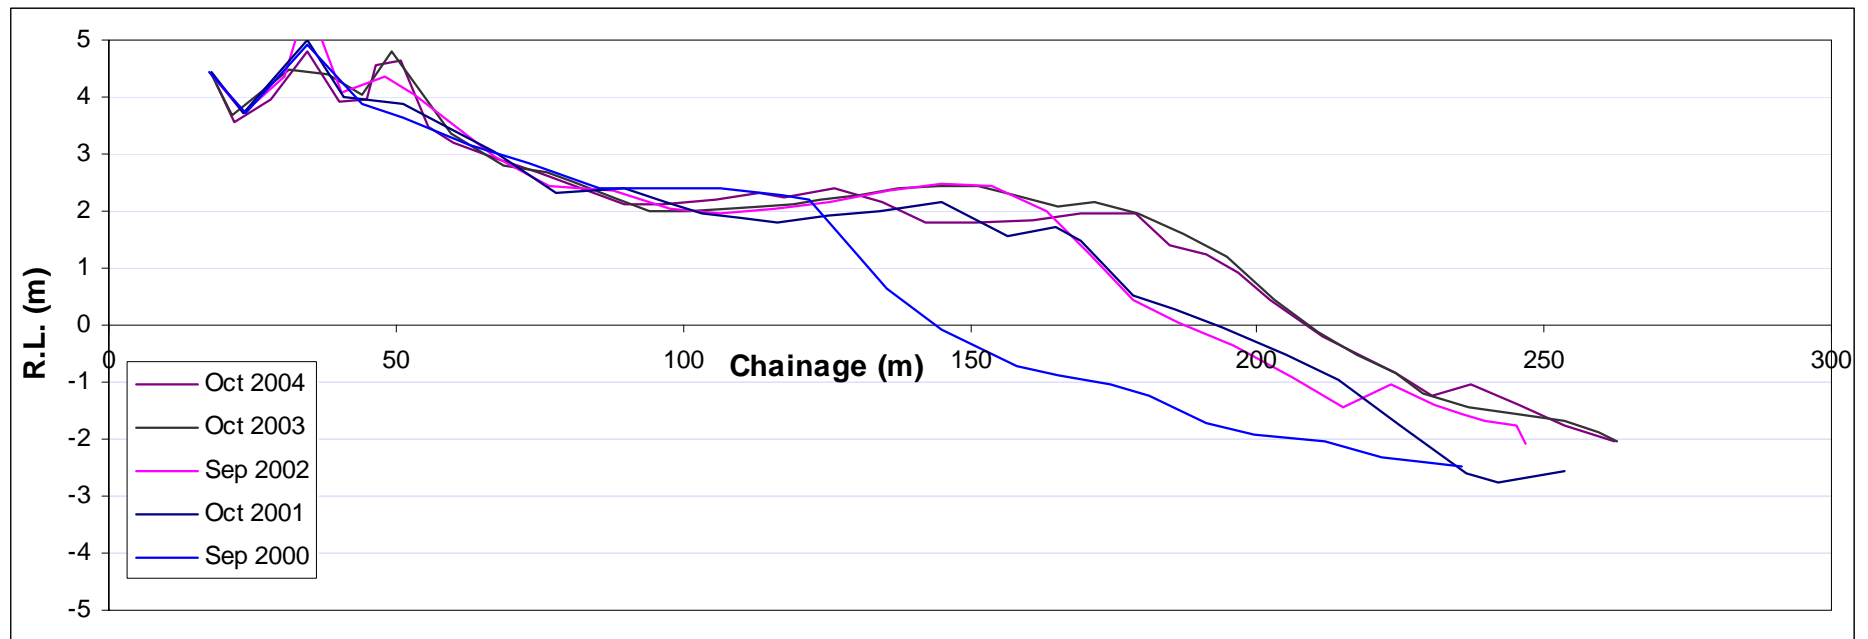
Figure A.15 Survey lines corresponding to CGM3 and CG9
