Tweed Sand Bypassing

Environmental Monitoring Report

May 2022 to April 2023

Project: Tweed River Entrance Sand Bypassing Project

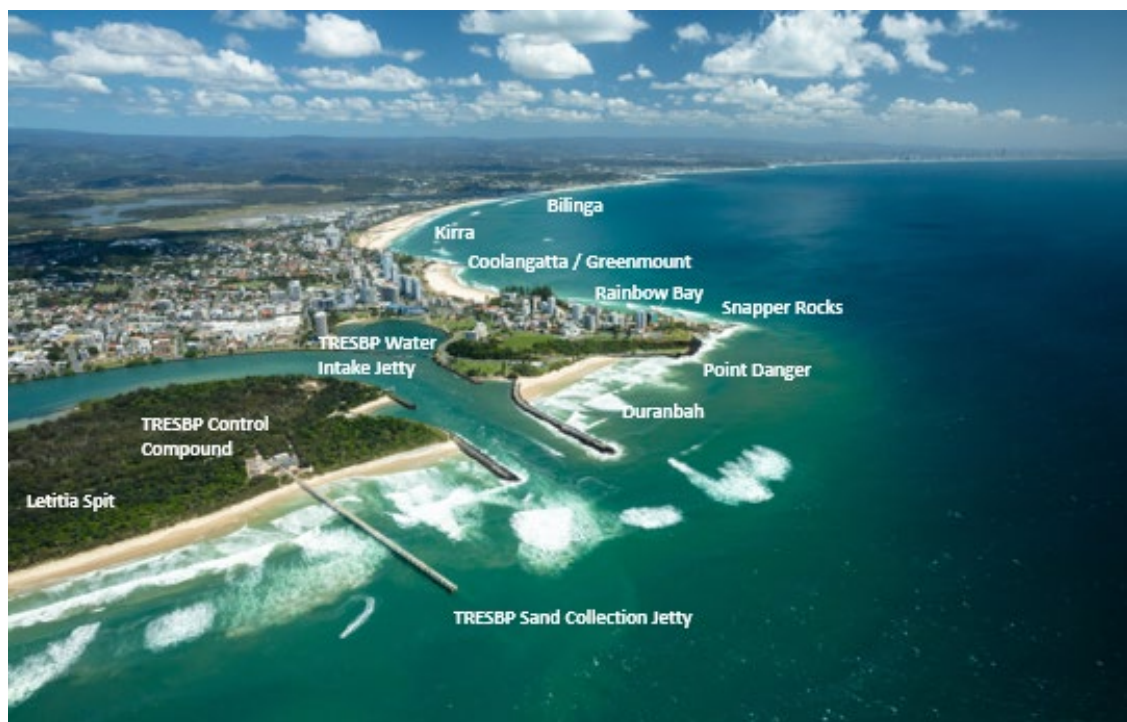
Figure 1. Aerial Photographs of Project Site, TSB system and locality (photo: October 2022)

- A sand collection jetty, pumps and control building at the northern end of Letitia Spit, about 250 m south of the southern Tweed River breakwater (refer to Figure 1).
- A clean water low pressure pump station mounted on a short jetty (intake Jetty) on the southern river training wall at the northern end of Letitia Spit (refer to Figure 1).
- A compound area at the landward end of the sand collection jetty for the housing of a control building and workshop, and sand slurry collection pit (refer to Figures 1 & 3).
- A sand delivery pipeline that crosses under the Tweed River about 250 m downstream of Jack Evans Boat harbour (refer to Figure 3 & 4).
- Sand delivery outlets at Snapper Rocks East, Snapper Rocks West, Duranbah, Greenmount and Kirra Point (refer Figure 4).

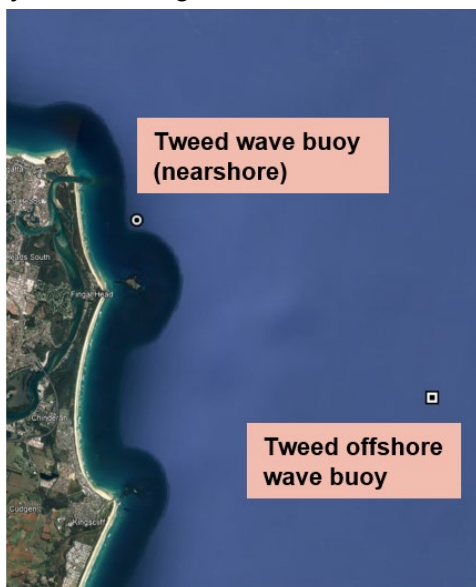
Figure 9 TSB Wave buoy locations

- 'Tweed Heads' nearshore buoy (installed Jan 1995) located in approximately 22m water depth off Letitia/ Fingal beaches; and
- 'Tweed offshore' buoy (installed Jan 2020) in approximately 60m water depth to the east and adjacent to Kingscliff and Dreamtime beaches.

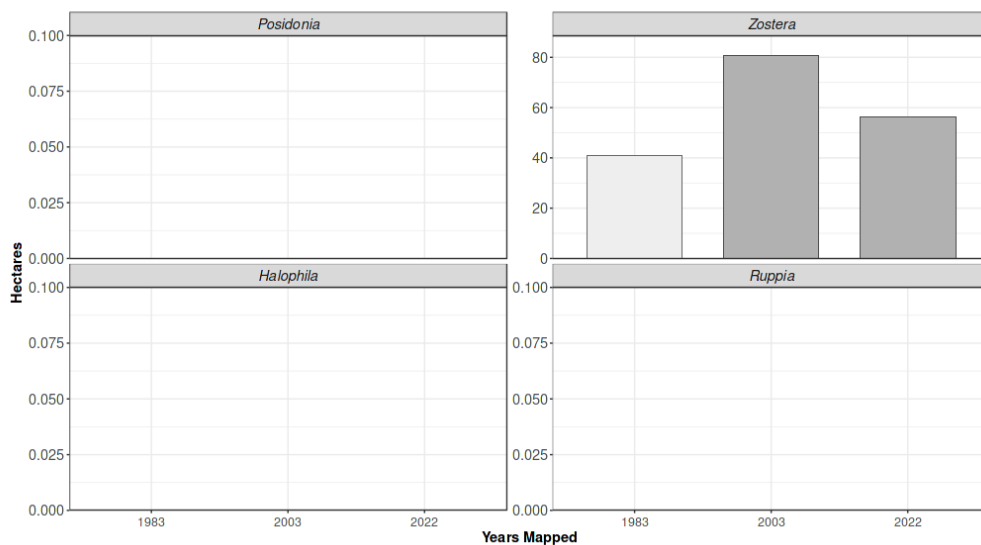
Figure 23 Tweed River Changes in mapped area of Seagrass (Department of Primary Industries, 2023)

Change in area (hectares) of mapped seagrass extent for the selected estuary. The areas presented below represent 100% of the mapped area for each genus. This includes areas of overlap where multiple genera occur. As such, totalling the values from these figures may over estimate the total amount of seagrass present in the selected estuary. Due to differences in mapping techniques, comparison of areas from the data mapped during the 1980s (light grey columns) should be used as an indication of the direction of change (increase vs decrease) rather than the magnitude of area change. In general, maps from the 1980s tended to overestimate areas of large habitat patches and may have missed small patches.
