# Seagrass Distribution

## Cook Island Aquatic Reserve

**Prepared for: Transport for New South Wales**

**January 2024**

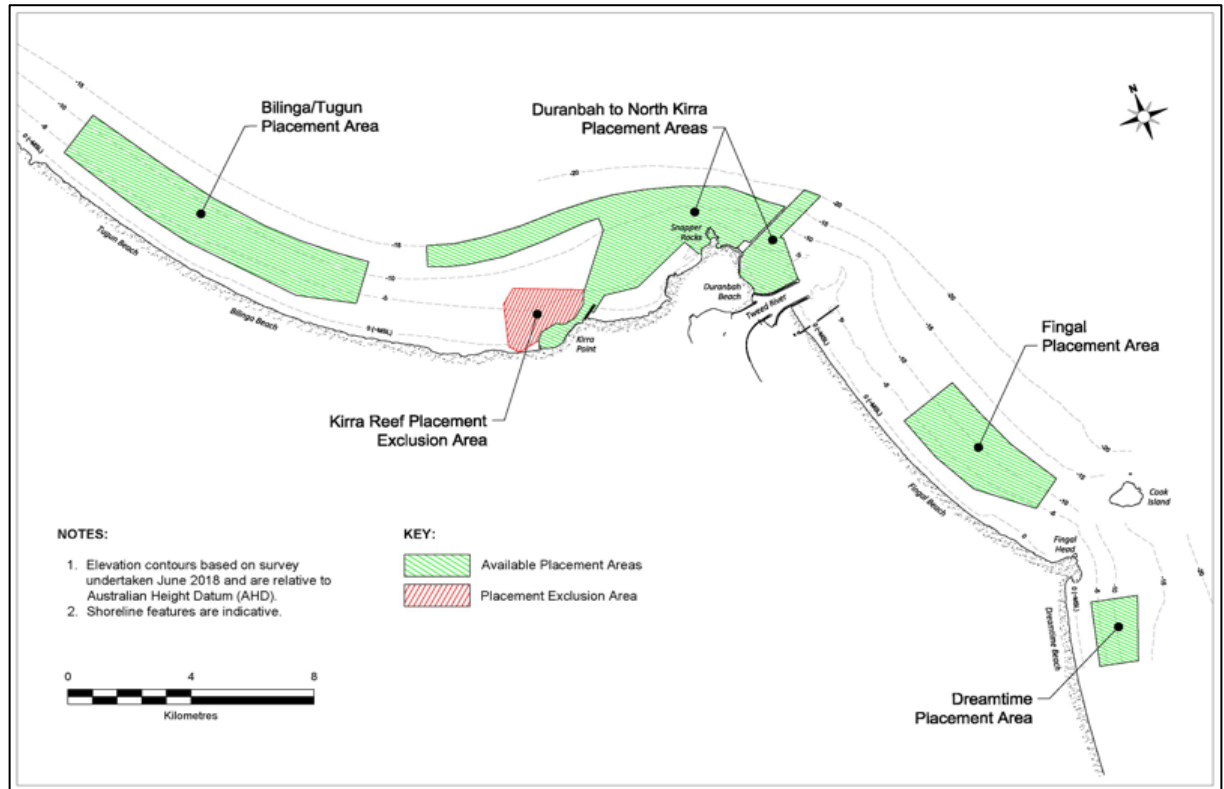
Figure 1.1 Current approved placement areas for disposing dredged sand (TSB 2023)

When dredging occurs, the dredge deposits sand in approved placement areas along the Tweed Coast and Southern Gold Coast (Figure 1.1). In 2019, additional placement areas at Fingal and Dreamtime were approved to provide greater flexibility in TSB operations. These areas are located near the Cook Island Aquatic Reserve, which is managed under the *Marine Estate Management Act 2014* to protect marine biodiversity and to support marine science, recreation and education. Prior to approval of the Dreamtime and Letitia deposition areas, a Review of Environmental Factors (REF) completed in 2019 stated *the habitat in the proposal area and adjacent habitats is a high energy coastal area of open beach that is not suitable for the establishment of seagrass* (APP 2019). However, since the REF, seagrass has been observed on the north-western side of Cook Island by local divers and by Ecological Service Professionals Pty Ltd (ESP) during the TSB Reef Monitoring Program (ESP 2020; ESP 2021; ESP 2022; ESP 2023).

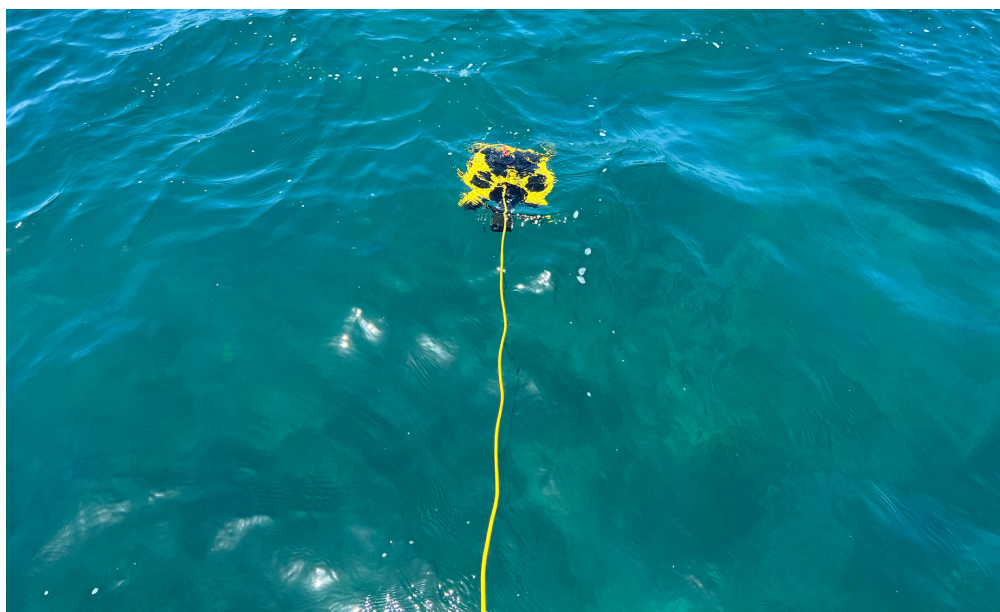
Figure 2.1 ROV used to assess seagrass in November 2023

The survey was completed using remote techniques from a commercial vessel operated by a suitably qualified skipper (i.e. coxswain or Master 4). The species composition, percent coverage and condition of seagrass was assessed qualitatively, based on expert assessment of georeferenced imagery (video and photos) at more than 1000 points across the surveyed area. Methods were adapted from Roelfsema & Phinn (2009) where a GPS unit is towed along the water surface with the type of substrate recorded using imagery from an underwater remotely operated vehicle (ROV) (Figure 2.1). Broad seagrass coverage categories were either determined directly from imagery or in the laboratory using georeferenced imagery.

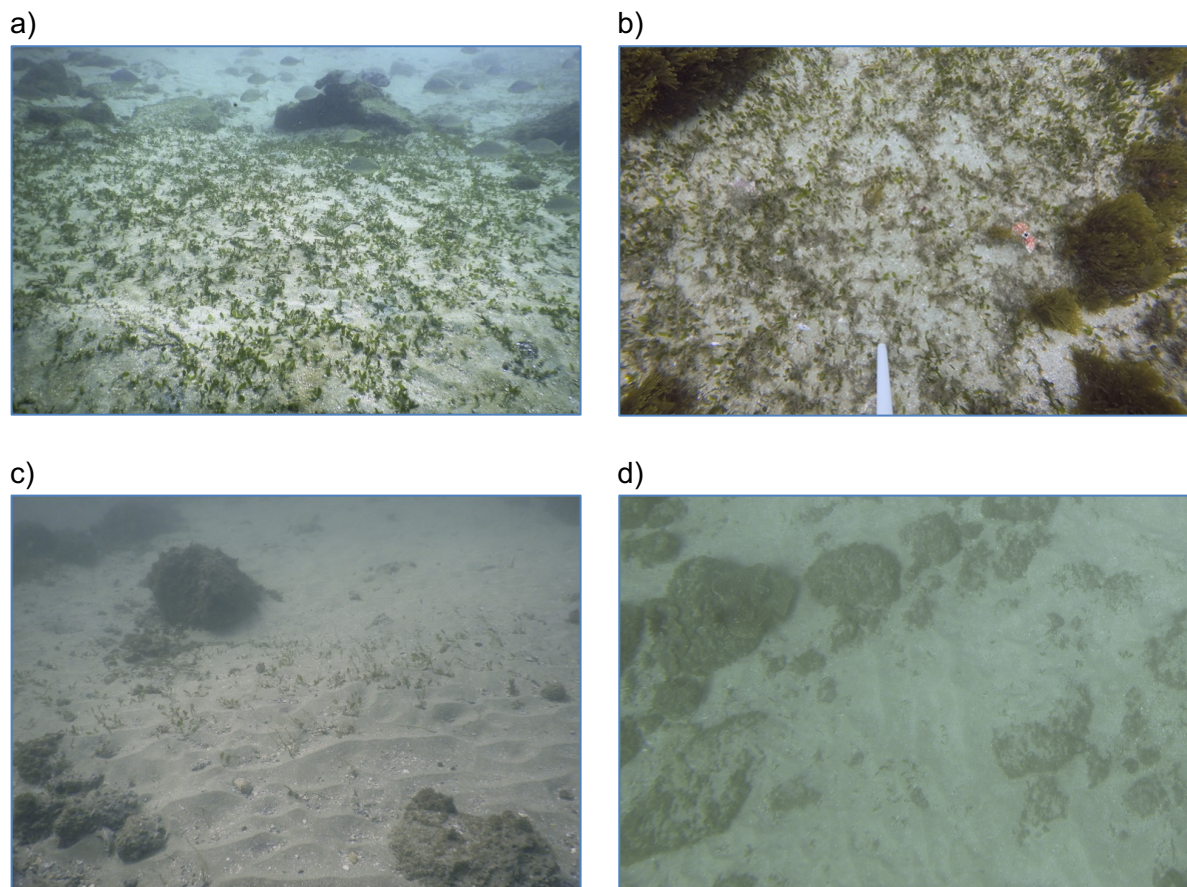
Based on observations from imagery available, the extent and coverage of seagrass patches changes annually (Figure 3.1). In July 2020, the seagrass on the north-western side of Cook Island was moderate to dense, covering approximately 30% to 50% of the space (between macroalgae, rock and rubble on sand) where it was present. This moderate to dense patch of seagrass was also present in May 2021, with the cover consistent with July 2020 (i.e. approximately 30% to 50% of the space where it was present). In June 2021, while seagrass in this area was still present, the coverage had declined, covering approximately 10% of the space where it was present. In May 2023, while still present, the cover again remained low, covering <10% of the space where it was present.

Figure 3.1 Seagrass *Halophila ovalis* at Cook Island in a) July 2020 b) May 2021 c) June 2022 and d) May 2023

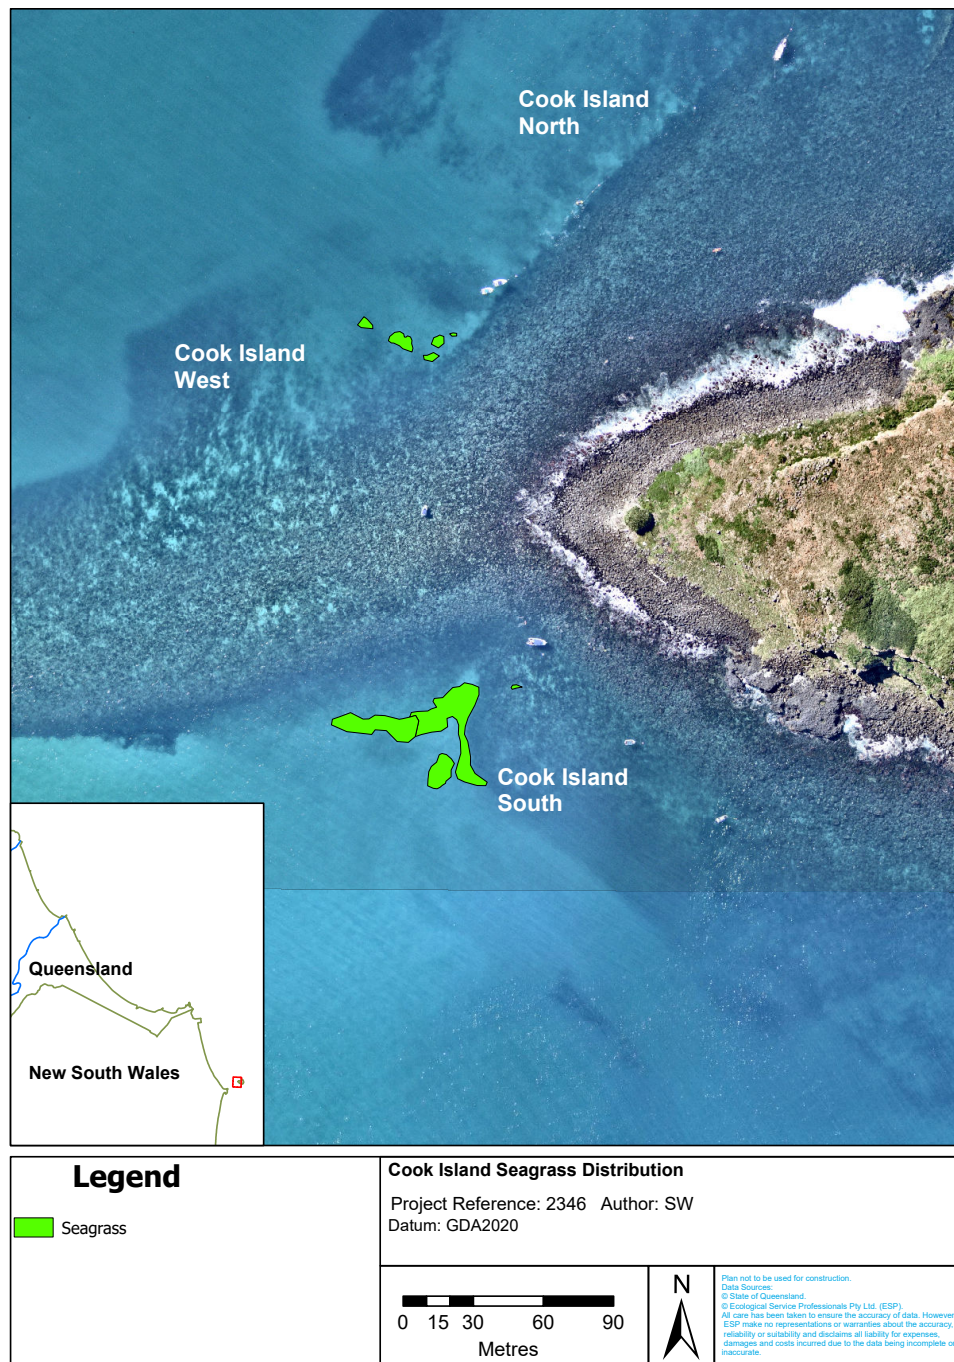
In November 2023, seagrass was recorded on the north-western and south-western sides of Cook Island (Figure 3.2). The seagrass present on the north-western side of the reef was recorded in patches of up to 10 m in diameter, with sparse to dense coverage of *H. ovalis* covering a total area of 111 m<sup>2</sup>. The seagrass was growing on sandy patches between rock covered with macroalgae at approximately 7 to 9 m depth (Figure 3.3 & Figure 3.4). The percent coverage of patches ranged from 15 to 50%. Seagrass on the north-western side of Cook Island was in good condition.

Figure 3.2 Seagrass distribution at Cook Island in November 2023

Seagrass grew at a similar depth on the south-western side of the island, although typically had a higher coverage (>60%) and much greater extent (a total of 847 m<sup>2</sup>) than on the north-western side (111 m<sup>2</sup>) (Figure 3.2). The seagrass was most dense on the fringe of the rocky reef (Figure 3.5) and decreased in coverage as the patches extended out over bare sand, with a distinct edge between the seagrass and bare sand (Figure 3.6). On the southern side of the reef, the community composition was typically dominated by healthy *H. ovalis* often growing with various foliose macroalgae (*Dictyota* sp.) on rubble (Figure 3.5). There was a patch of mixed seagrass (*H. ovalis* and *Zostera muelleri*) at the western extent covering 268 m<sup>2</sup> (Figure 3.7). The seagrass transitioned to sparse macroalgae and rocky rubble habitat further west. Seagrass on the south-western side of Cook Island was in good to very good condition.

The extent and condition of seagrass measured around Cook Island in November 2023 provides comparative data against which (any) future potential impacts of TSB operations can be measured. Given the spatial variability in the extent and cover of seagrass over time and limited suitability of comparative sites (as offshore seagrass in the region is scarce), ongoing annual monitoring (ideally in the month of November) to confirm the extent and coverage of seagrass around Cook Island is recommended to provide good baseline data on the extent and condition of seagrass over time.

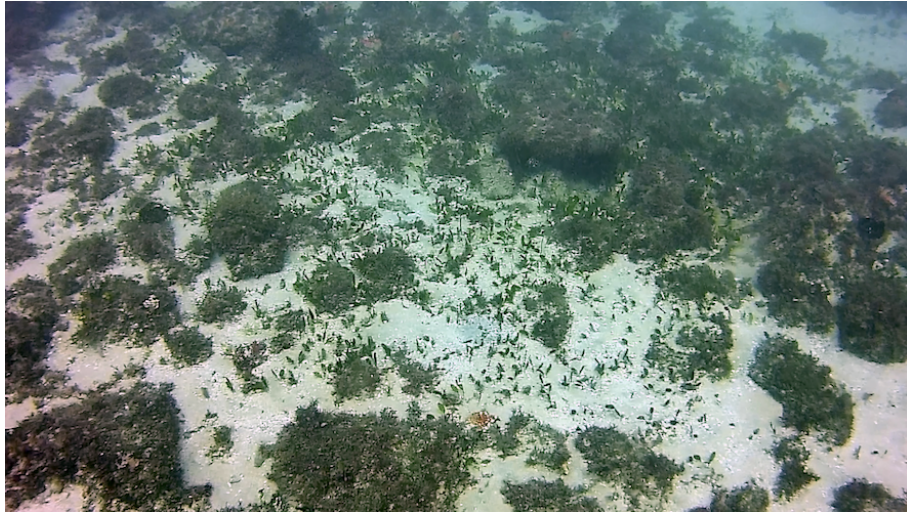
Figure 3.3 Small patch of sparse seagrass (*H. ovalis*) on the north-western side of Cook Island

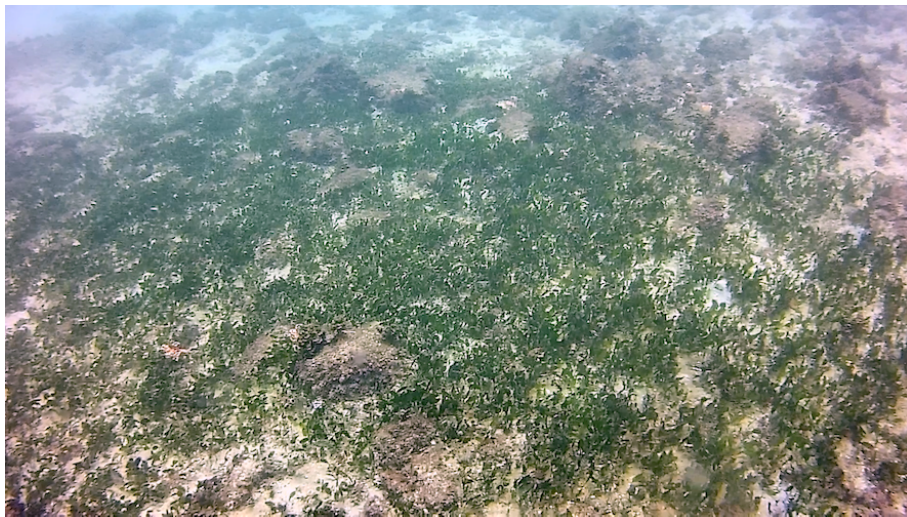
Figure 3.4 Patch of dense seagrass (*H. ovalis*) on the north-western side of Cook Island

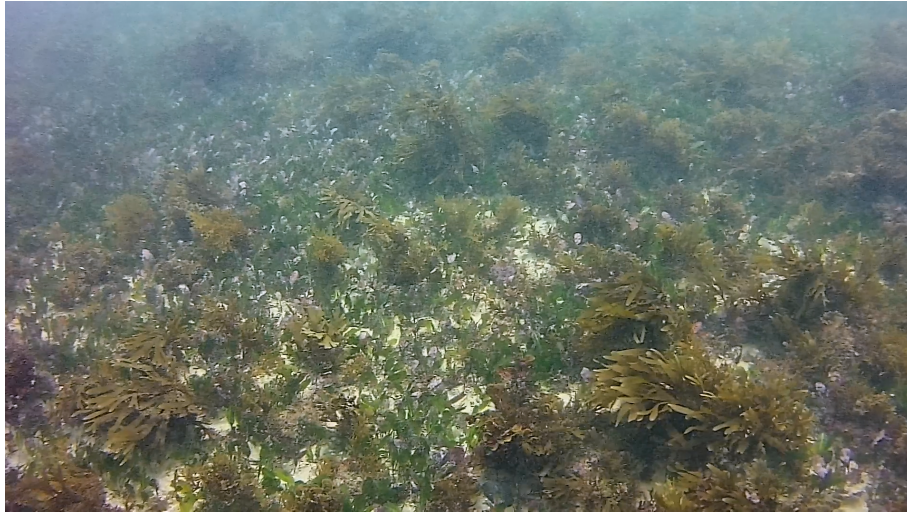
Figure 3.5 Dense seagrass and macroalgae on the southern side of Cook Island

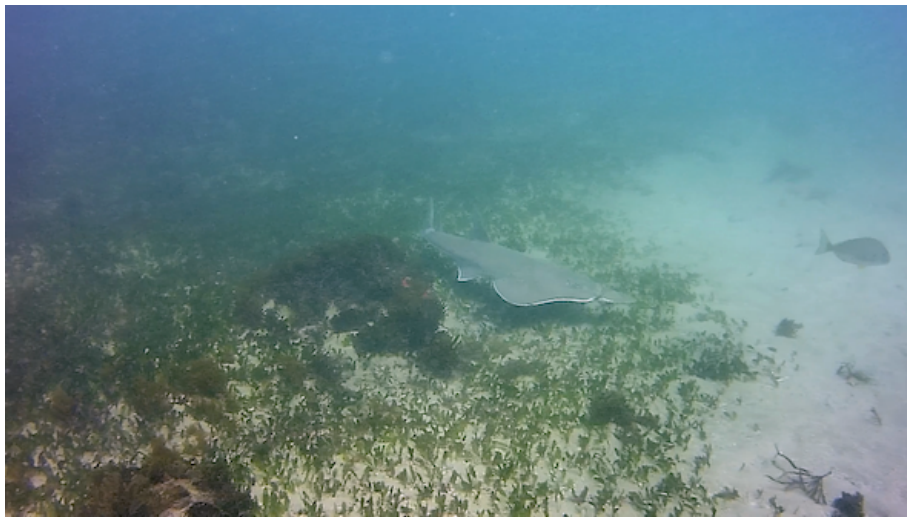
Figure 3.6 Edge of seagrass and bare sand on the southern side of Cook Island

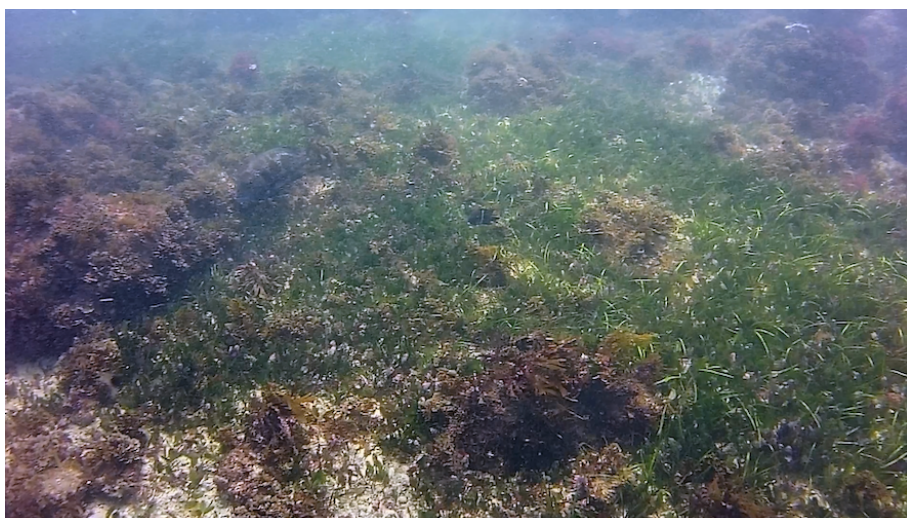
Figure 3.7 Mixed seagrass community (*Halophila ovalis* & *Zostera muelleri*) on the southern western side of Cook Island
