# Duranbah Beach Surf Quality Investigation

TPO-ENG-1718-68

Client: NSW Department of Industry – Crown Lands

Date: 25 January 2019

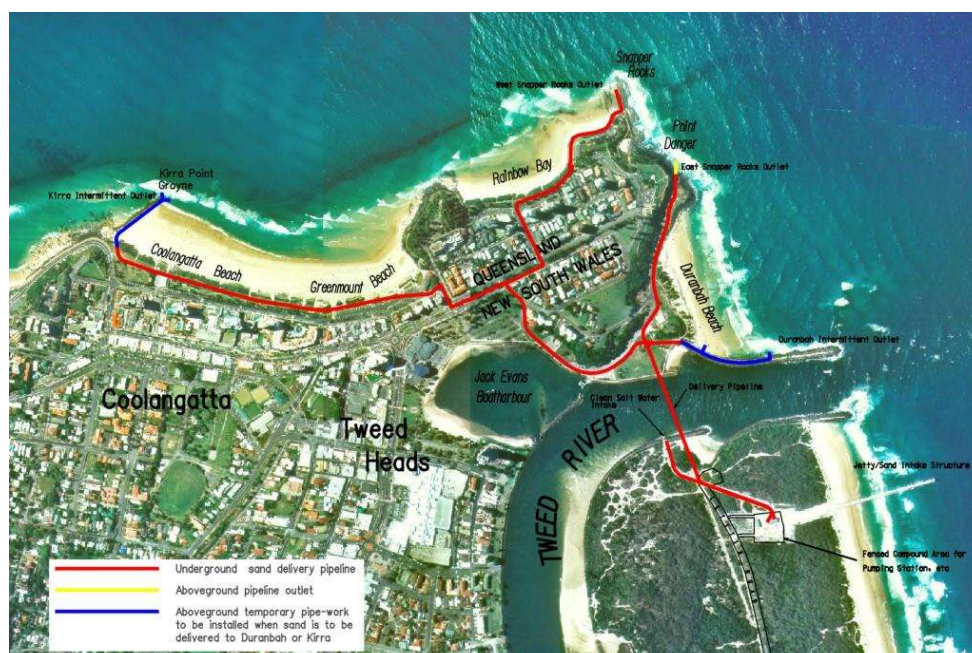
Figure 1 Location of existing pipeline network (source: Lands, 2018)

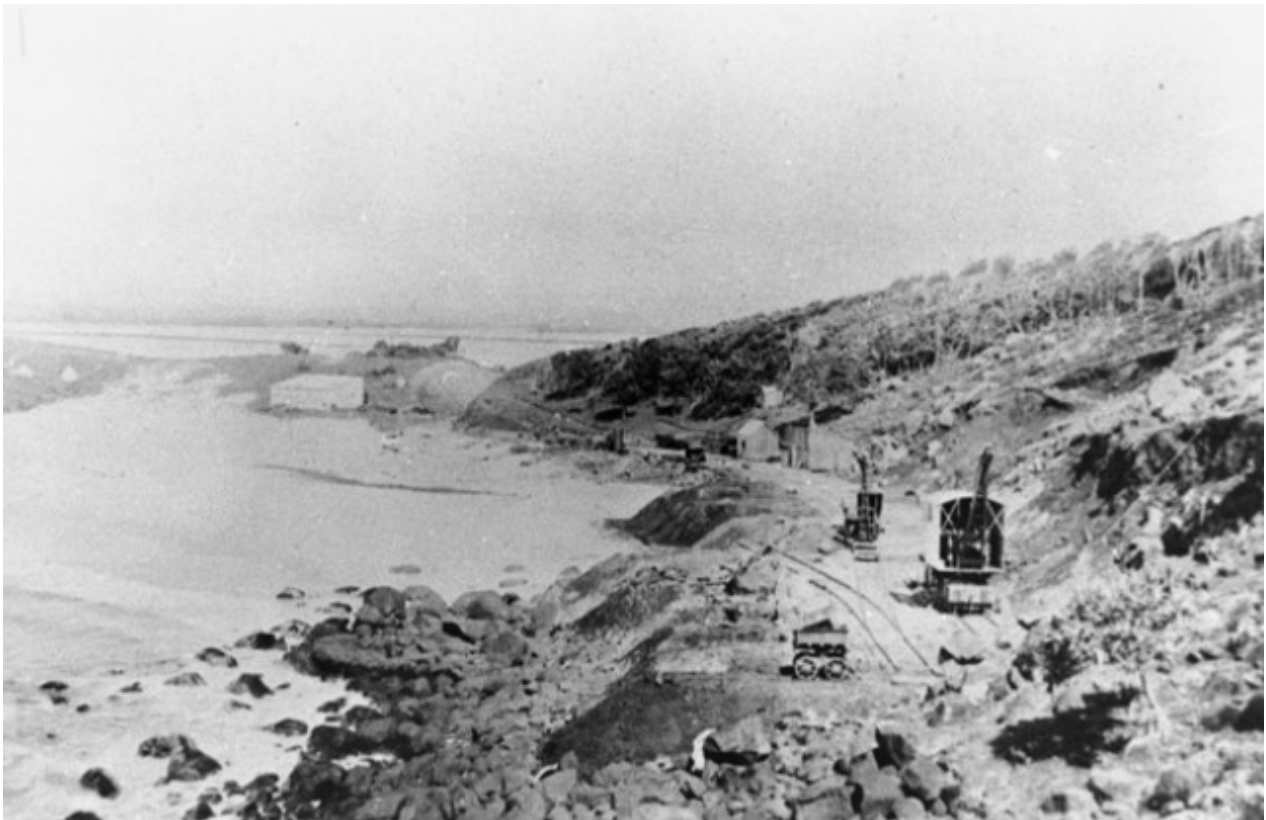
*Figure 2 Quarrying of Point Danger basalt in order to build the original Tweed River training walls, circa 1890 -1910 (Guthrie, 2011)*

Point Danger is a remnant basaltic flow from the Tweed Volcano. It overlays much older, well-bedded argillite of the Neranleigh-Fernvale beds (NF beds) and dates to 240-290 million years ago. Originally Point Danger rounded off into the ocean until it was quarried from mid-1890 -1910 to supply rocks for the original Tweed River training walls, Figure 2.

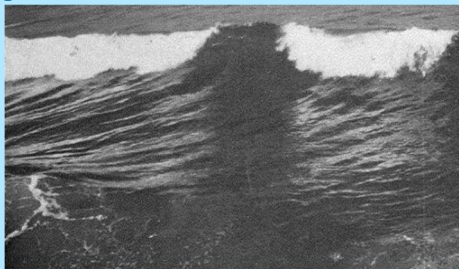
<ul style="list-style-type: none"> <li>• Bubbles and turbulent water spill down front face of wave</li> <li>• The upper 25% of the front face may become vertical before breaking</li> </ul> <p>Iribarren Number:</p> $\xi_b < 0.4$	<p><b>Plunging Breaker</b></p>

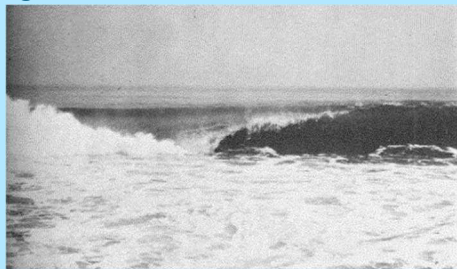
<ul style="list-style-type: none"> <li>• Crest curls over a large air pocket</li> <li>• Smooth splash-up usually follows</li> </ul> <p>Iribarren Number range:</p> $0.4 < \xi_b < 2.0$
<p><b>Surging Breaker</b></p>

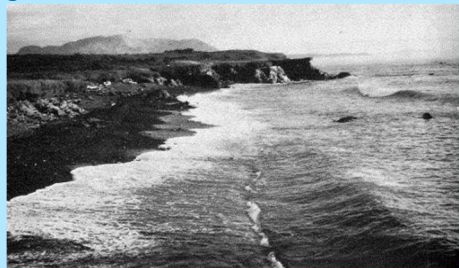
<ul style="list-style-type: none"> <li>• Wave slides up beach with little or no bubble production</li> <li>• Water surface remains almost plane except where ripples may be produced on the beach face during runback</li> </ul> <p>Iribarren Number:</p> $\xi_b > 2.0$	<p><b>Collapsing Breaker</b></p>

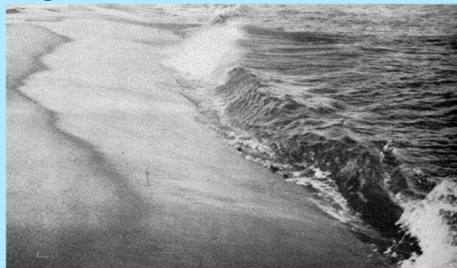
<ul style="list-style-type: none"> <li>• Breaking occurs over lower half of wave</li> <li>• Minimal air pocket</li> <li>• Usually no splash-up with bubbles and foam present</li> </ul> <p>Iribarren Number:</p> $\xi_b > 2.0$

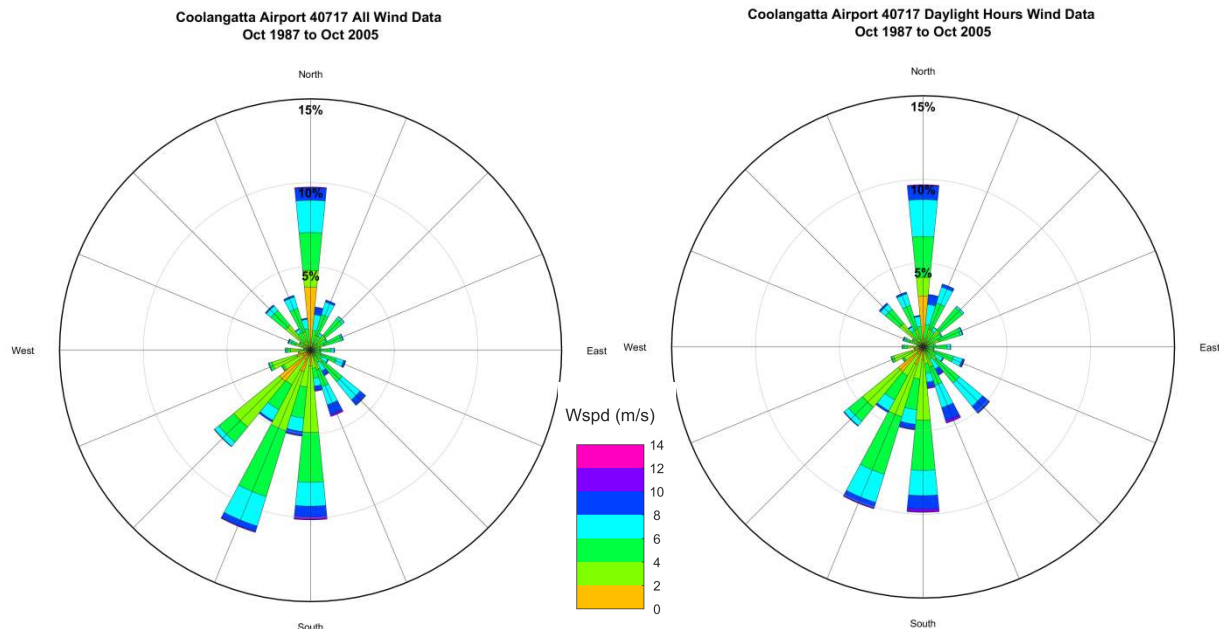
Figure 6 Wind rose of all three hourly averaged wind speed and direction (left) Similar wind rose for daylight hours (right). BoM weather station, 40717: Coolangatta Airport Oct. 1987 to October 2005.

Ten-minute wind speed and direction recordings were averaged over three-hour intervals for the collection period. A wind rose for the entire collection period can be seen in Figure 6 (left). The wind data was then filtered to ascertain wind speed and directions that occur only in daylight hours (civil dawn to civil dusk) under the assumption that surfing will predominantly be practised between these times, Figure 6 (right).

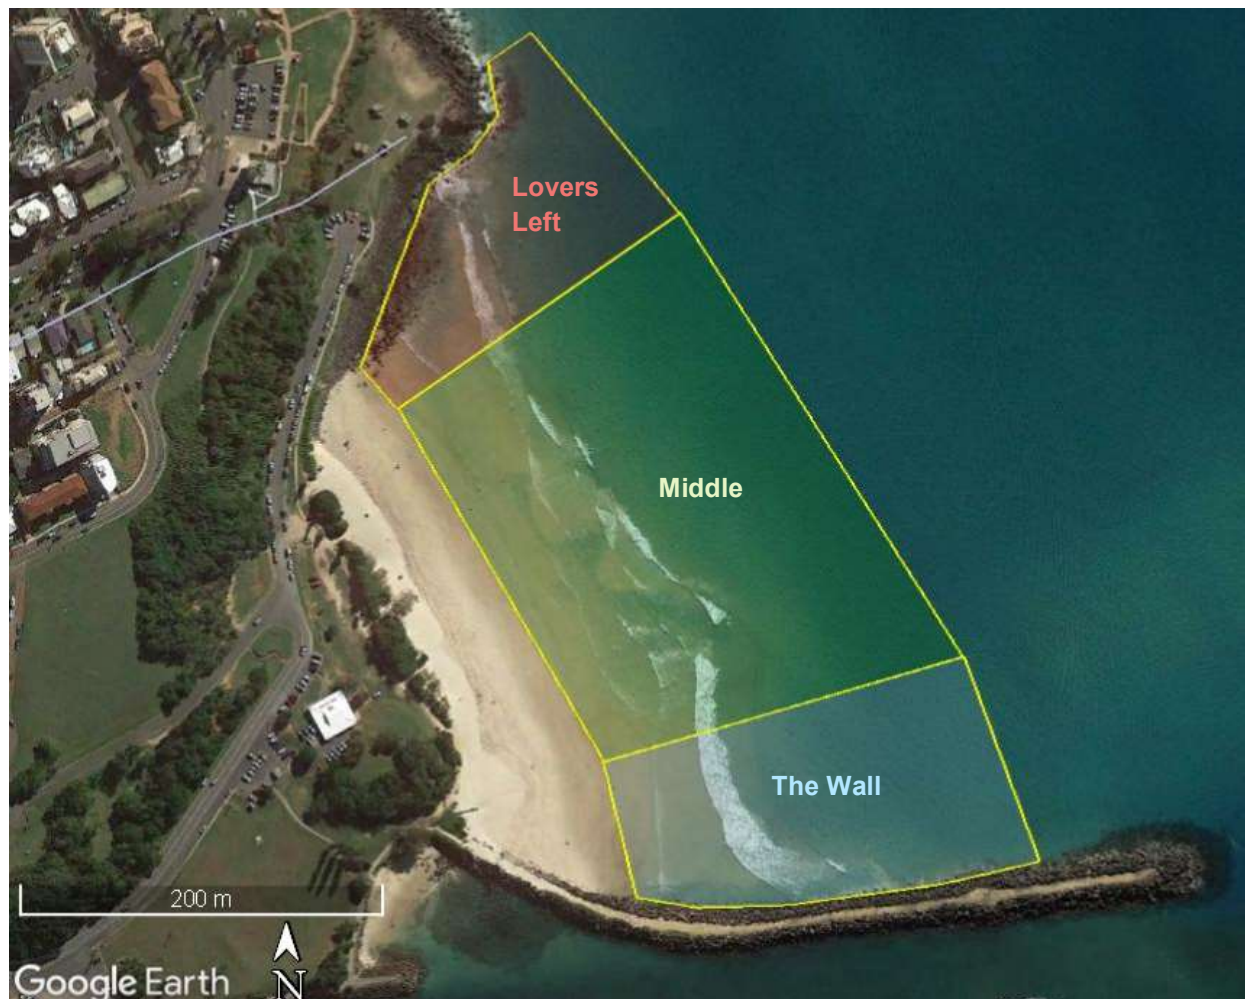
Figure 11 Aerial image of Duranbah Beach designating the boundaries of the three surfing zones of Duranbah Beach (image: Google Earth, 5 May 2016).

In terms of surfing, there are three main zones along Duranbah Beach; northern training wall (the Wall), the Middle and Lovers Left, see Figure 11. A description of each of these zones, including the coastal processes, wave breaking mechanics and bathymetric conditions is provided in the following sub-sections.

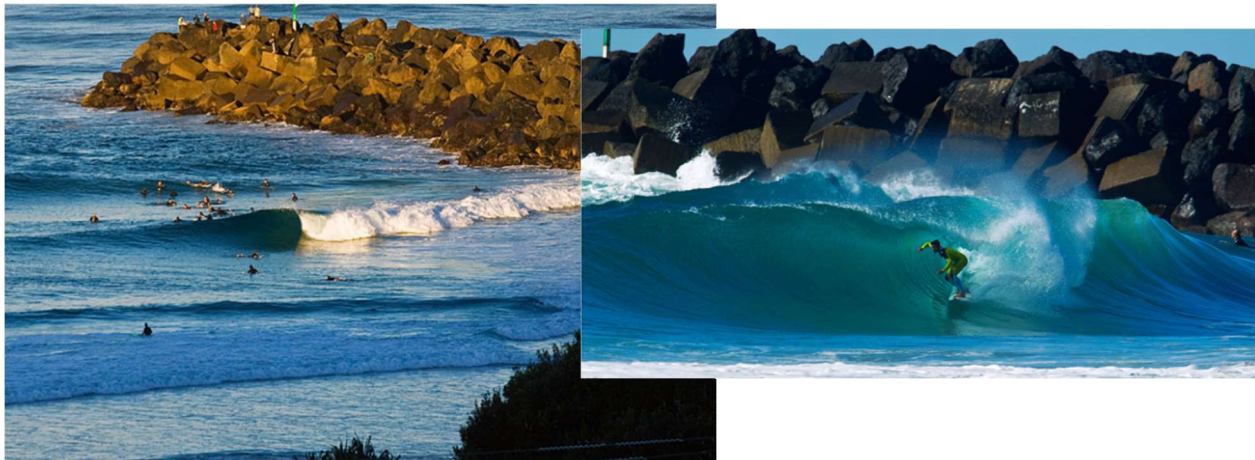
Figure 12 High quality surfing conditions at The Wall (pictures: Andrew Shield)

The Wall is located at the southern end of Duranbah Beach. The spot typically breaks adjacent to the northern training wall. On some occasions the wave can start out near the end of the training wall. The wave is predominantly a medium length right hand break, or right-hander. A right-hand wave breaks to the right when viewed by the surfer facing the beach. There is a permanent rip that runs out to sea from the shoreline along the wall. Along the northern edge of this rip a sand spit extends out to sea where incoming waves peel along its length. Depending on the angle of the incoming wave crest and section length, sometimes a shorter left-hand wave breaks into the rip against the training wall (Figure 12 right). However, the right-hander is the most surfed wave along this zone of the beach.

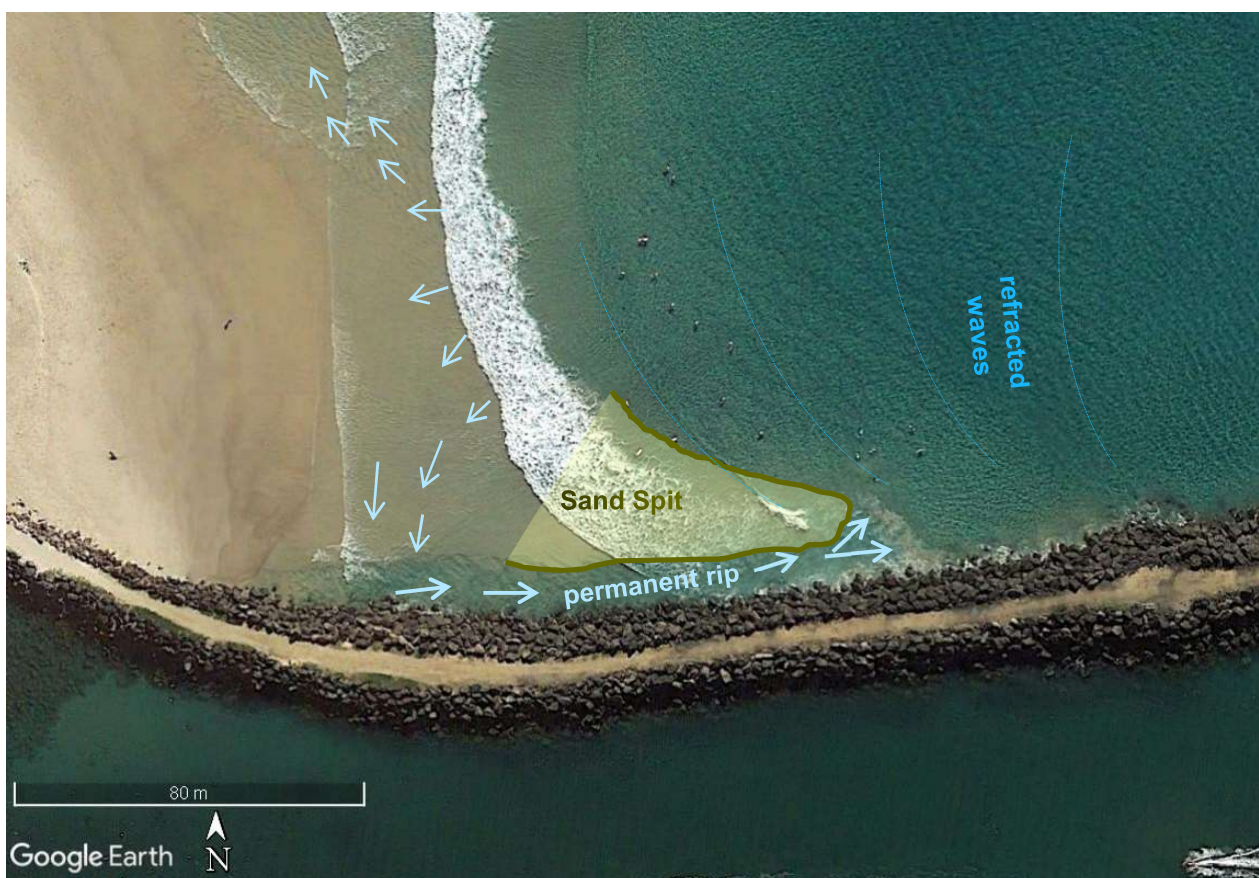
Figure 13 Geomorphic features of the 'Wall' at the southern end of Duranbah Beach. (image: Google Earth, 15 May 2016).

The sand spit of which the waves break along at the Wall is one of the most consistent geomorphic features of Duranbah Beach due to the permanence of the rip at this location. As most of the other rips along the centre and at the northern end of Duranbah Beach are transient or semi-permanent in nature, a high proportion of the water that is trapped along the southern part of the beach by incoming waves makes its way back out to sea through this rip, as seen in Figure 13.

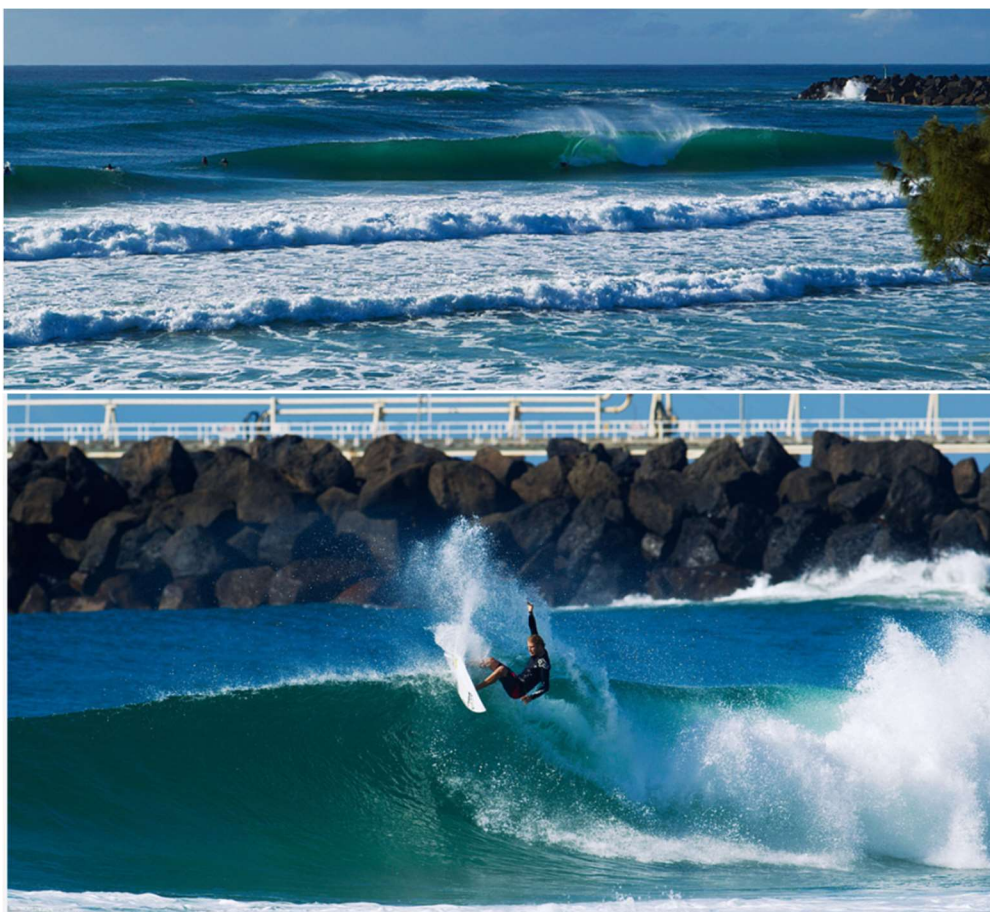
Figure 14 High quality surfing conditions on the peaks in the Middle section of Duranbah Beach (pictures: Andrew Shield)

Sometimes referred to as 'the middle section', 'middle peak' or 'middle bank', this wave breaking zone consists of between one to three 'A-frame' peaks (waves that peak up and break in both a left and right direction). As the name states, this section of Duranbah is located in the centre of the beach, just north of the Wall and just south of Lover's Left (**Sec 4.2.3**). Example images showing high quality surfing conditions at the Middle are provided in Figure 14.

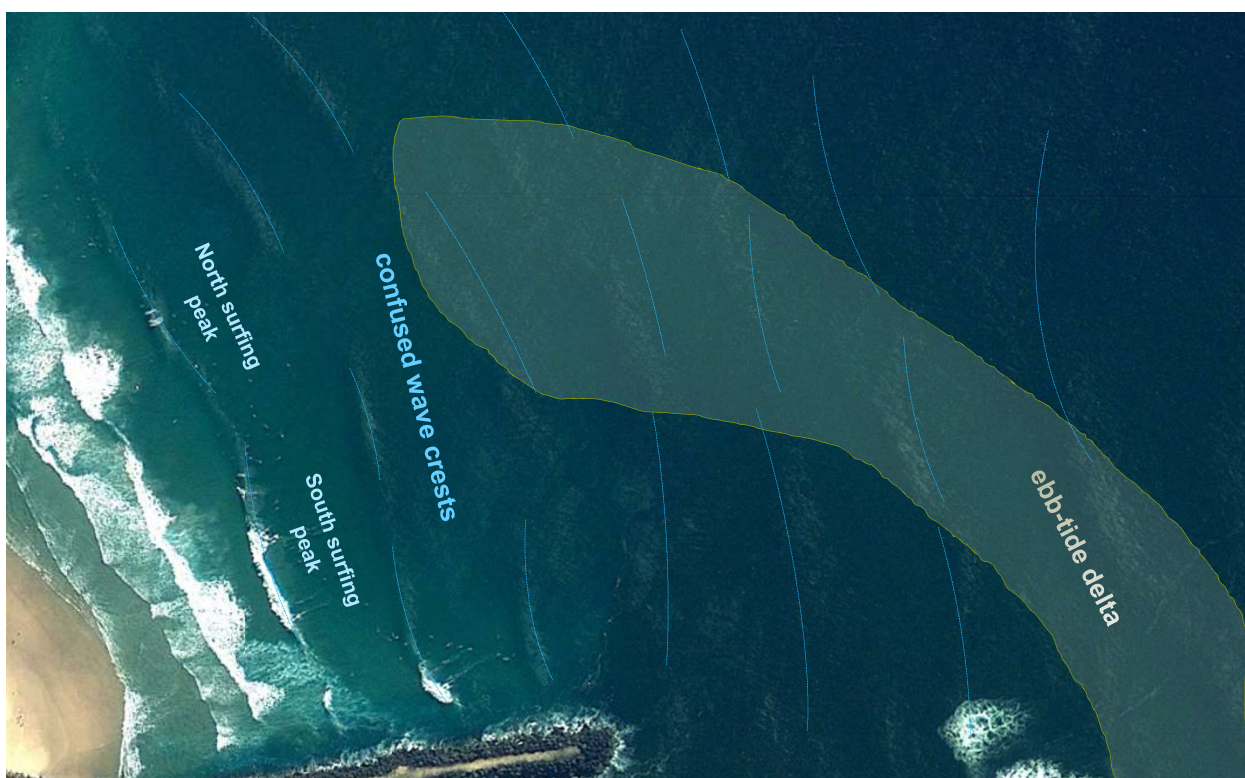
Figure 15 'Confused' wave crests in the lee of the Tweed River entrance bar. Two distinct peaks can be seen to be breaking along the 'Middle' section with several surfers centred on the breaking point of each (source: Google Earth 30 April 2009)

Consequently, during periods of medium to low wave heights along the rest of the Gold Coast, this section of Duranbah experiences larger waves as a secondary effect of the interference. These “peakier” waves are more amenable to high performance surfing with short but intense waves. The number and location of the resulting peaks as well as the breaking intensity and subsequent peel angles is a function of the shape, depth and location of the entrance bar to the wave breaking zone as well as incoming wave height, period and direction.

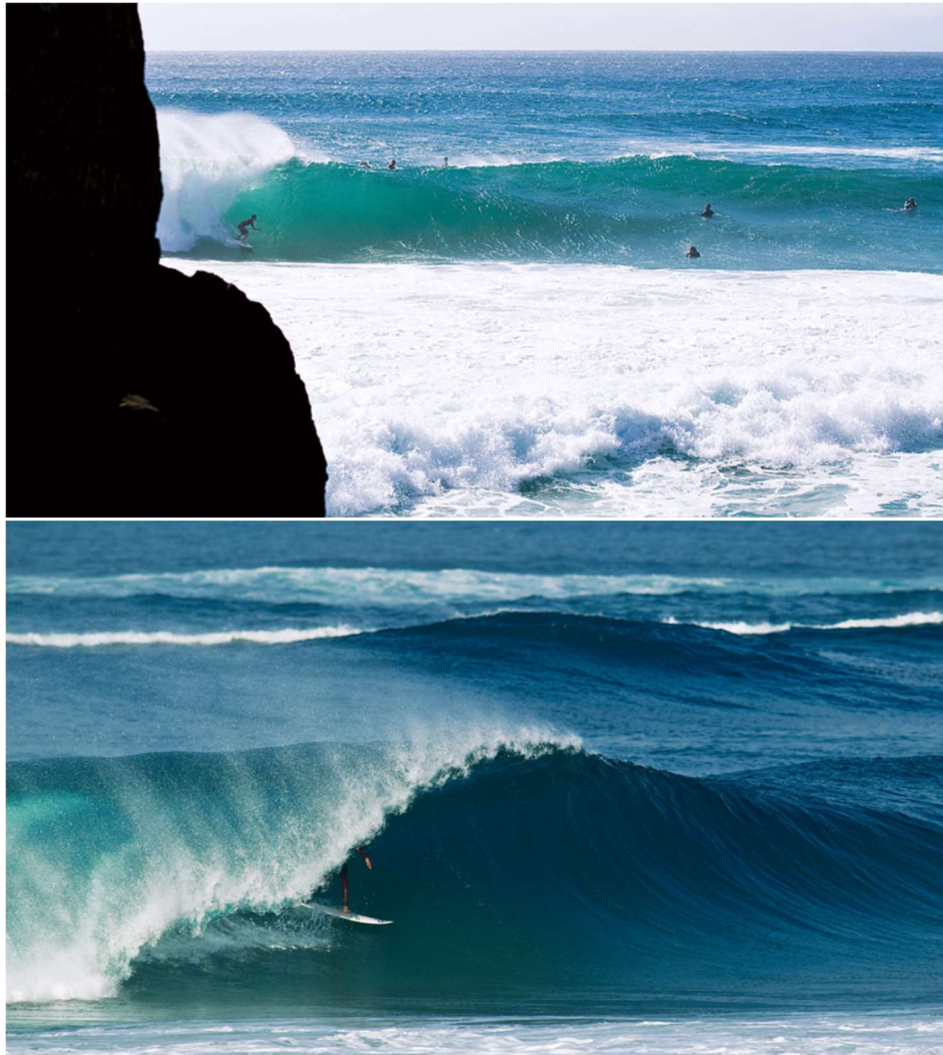
*Figure 18 High quality surfing conditions at the Lovers Left section of Duranbah Beach (pictures: Andrew Shield). Note the bottom picture is located further south (towards the middle of Duranbah Beach) than the top.*

Due to the less frequent occurrence of north-east swells of rideable height in combination with offshore or light, Lovers Left is known as an inconsistent surf spot. Even though it is generally classified as a pointbreak, Lovers Left is sometimes referred to by surfers as any left-hand ride that occurs at the northern end of the beach, Figure 18. Wave are generally short in nature and have a high breaker intensity.

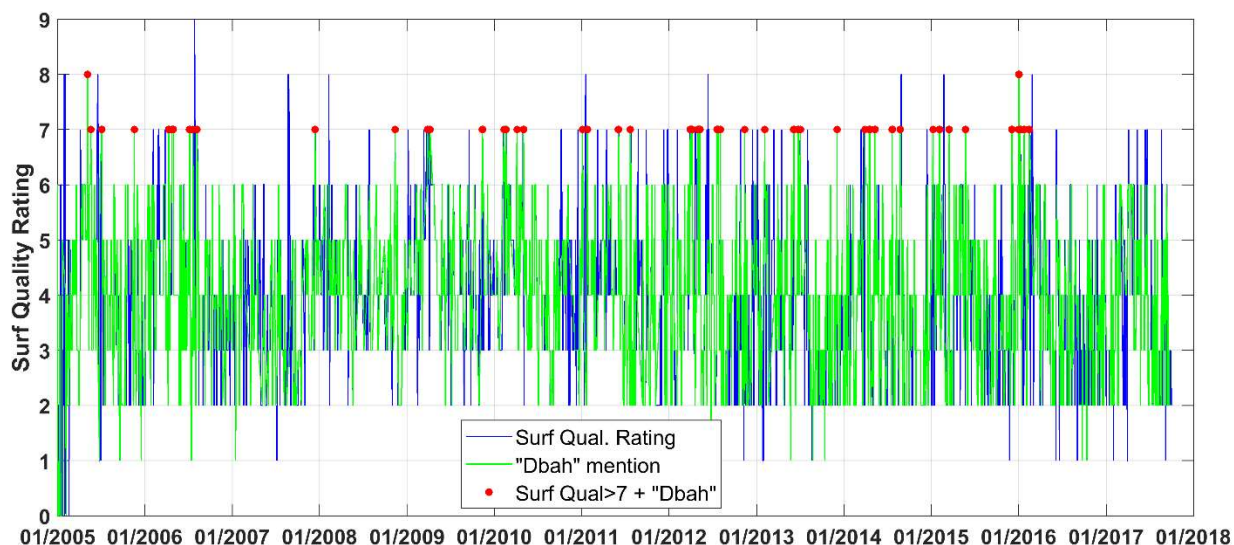
Figure 19 Analysis of Coastalwatch surf report data undertaken by John Charlton from 2005 – 2018. Blue line represents surf quality rating (1-10). Green line represents surf reports that mention 'Duranbah'. Red dots signify surf quality rating greater than 6 and mentioning Duranbah.

To identify high quality surf at Duranbah Beach, analysis was undertaken on the Coastalwatch dataset. A search was used to find days when the terms ‘Duranbah’, ‘Dbah’ or ‘D’bah’ were mentioned in the surf report. An additional filter identified when the surf quality rating was given as higher than a score of seven (top 1% of surf quality ratings). Of the 7,022 individual surf reports, 4,099 (58 per cent) mentioned Duranbah as the most suited beach for the daily conditions. This reaffirms the beach’s consistency surf status. Of these 4,099 mentions, 127 individual records had a surf quality rating higher than seven, this analysis is visualised in Figure 19.

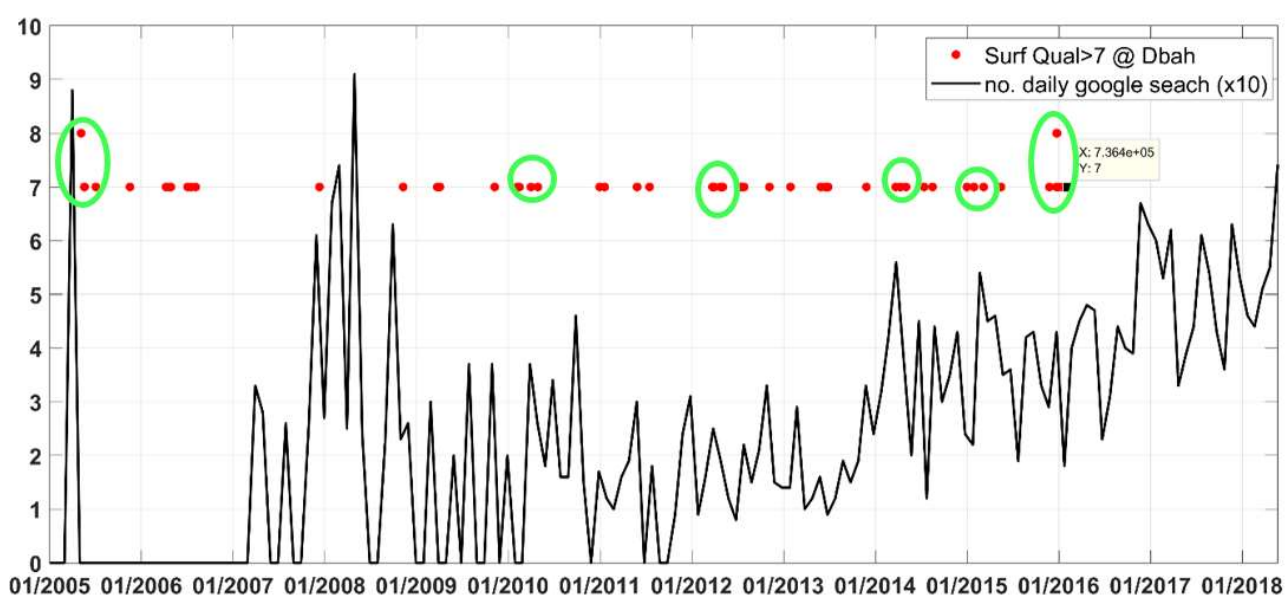
Figure 20 Identified high surf quality events at Duranbah (red dots) plotted against Google™ Analytics of "Duranbah" searches.

These clusters were then cross-checked with internet searches for "Duranbah" attained through the Google Analytics online tools to determine if there has been public searches, check-ins or video up/download activity undertaken. This cross-check of search history or activity can be seen represented by the black line in Figure 20.

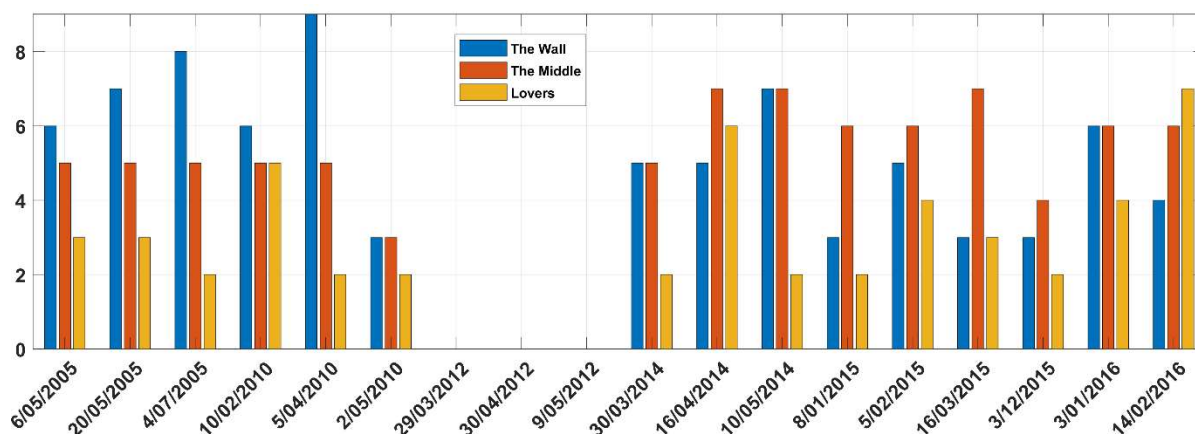
Figure 21 Surf quality rating (1 = poor, 10 = excellent) at each of the breaks of Duranbah Beach over the high surf quality clusters identified in Coastalwatch surf reports.

Of the 18 selected dates within each cluster, that only four of these dates had all three breaks (the Wall, the Middle, Lovers) with a rating based on image analysis of greater than 5, as seen in Figure 21. From this analysis and the definition of surf amenity at each of these locations, due to the nature of the metocean and geomorphic conditions that provide amenity at each break, it would be very rare for all three locations to be providing quality conditions at the same time. In general Lovers Left requires a N to ENE swell to provide the appropriate refraction around Point Danger for high surf quality (in conjunction with a light or offshore breeze). Whereas both the Wall and Middle require the more dominant E to SE swells (in conjunction with a light or offshore breeze). As such, for the purposes of this study, it is more cogent to focus on conditions at the Wall and (even more so) in the Middle in order to ascertain the influence the TSB project may have on surf quality at Duranbah Beach. Please note it can be seen that there was no video/imagery data for 2012 and as such this surf quality data cannot be verified and as such have been skipped.

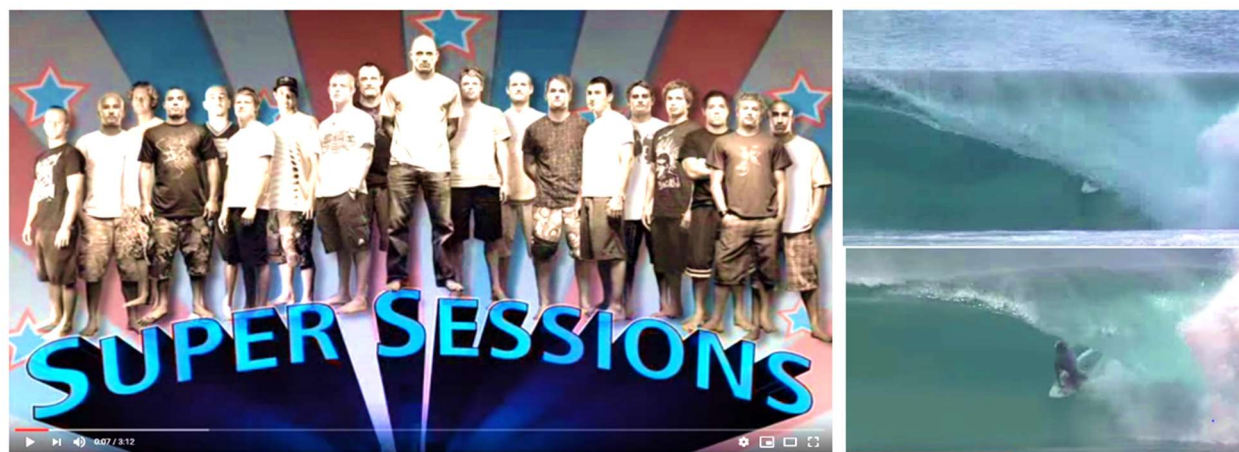
Figure 22 Screenshots from the Surfline video: Super Session, uploaded Feb 21, 2010 (source: [https://www.youtube.com/watch?v=s\\_piYvwsuYo](https://www.youtube.com/watch?v=s_piYvwsuYo))

In addition to these dates, another date has been selected based on one of the most popular video clips taken of Duranbah Beach posted by the surfing forecast website surfline.com, Figure 22. The video clip was posted on 21 February 2010 which coincides with the running of the Quiksilver Pro World Championship Tour (WCT) event held yearly at Snapper Rocks (27 February – 10 March, 2010) and has received over 32,000 views. The video features the world's best surfers practising prior to the commencement of the WCT event. Most of the surfing is seen to occur in the Middle and the Wall. The content for the video was collected over 2 or 3 sessions at Duranbah Beach in the week prior to the posting on the web (13 - 20 February 2010). Both the surfing and the conditions are seen to be 'world-class' in the video. Based on the quality of the waves in the footage and its online popularity (as opposed to videos created in similar time periods prior to the Quiksilver event in following years) the week commencing 13 February 2010 has also been identified as having high surf amenity for further analysis.

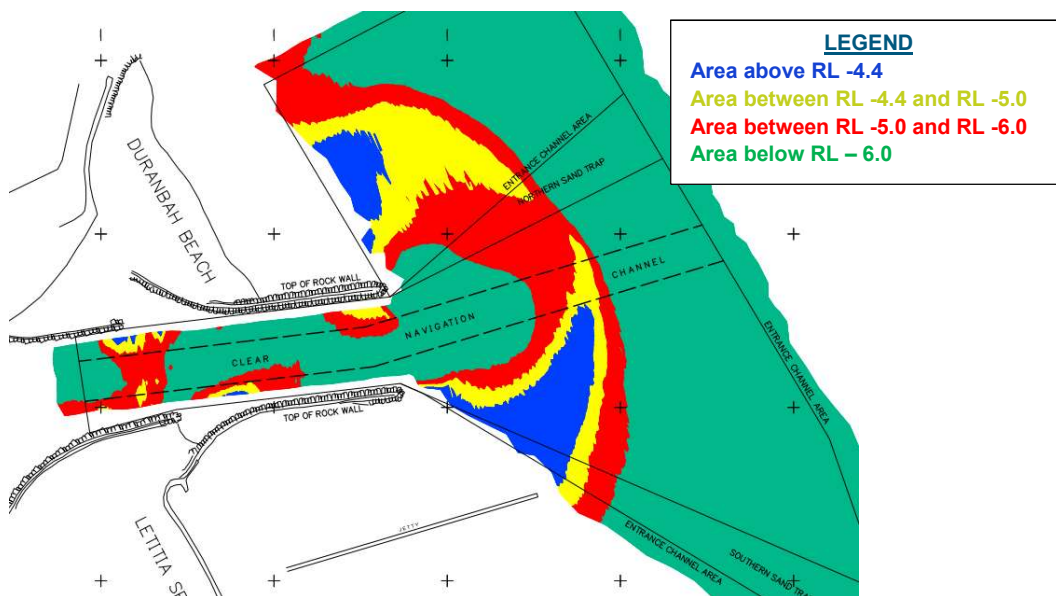
Figure 24 Tweed River Entrance Survey, November, 2017 showing a Centre breach state of the TRB. (Source: Lands)

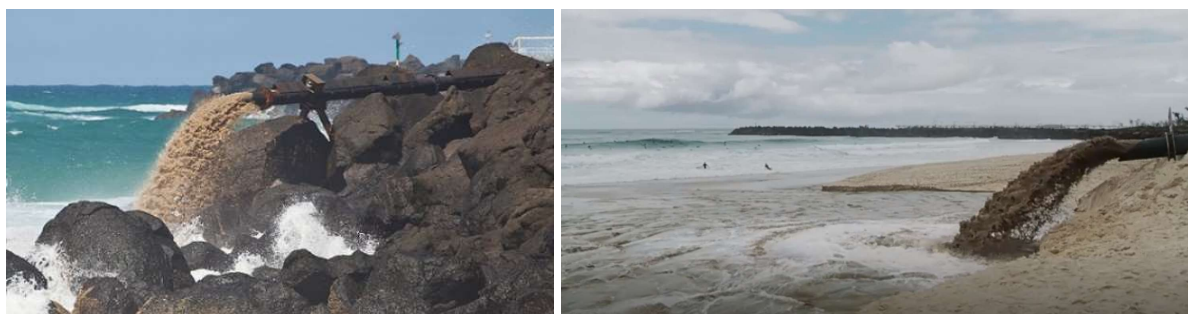
Figure 28 Sand pumping at Duranbah Beach; (left) off the northern training wall (source: Joli). (right) via temporary pipeline to the northern end of Duranbah Beach (source: Coastalwatch)

The use of a temporary sand pumping outlet (Figure 28) was setup to provide flexibility for varying discharge locations to address changes in the sand nourishment needs over the year and provides an effective mechanism for achieving the objectives of the sand delivery under a primarily twice-a-year placement program. It has been found that different discharge locations were better suited to achieve certain outcomes. The most pertinent of these to providing surf amenity has been the discharge from the training wall into the intertidal zone tends to more readily restore beach width with and build up the nearshore shoal along the training wall to form the surfing bank described in Section 4.2.1.

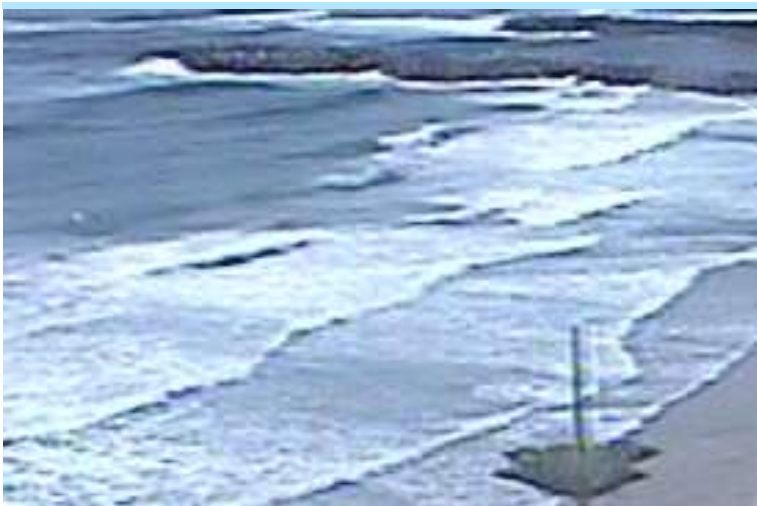
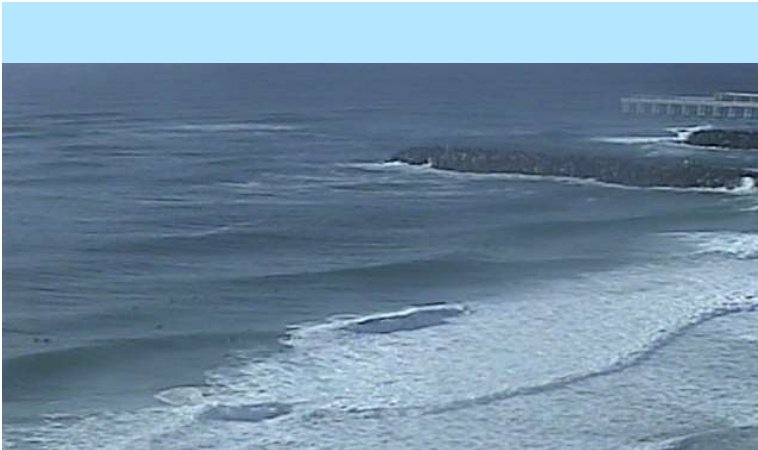
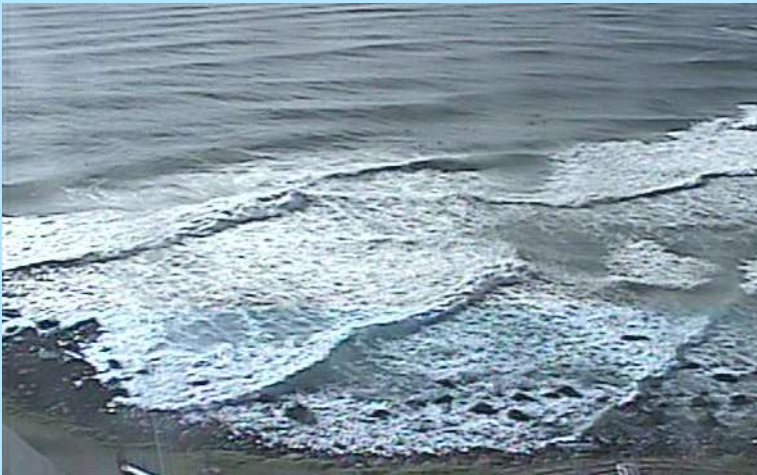
Date	Cluster	Number of Surfers (approx.)	Conditions Description	Wall Rating	Wall Image	Middle Rating	Middle Image	Lovers' Rating	Lovers' Image
06-May-2005	1	40 (9am)	<ul style="list-style-type: none"> <li>Hs~1.5m</li> <li>light winds until 12:00</li> <li>1 predominant peak in the middle</li> <li>Lovers' 200m wide of headland</li> </ul>	6

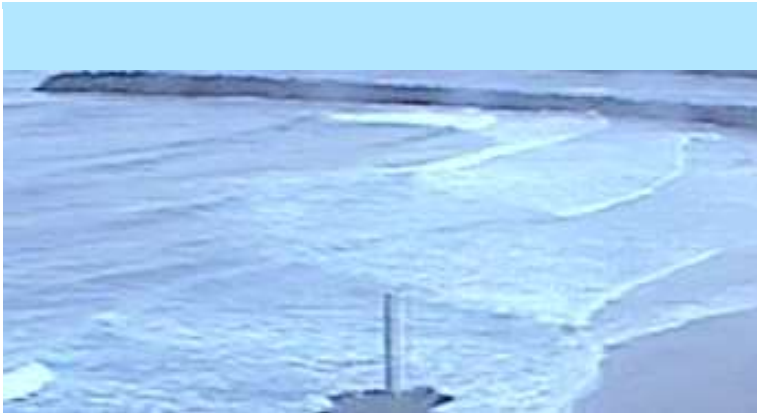
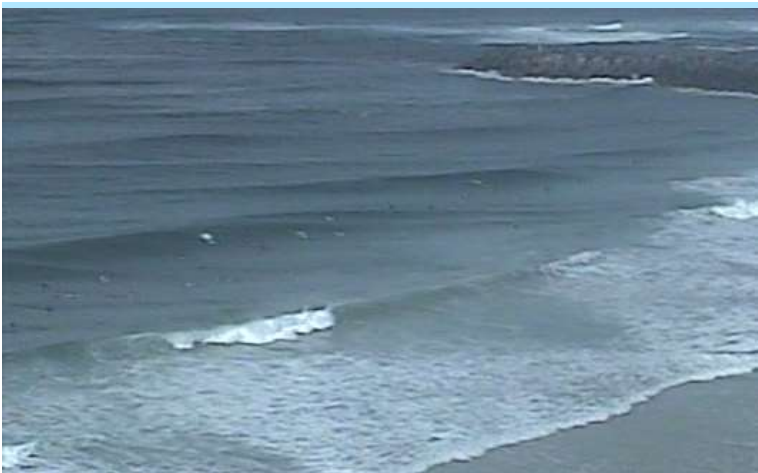
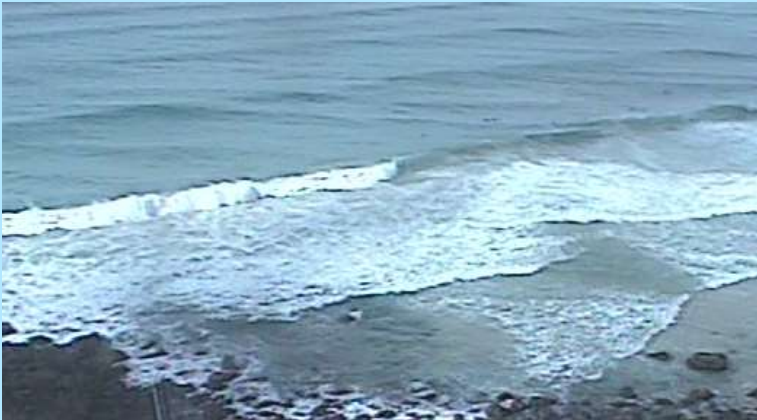
WRL: 08:00
20-May-2005	1	30 (9am)	<ul style="list-style-type: none"> <li>Hs~1m, very sth</li> <li>light winds all day</li> <li>2 predominant peaks in the middle</li> <li>Lovers' 300m wide of headland</li> </ul>	7

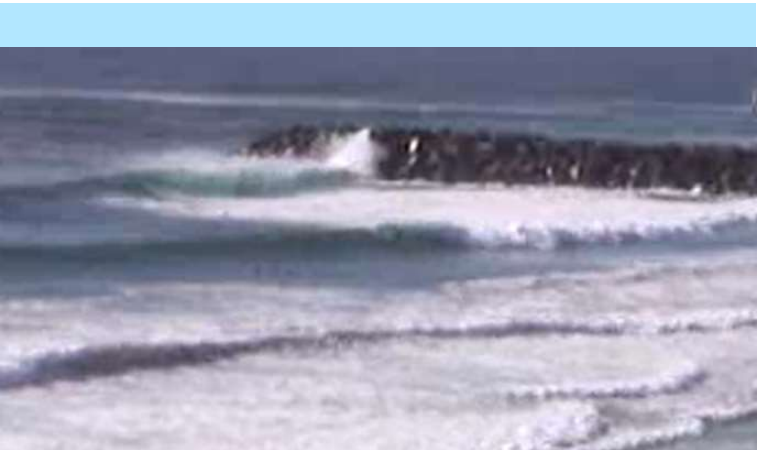
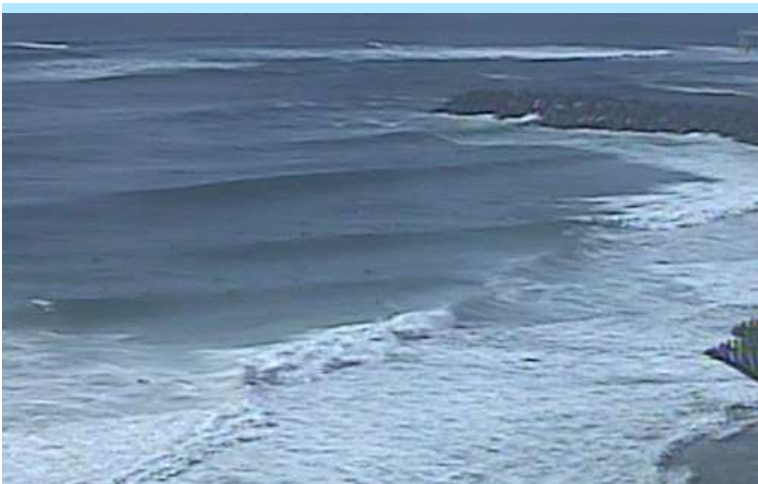
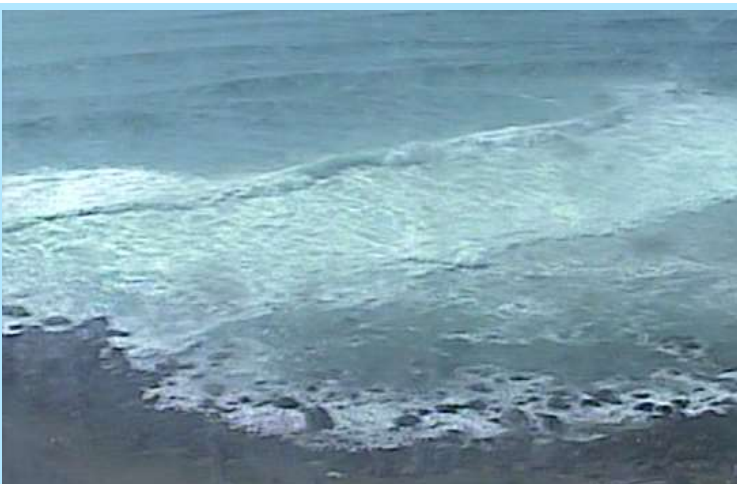
<p>WRL: 09:00</p>
05-Apr-2010	2	30-40 (09:00)	<ul style="list-style-type: none"> <li>• Hs~1.5-2m.</li> <li>• light winds until 15:00</li> <li>• long right-hand bank against the wall</li> <li>• 1 predominant peak in the middle</li> </ul>	9

- 5 April 2010 (rating of nine for the Wall and five for the Middle)
- 10 May 2014 (ratings of six for both the Wall and the Middle)

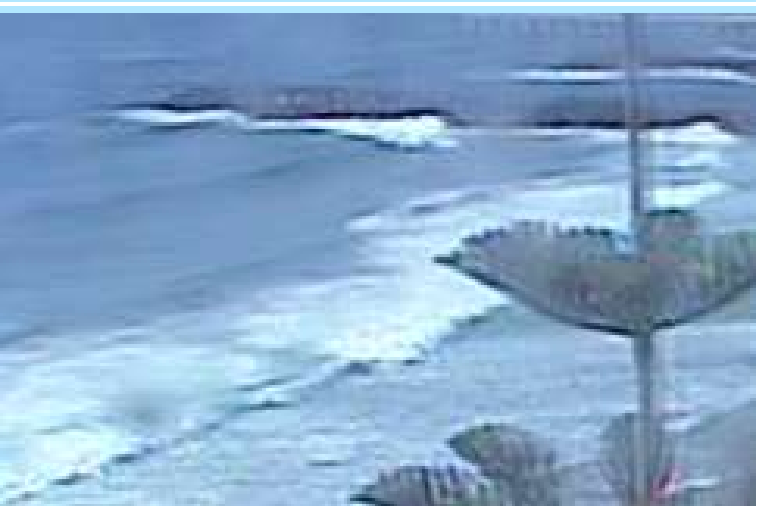
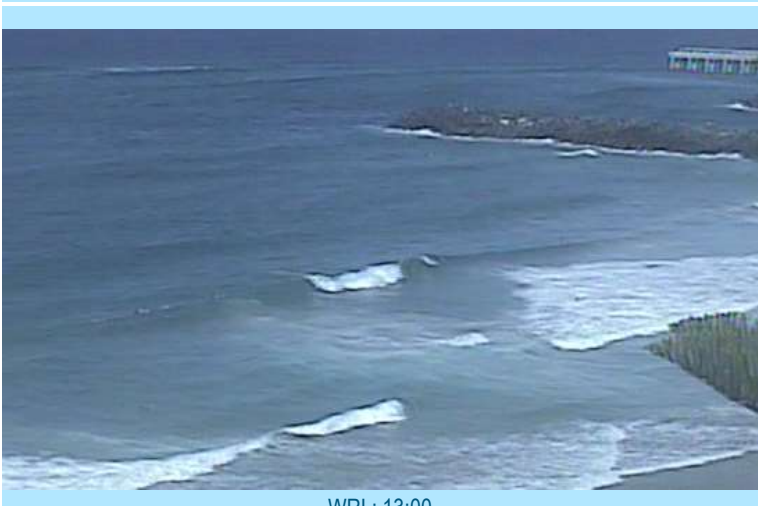
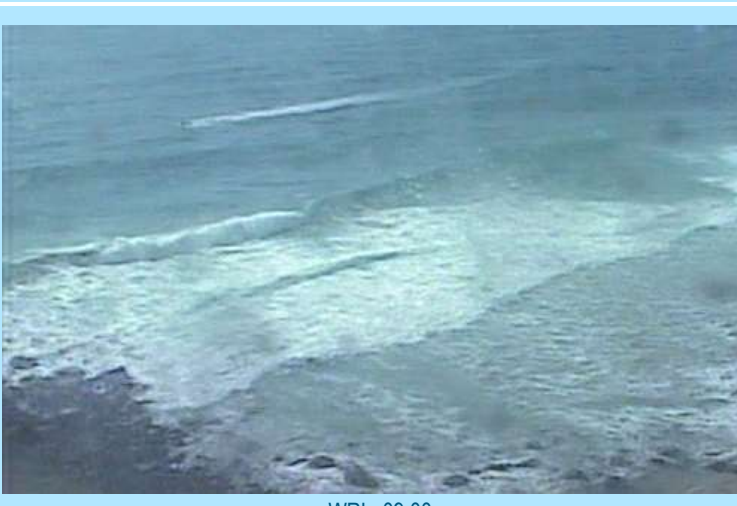
<p>WRL: 09:00</p>
02-May-2010	2	20-30 (09:00)	<ul style="list-style-type: none"> <li>• Hs~1m.</li> <li>• light winds until 15:00</li> <li>• small inside right against wall – high peel angle (fat)</li> <li>• no predominant peak in the middle, very straight</li> </ul>	6

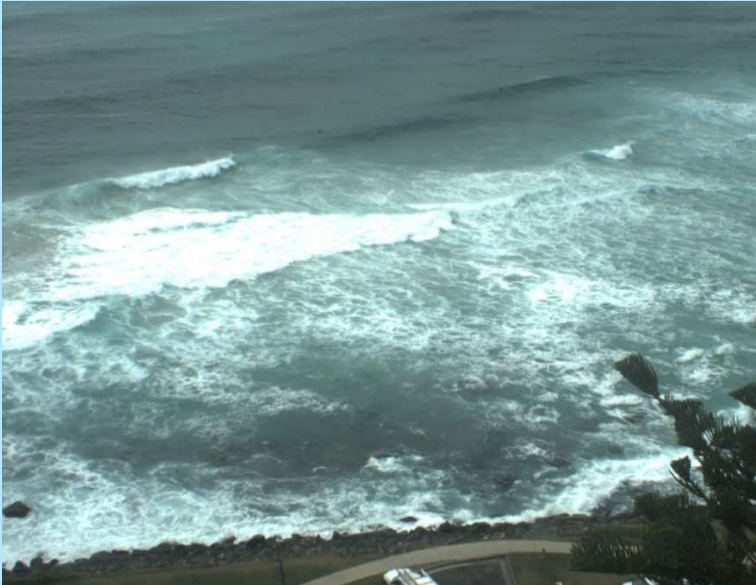
WRL: 11:30
16-Mar-2015	5	20 (09:00)	<ul style="list-style-type: none"><li>• Hs~1.5-2m.</li><li>• Large transient peaks</li><li>• Some waves breaking on delta</li><li>• waves breaking against nth wall</li></ul>	3

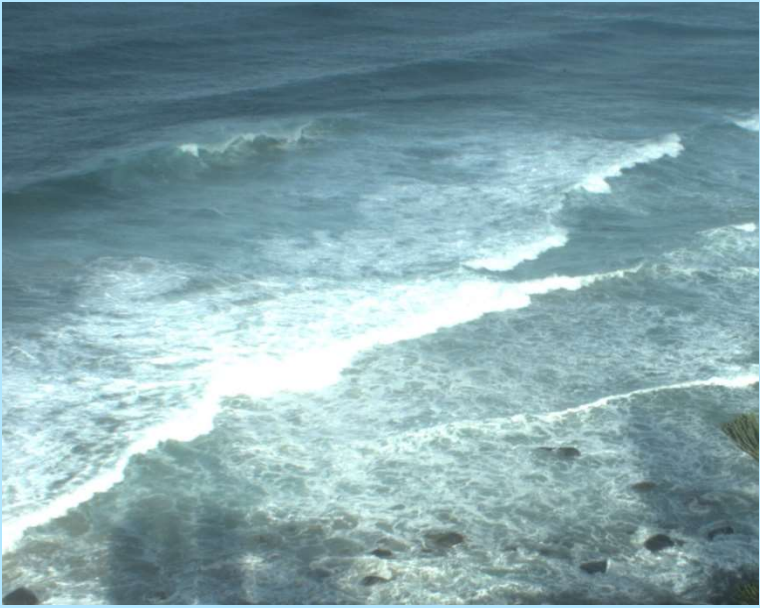
WRL: 15:00
3-Dec-2015	6	20-30(09:00)	<ul style="list-style-type: none"><li>• Hs~1m.</li><li>• windy by 10:00</li><li>• very straight</li><li>• transient peaks</li></ul>	3

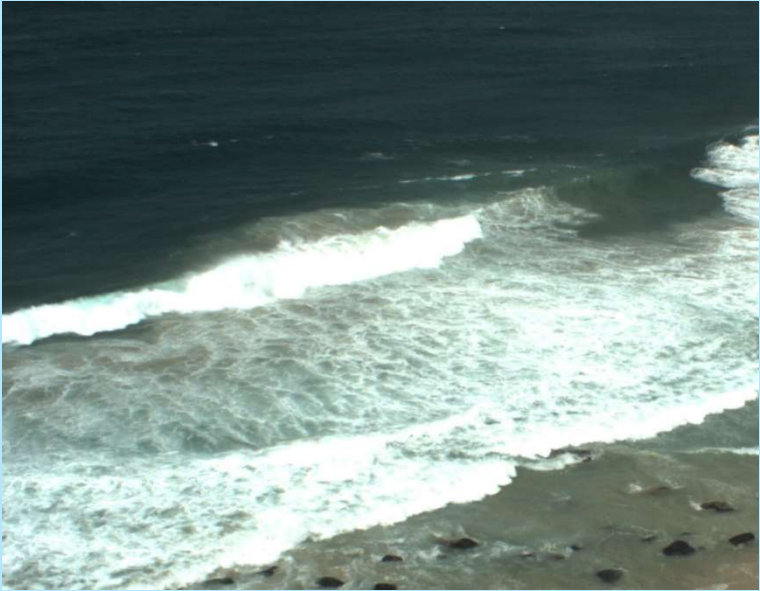
03-Jan-2016	6	50-60 (09:00)	<ul style="list-style-type: none"><li>• Hs~1m.</li><li>• transient peaks</li></ul>	6

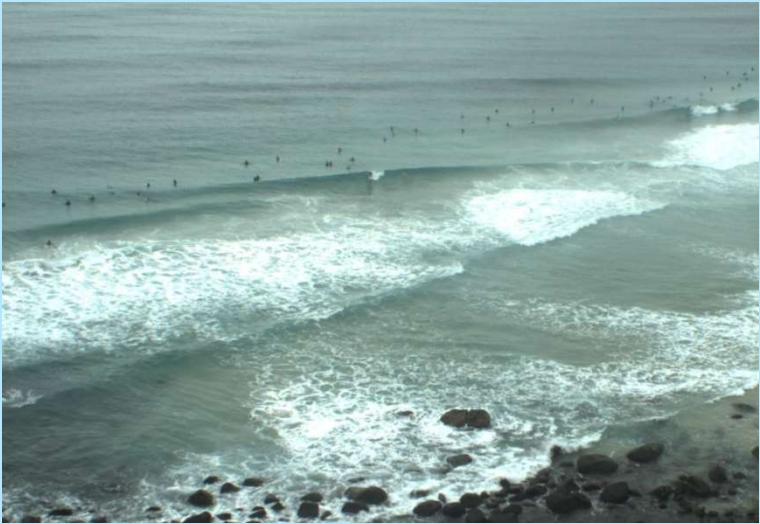
<p>WRL: 9:30</p>
14-Feb-2016	6	30 – 40 (09:00)	<ul style="list-style-type: none"><li>• Hs~1m.</li><li>• 2 predominant peaks</li><li>• Predominant south swell</li><li>• Windy by 13:00</li></ul>	4
